GRAYLING HEALTH CLINIC

Alaska Rural Primary Care Facility Code and Condition Survey

Final
July 23, 2001

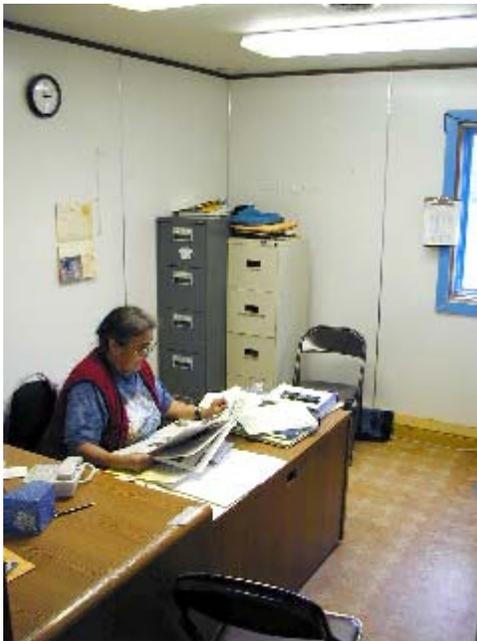
Main office area

- e. Administration / Records – There is the single office room space used for all administrative, records, scheduling, telemedicine and other functions. The functions are also spread to the office/corridor in the rear that has a desk and computer for other health workers. Note that electrical service is completely inadequate for the needs of the equipment.
