DISTRICT TRIP REPORT

Project: Denali Commission Moorings Points Phase 4 – Yukon River

Description: Ruby Trip Report

Date: 6 June 2011

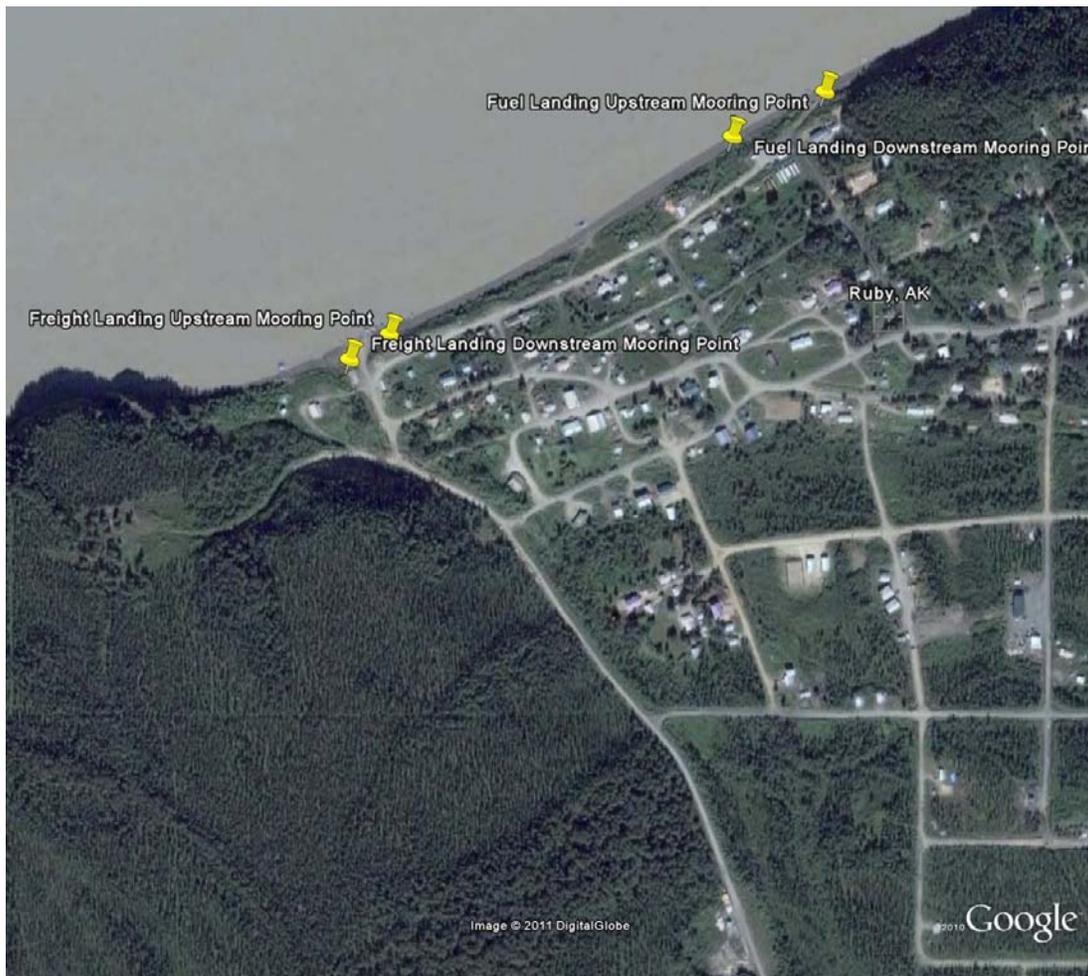
Figure 1. Overview of Ruby, barge landings, and proposed mooring point locations. The Yukon River flows right to left.

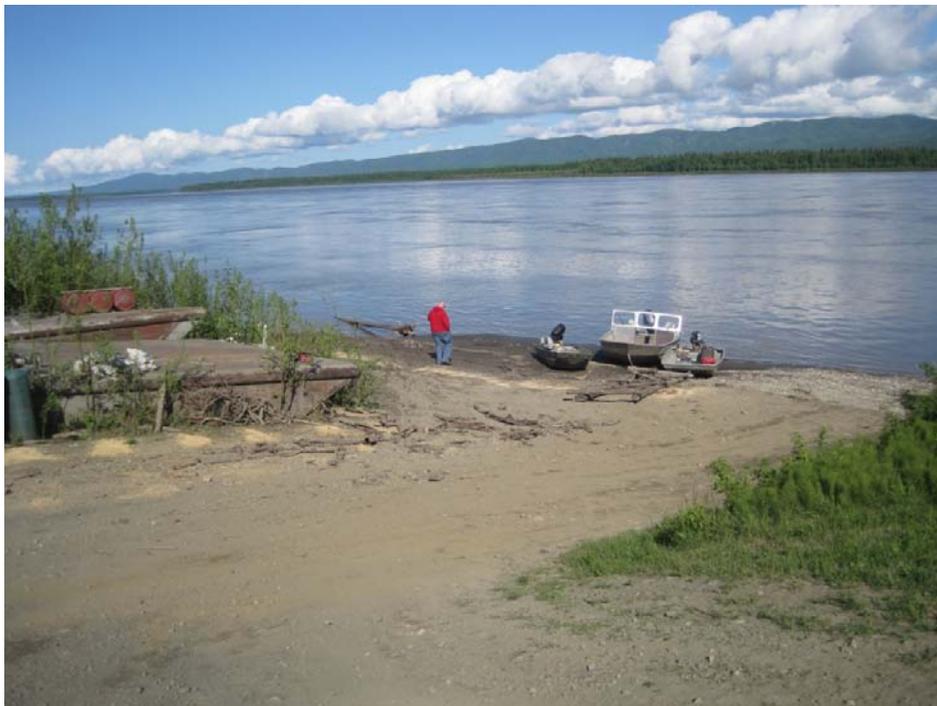
The freight landing is the downstream landing in Ruby. It consists of a ramp perpendicular to the river (Photo 1) with bluffs adjacent on both sides. There is some evidence of bank sloughing but in general, the banks look rather stable.

Photo 1. Ruby freight barge landing site. Note abandoned barges to the left of the ramp. Proposed downstream mooring point at this site is adjacent to the far end of the furthest barge.

The location for the proposed downstream mooring point is located by a small creek and adjacent to the stern of a barge that appears to be abandoned in a brushy area (Photos 1 & 2). Google Earth coordinates of this location are approximately 64°44'20.06"N and 155°29'55.61"W. An above grade installation is appropriate at this site.

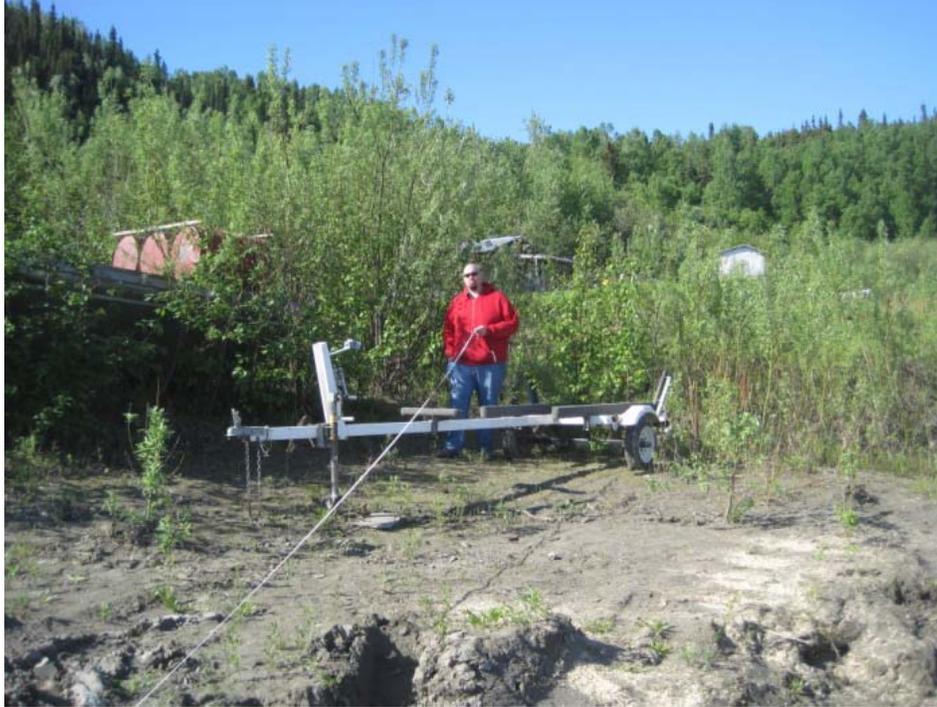
Photo 2. Corps employee standing at location of proposed downstream mooring point. Abandoned barge is to the left of employee partially obscured by brush. A small creek is located immediately behind him.

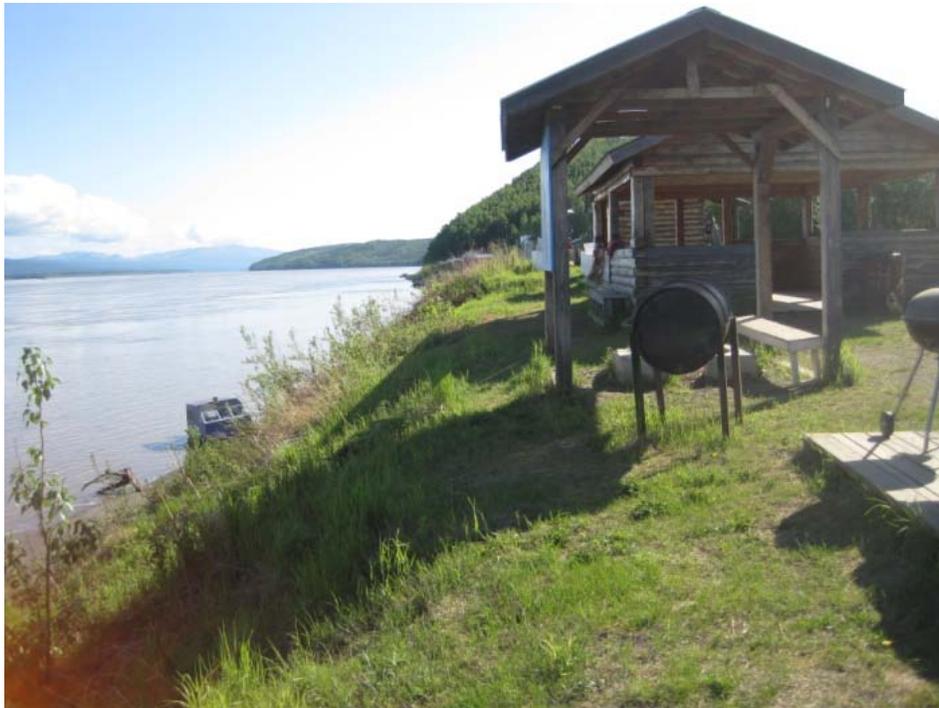
Photo 3. Looking upstream from proposed location of Ruby freight landing upstream mooring point.

The location of the proposed upstream mooring point is 150' from the downstream mooring point at the top of bank approximately 8 feet west of a picnic table in a small park area (Photos 3 - 6). Google Earth coordinates of this location are approximately 64°44'20.89" N and 155°29'52.51"W. A below grade installation is recommended here to avoid potential conflicts with activities at the park and picnic area.

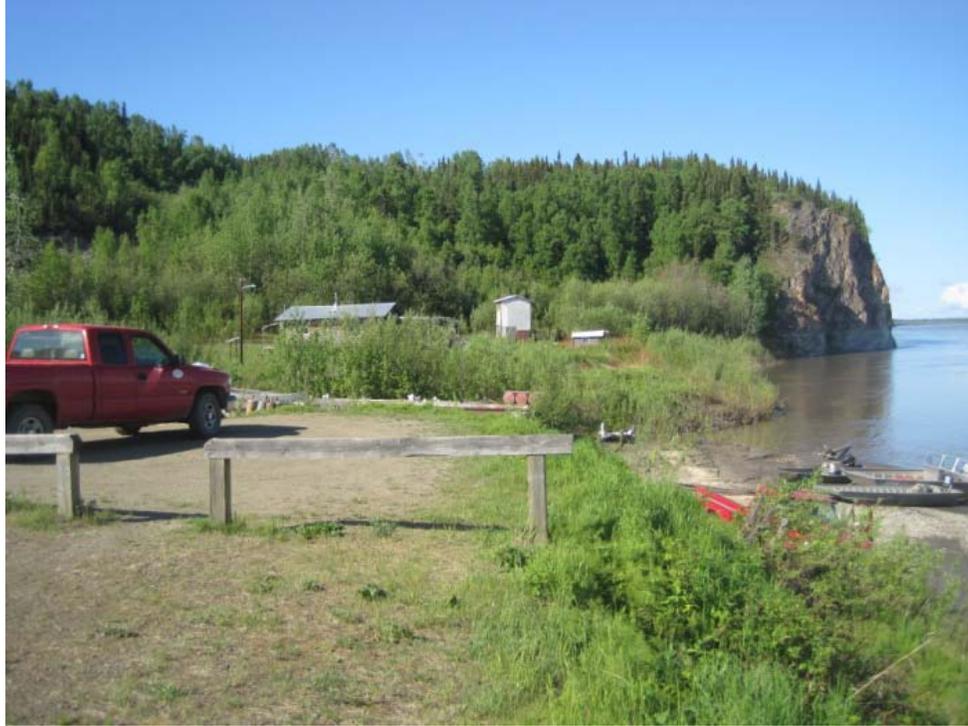
Photo 4. Looking downstream from proposed location of Ruby upstream freight landing mooring point.

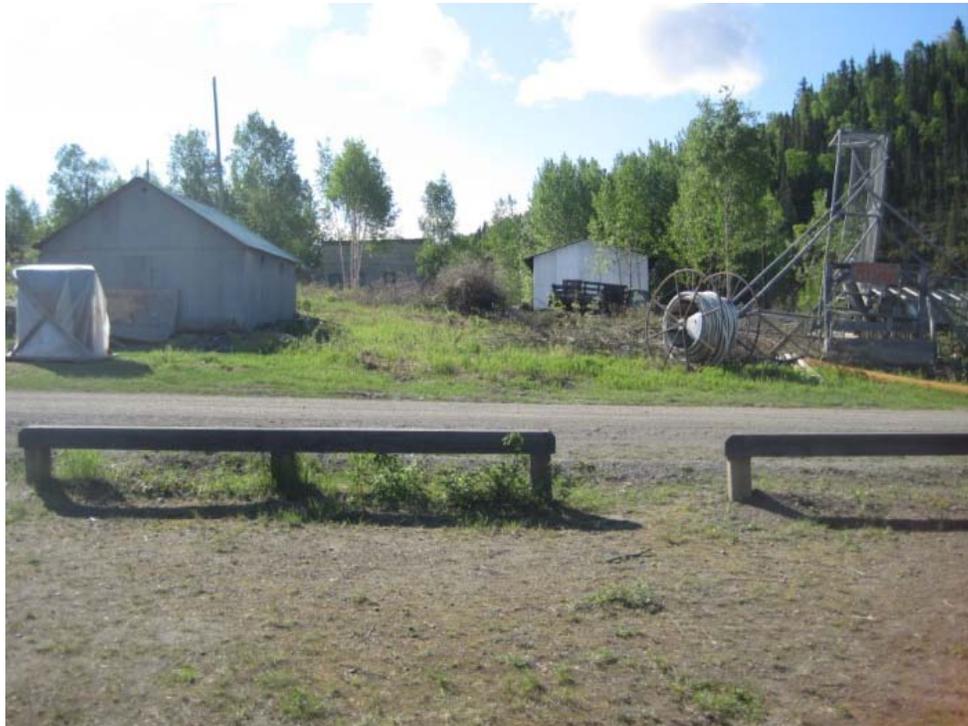
Photo 5. View inland from proposed location of Ruby freight landing upstream mooring point.

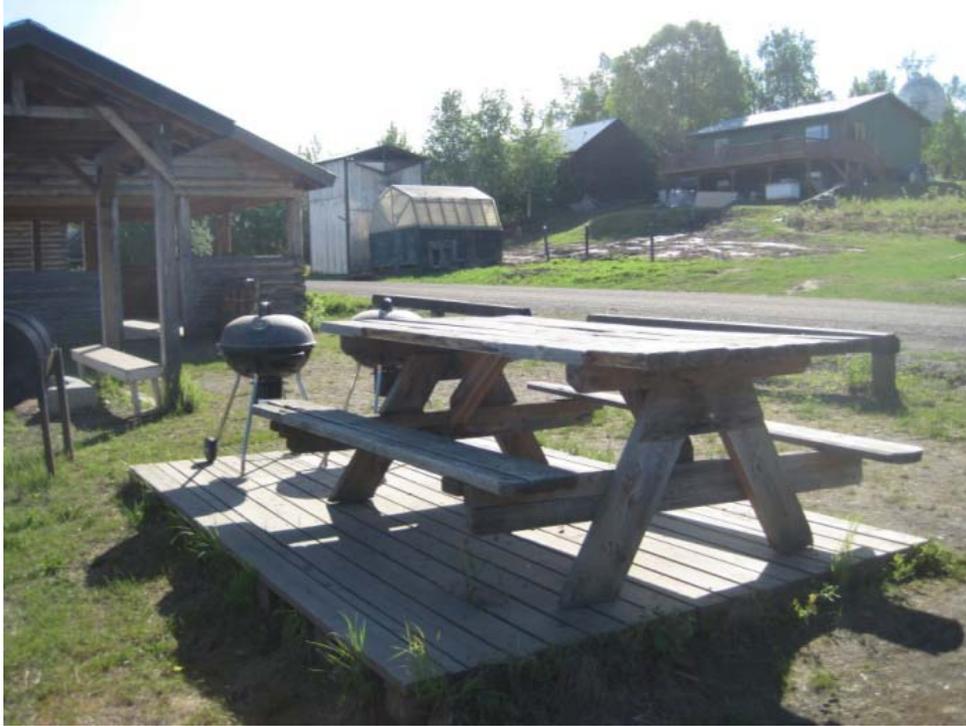
Photo 6. View of picnic table adjacent to proposed location of Ruby freight landing upstream mooring point.

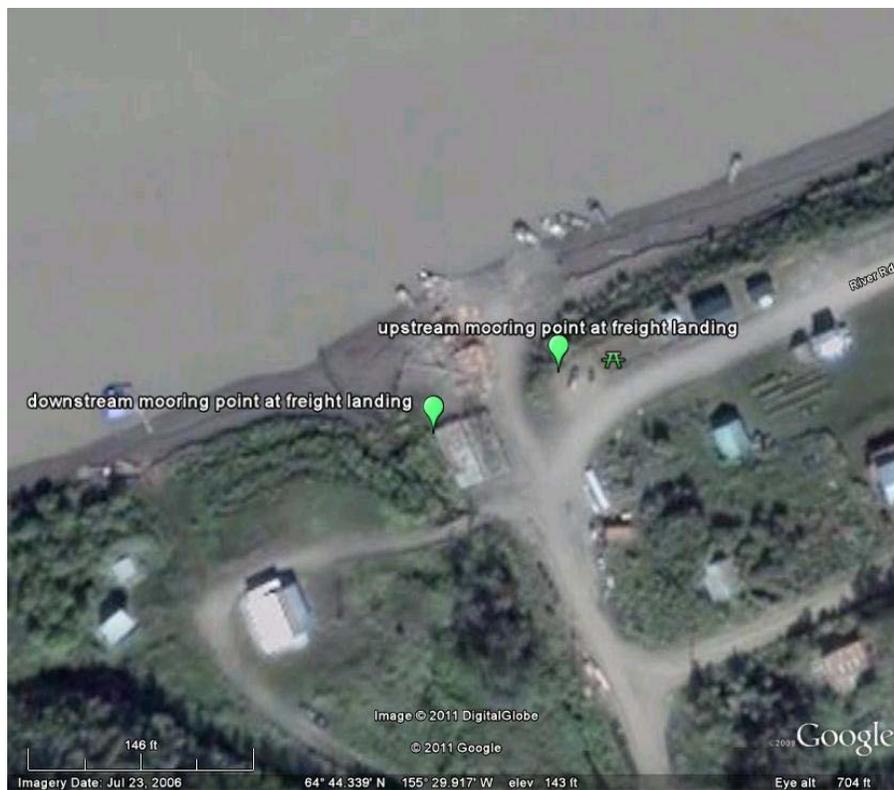
Figure 2 is a Google Earth image showing the proposed locations of both mooring points.

Figure 2. Overview of Proposed Freight Landing Site Mooring Points

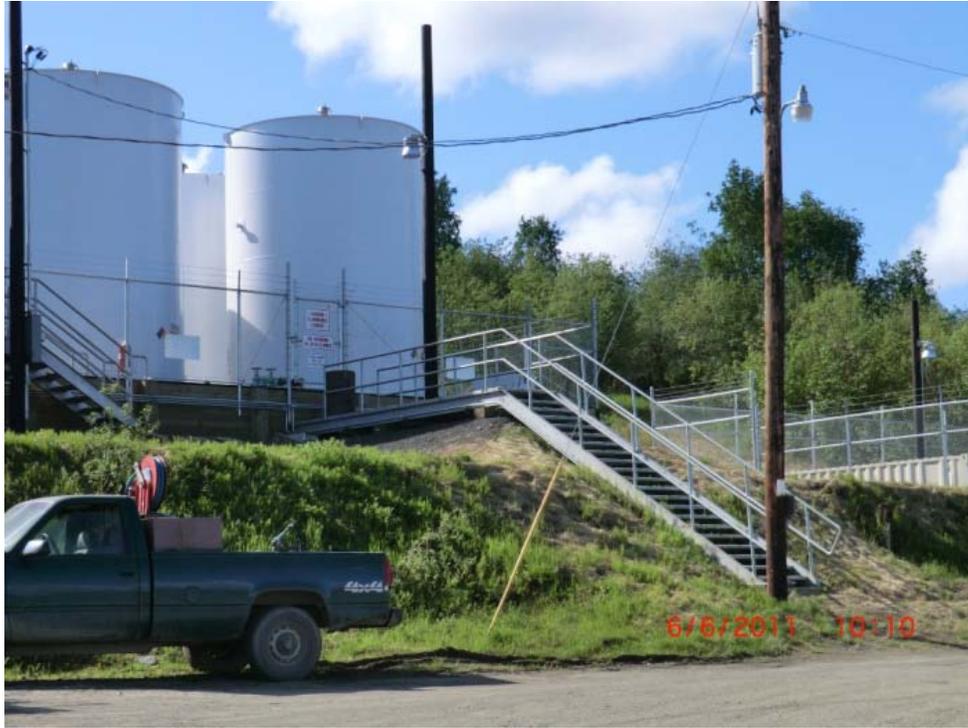
The fuel headers are at the top of a metal staircase located at the base of the tank farm (Photo 7).

Photo 7. Ruby fuel headers adjacent to top of stairs.

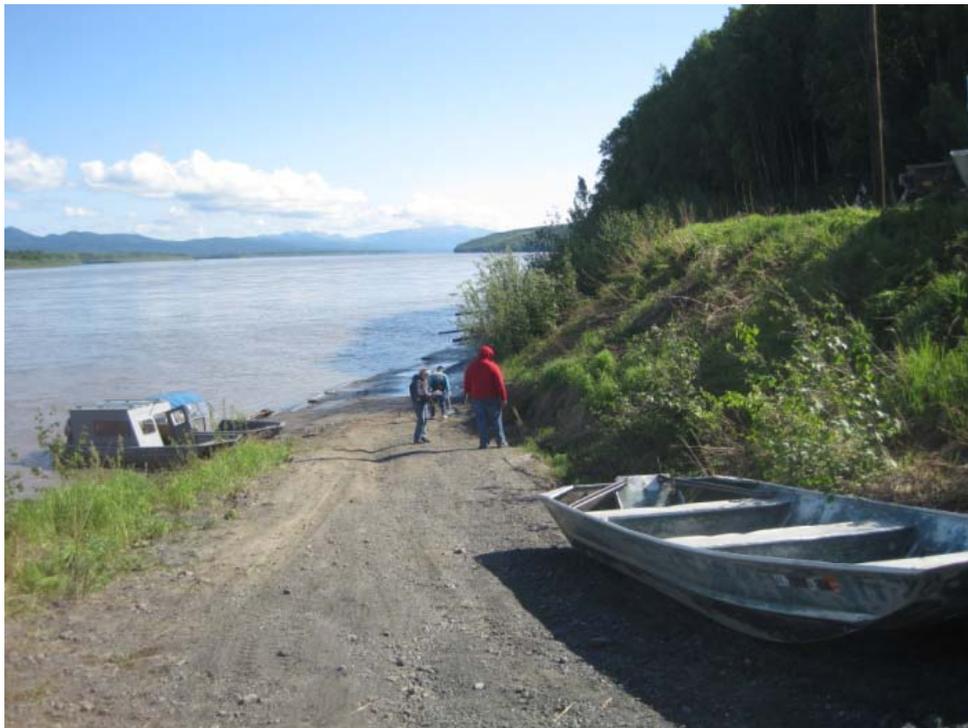
This landing site consists of a ramp parallel to the river that angles down the river bluff to the shore of the river (Photo 8).

Ruby residents informed us that barges have tied off to the utility pole located at the top of the bluff above the broken cable (Photo 8).

Photo 8. Ruby fuel barge landing site looking upstream. The proposed upstream mooring point location is 75 feet upstream of the centerline of the landing. The mooring point would be above ground at the top of the bluff.

Matt Sweetsir recommended placing an upstream mooring point 75 feet upstream of the centerline of the ramp at the top of the bluff. Google Earth coordinates of this location are approximately 64°44'29.00"N and 155°29'18.39"W.

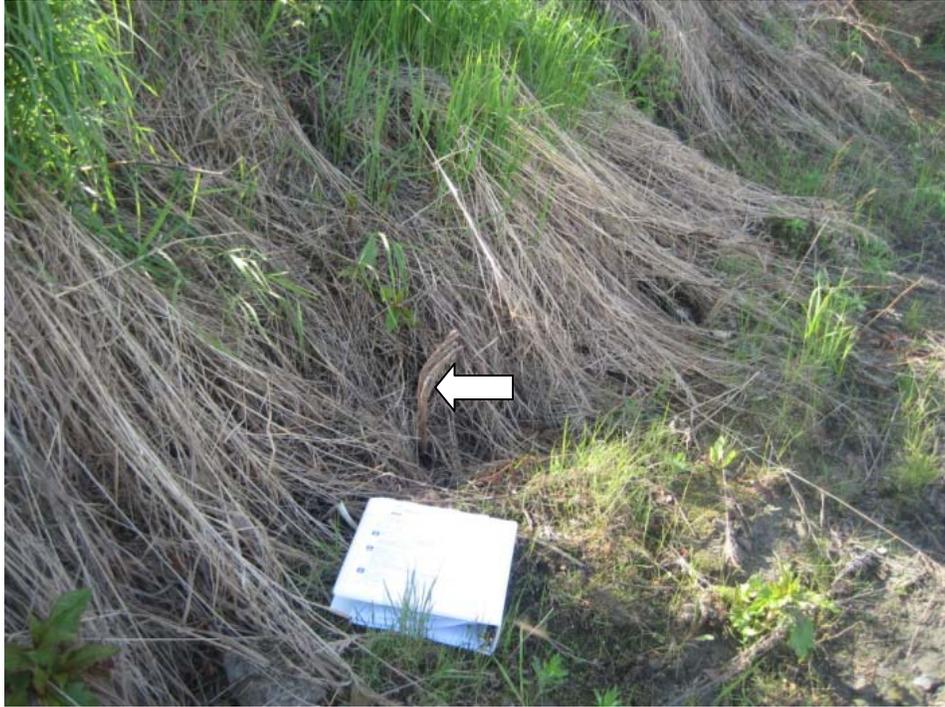
We were told there were deadmen with cables at this landing site. The fuel operator, Ivan, told us that one mooring point became buried and hasn't been located since the landing ramp was regraded following the most recent flood in 2010. We found a broken mooring cable at the base of the bluff adjacent to the landing ramp (Photo 9). This could be a remnant of the deadman.

Photo 9. Broken mooring cable (located above notebook)

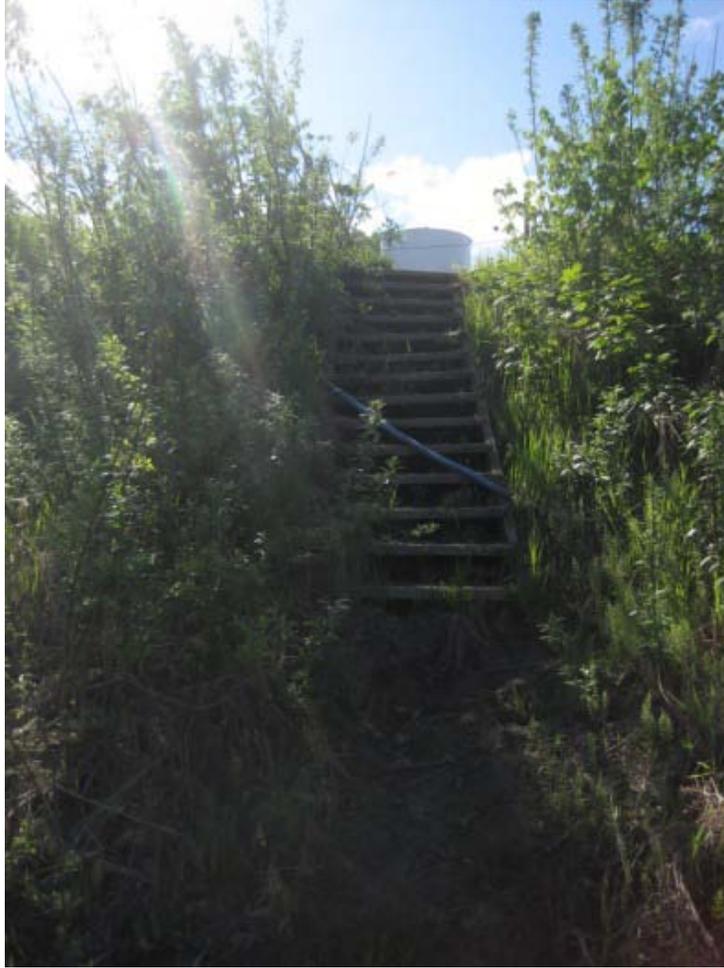
Photo 10. Stairs leading to area of fuel headers. The downstream fuel landing mooring point is to be placed 75 feet downstream of the stairs.

Matt Sweetsir recommended placing a downstream mooring point at the top of bank 75 feet downstream from a staircase that transects the river bank to reach the fuel headers (Photo 10). Google Earth coordinates of this location are approximately 64°44'27.49"N and 155°29'25.64"W. An above grade installation is appropriate at this location.

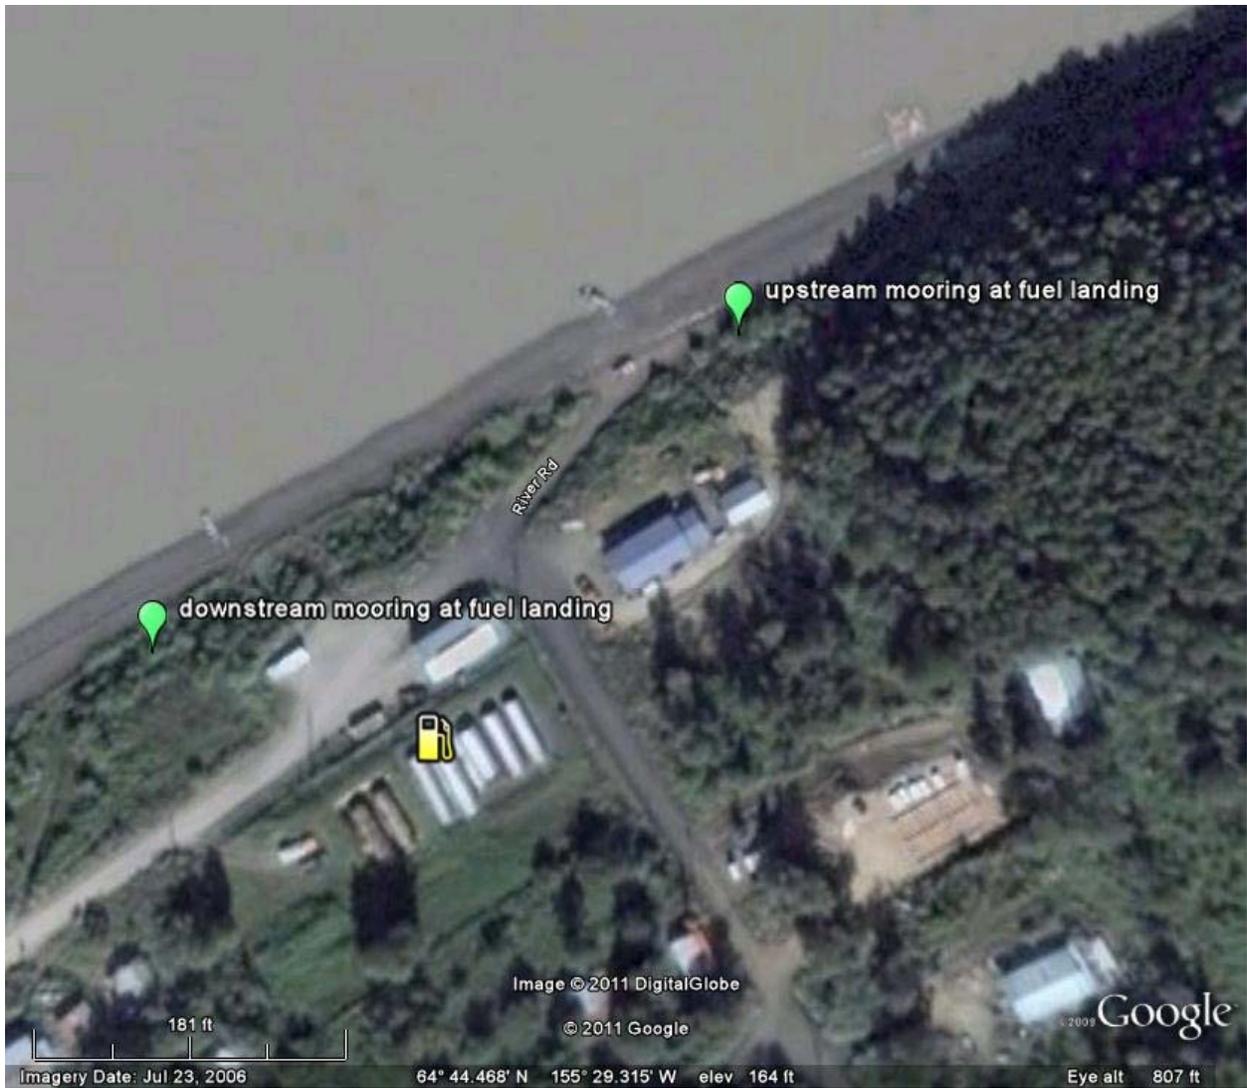
Figure 3 is a Google Earth image showing the proposed locations of both mooring points.

Figure 3. Overview of Proposed Mooring Points at Fuel Landing Site
