# Adak Airport Lighting Replacement Rebid/58433

Weekly Progress Report (8/25/08)

Period: 8/12/08 to 8/24/08

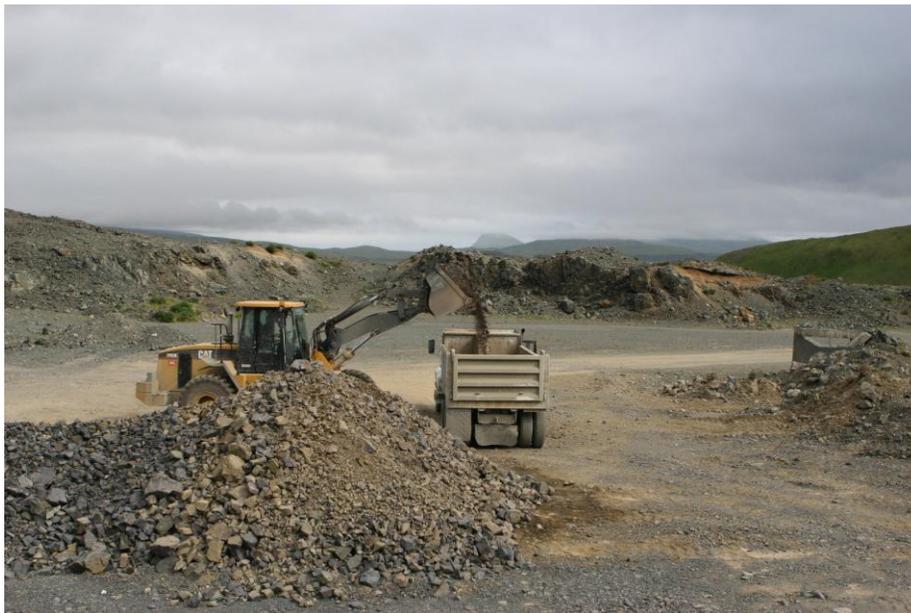
Segmented Circle Borrow material has been significantly increased by load counts. The dump truck has 15 CY capacity and I have estimated 10 CY per load. We have counted over 370 loads where plan quantity is 2870 CY in place. I still have to calculate based on the OG shots and Final Shots.

Loading Borrow, Lower Navy Pit

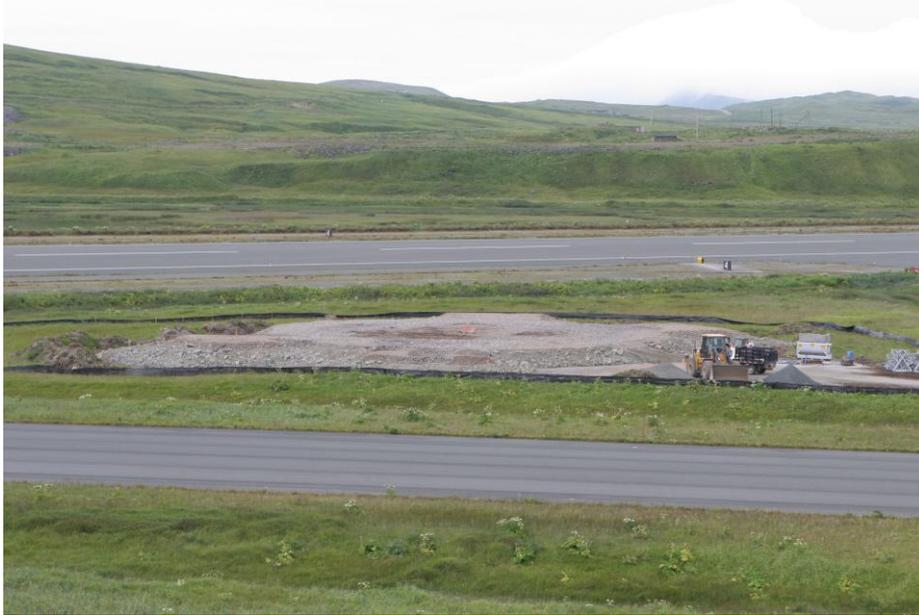
Hauling completed by 8/12/08, but I discovered some problem. When it was laid out, the indicator pads were staked with clockwise pattern by mistake. The Landing Strip Indicator did not line up with current Runway layout. Lakloey repaired the problem by 8/14/08.

Segmented Circle Pad, looking north

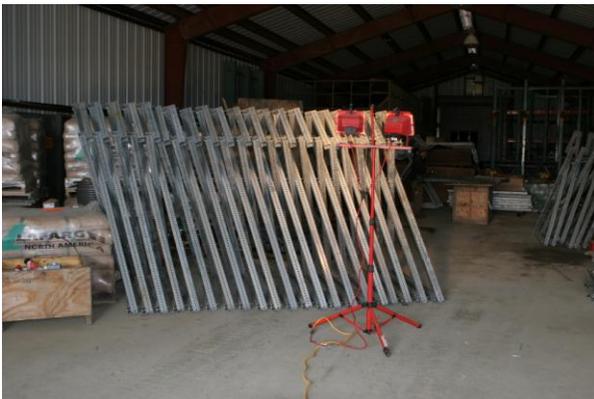
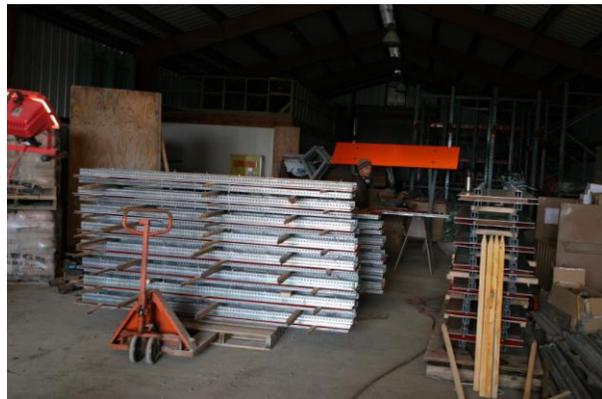
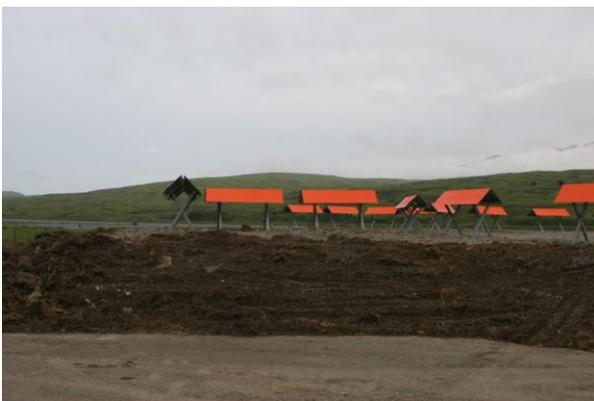
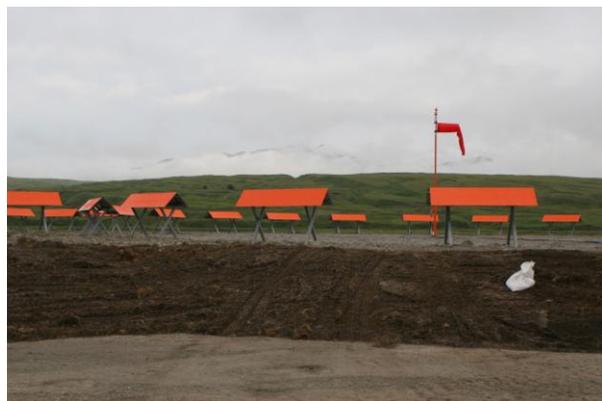
Stanchions were pre assembled in the shop and staged at the Segmented Circle Pad for the installation. Orange reflectors were attached on site.

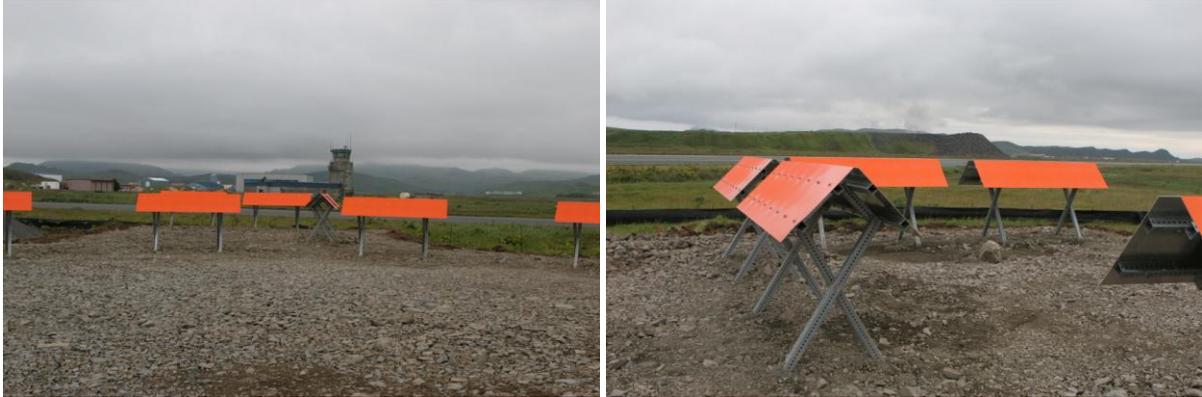
After the installation, the slopes were dressed up with the top soil that were saved during the grubbing process and seeded, fertilized.

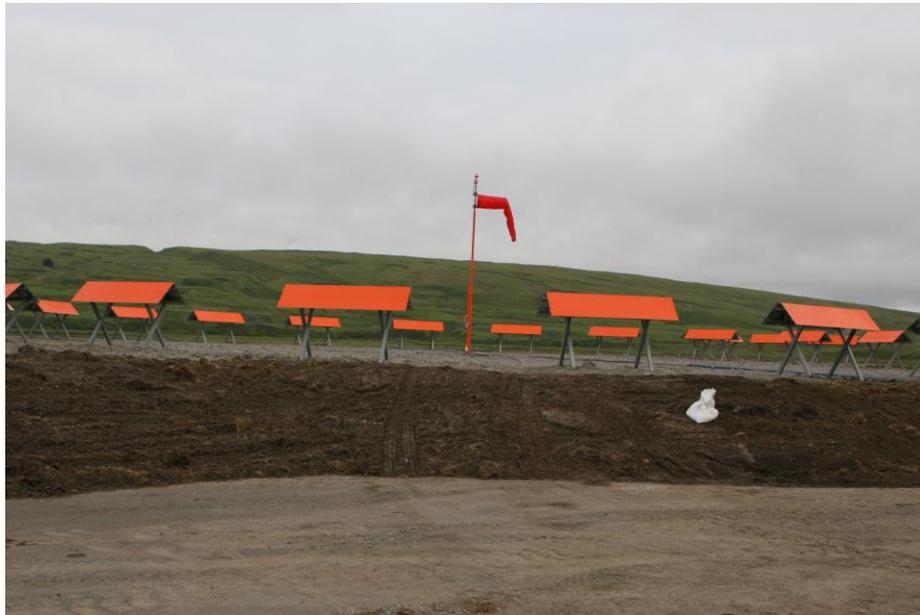
Wind Cone at Segmented Circle

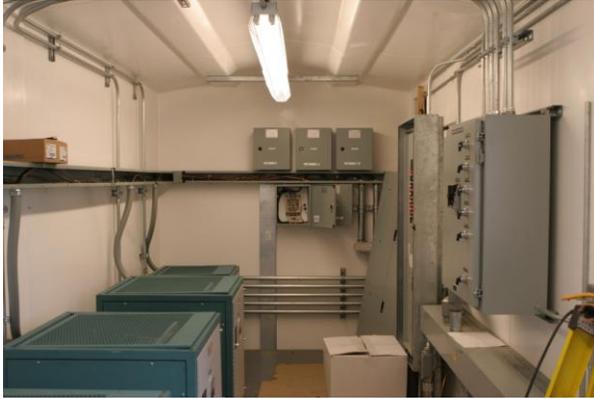
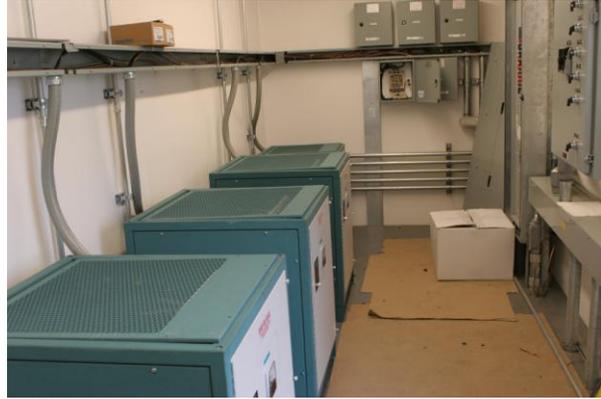
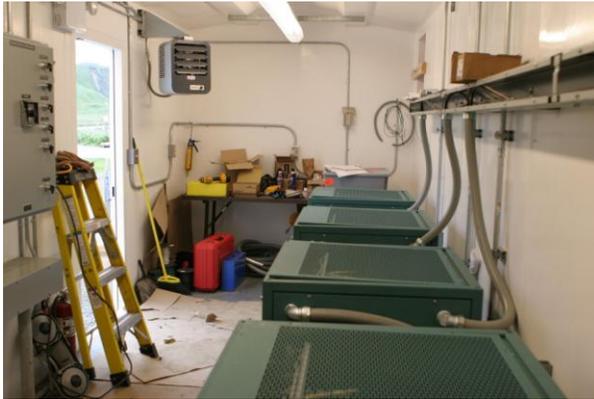
T2516A Transformer

All regulators have been installed and radio controller has just installed yesterday (8/24/08). We weren't expecting the regulators until next week. Somehow, Alaska Air was kind enough to send our project's freights before local groceries. We have also received wrong kind of exhaust system rather than what Lakloey ordered. EE Building is ready to be tested except the exhaust system.

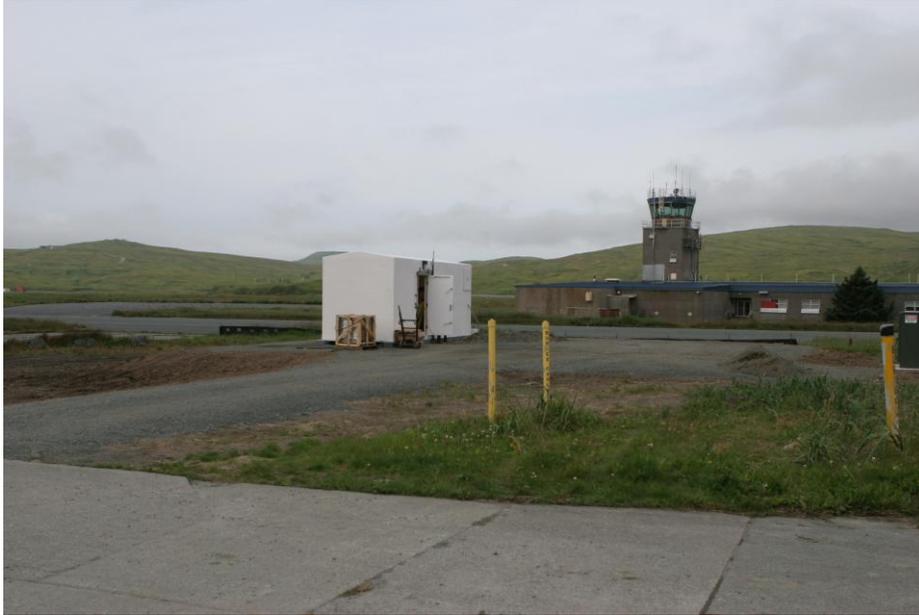
Our Proud EE Building!

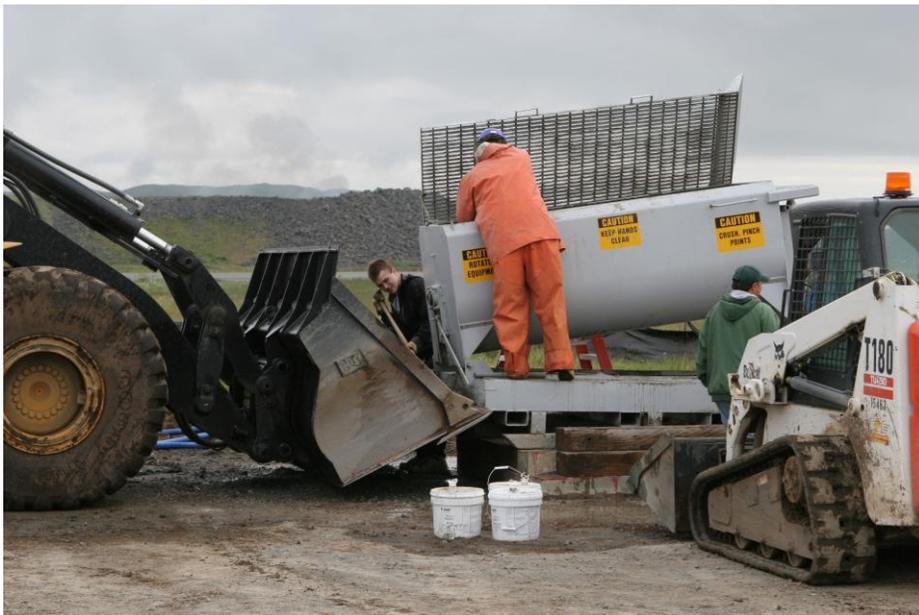
Last concrete mixing happened on 8/23/08. We finally received our beloved 8-nuts and washers to complete the Rotating Beacon Foundation. We mixed about little over 2 CY and cleaned up the mixing plant for good.

The Last Concrete Mix

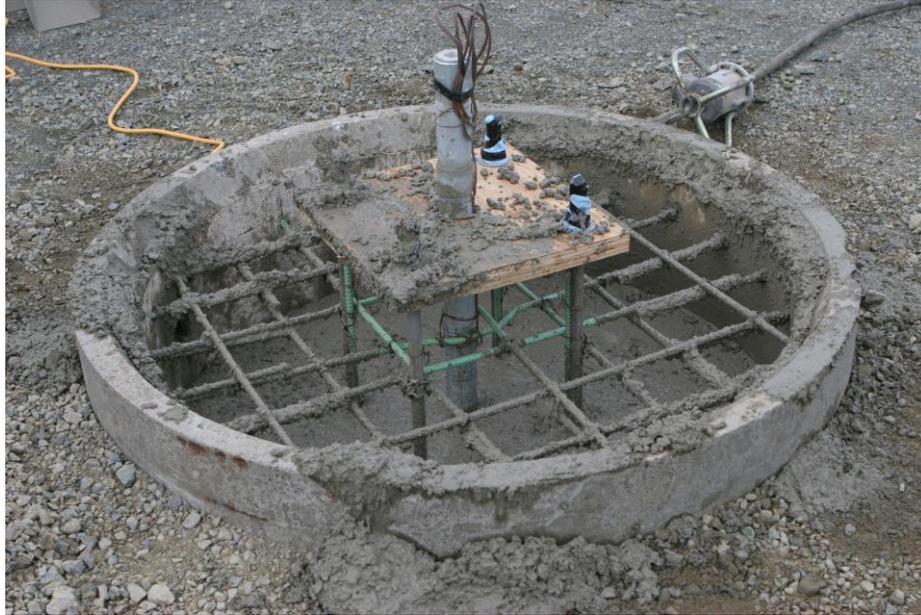
P.E. Stamped Rotating Beacon Foundation (notice the template made by CMK)

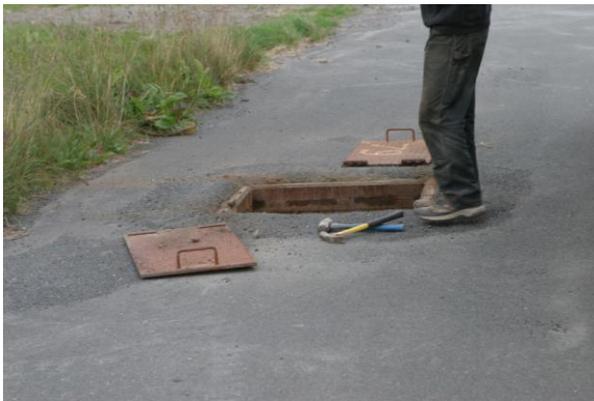
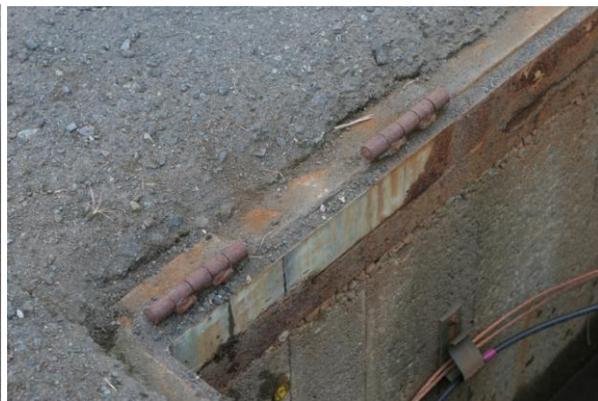
Our design utilizes the existing frame. New galvanized hand hole will be slipped into the existing metal frame. We removed the hinges and cleaned up the edges of the existing hand holes so we could install the new hand holes up on arrival.
