SELDOVIA BOAT HARBOR IMPROVEMENTS
TECHNICAL REPORT

FEBRUARY 2011

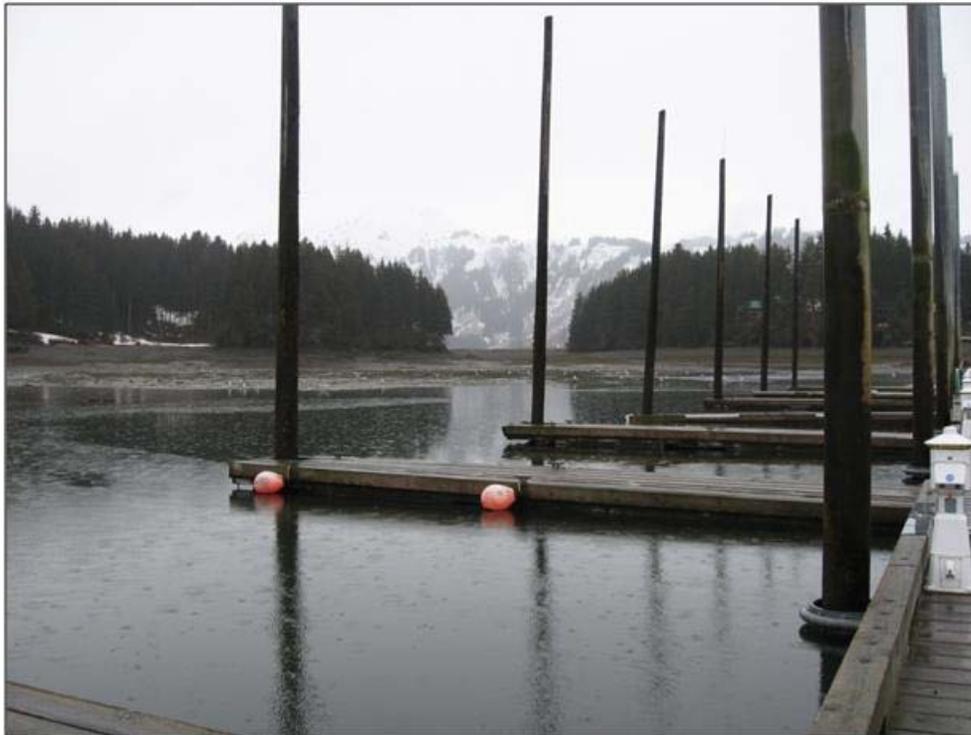
Figure 4. Visible ground off the end of E float

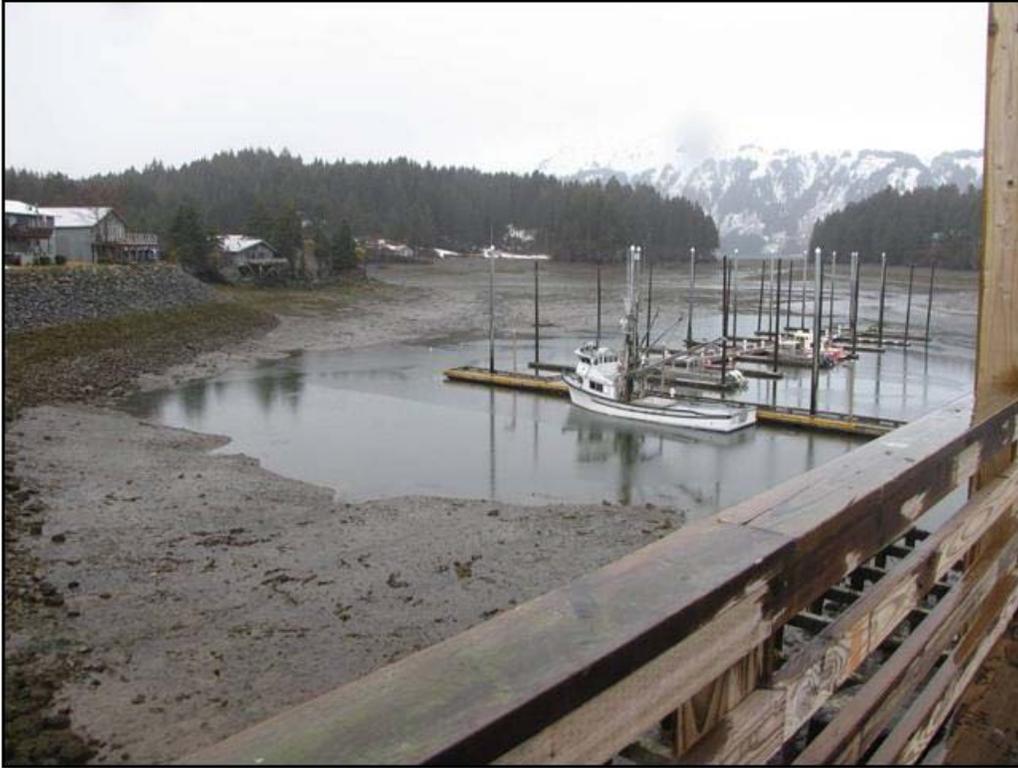
Figure 5. Visible shoaling off the south main float (foreground) and E float (background)

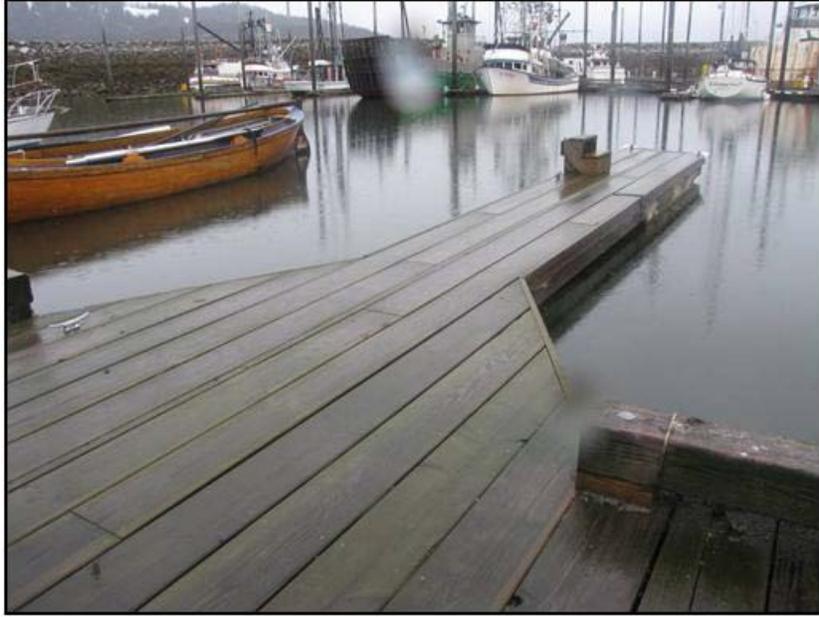
Figure 7. B Float Finger Float configuration only allows boaters to moor bow in

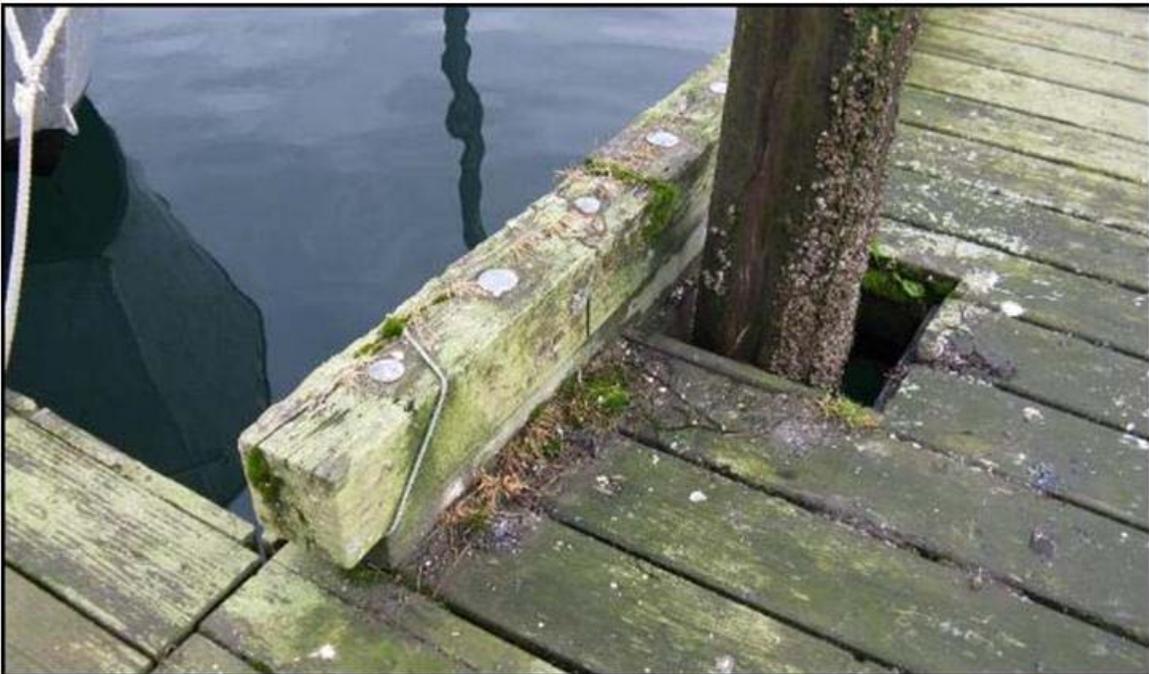
Figure 8. Vegetation and moss growing on decking and bull rail along C Float

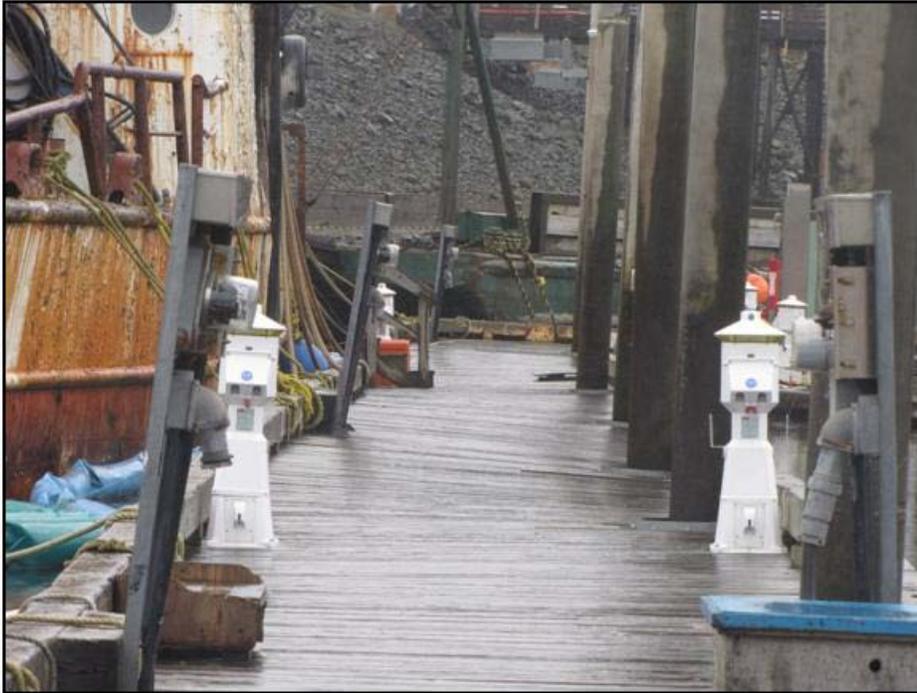
Figure 11. Visible warping along the north main float

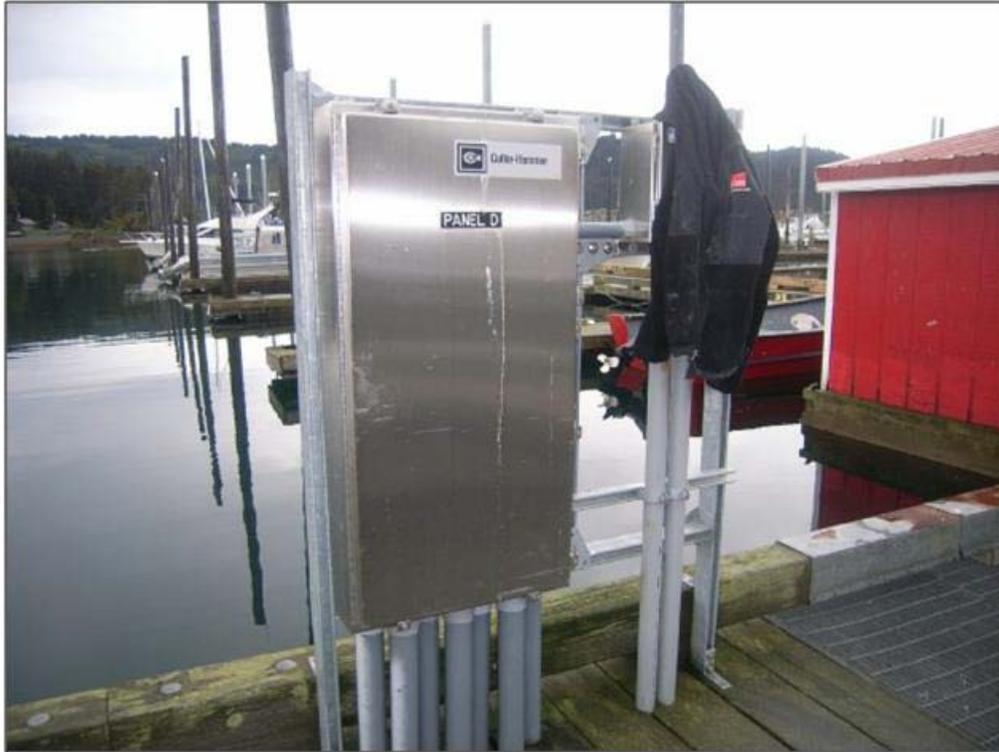
Power pedestals located at beginning of A float, all pedestals on A float, and a walkway extending from A float into the entrance are old, and have not been replaced. These power pedestals, meters, circuit breakers, and power receptacles are decayed, corroded and unreliable for safe use. Figure 14, Figure 15, and Figure 16 are show examples of existing electrical panels, power pedestals, and overhead lighting, respectively.

Figure 14. Electrical Power Panel D near the Gangway

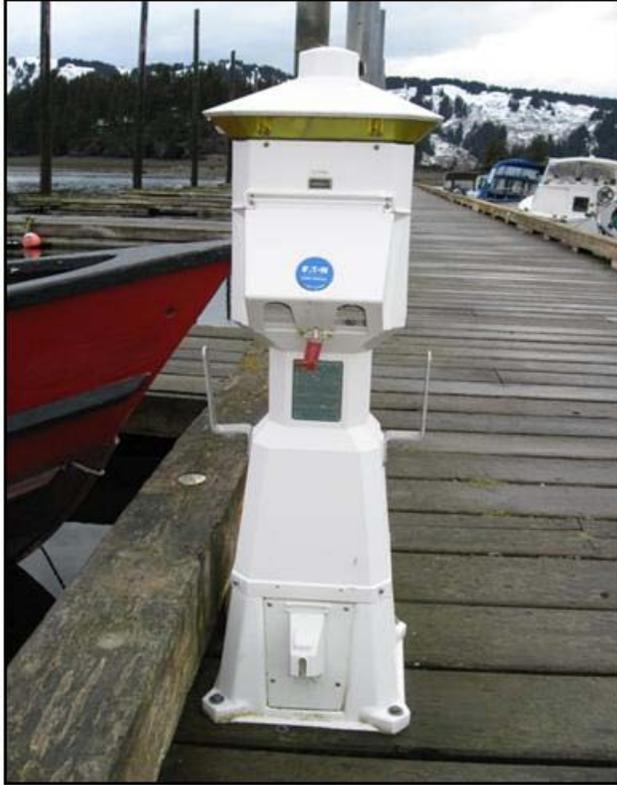
Figure 15. Example of existing power pedestal

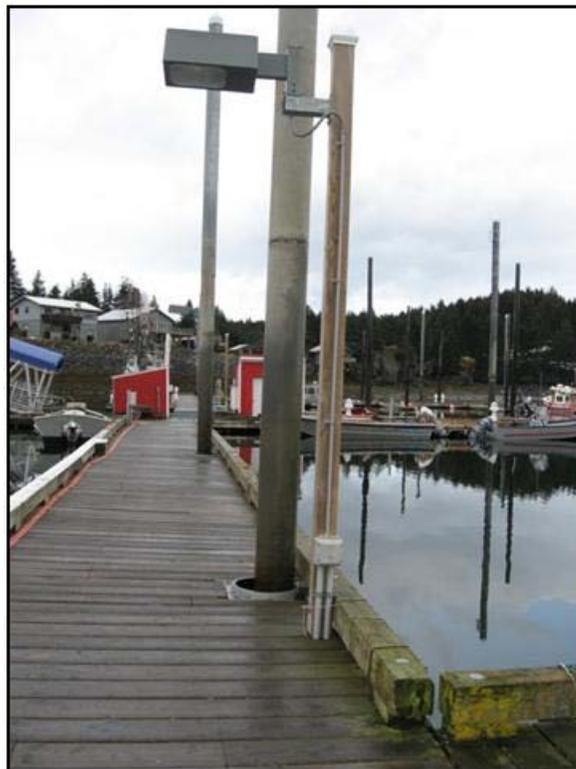
Figure 16. Example of existing overhead lighting

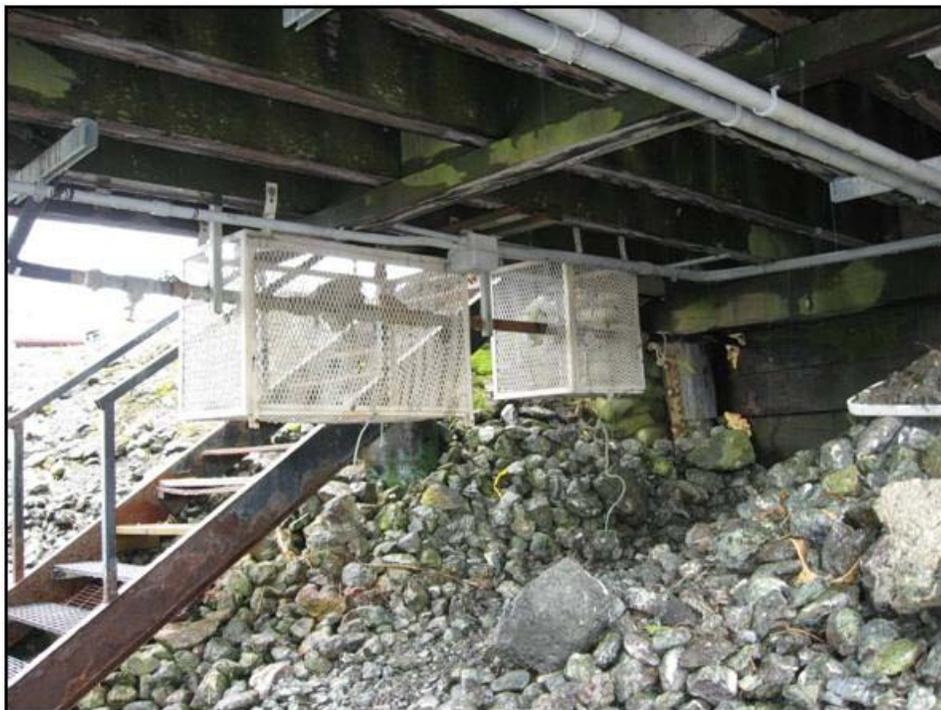
Figure 18. The valve train consists of a 2” meter (inside right enclosure), check valve, backflow preventer (inside left enclosure), hose connection and a shut off valve. Access to the water meter requires stepping off the stairs to the sloped rocky area. Water meter gauge can only be read on this side of the meter.

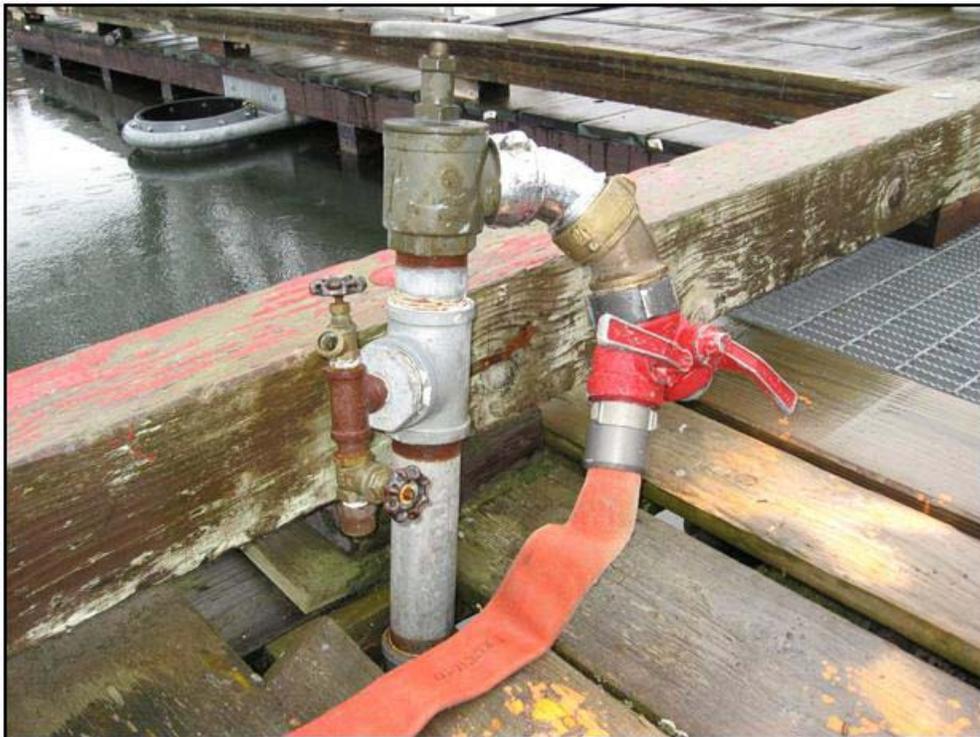
Currently the hose stations on floats D and E are served by an under-the-boardwalk 2-inch galvanized pipe with a 2-inch branch to the hose stations and a 1-inch branch to the fish washing area. Hose stations on floats A, B, and C are served by various size flexible hoses (fire hose) with wye connections. Figure 20 shows a 2-inch hose station with connected fire hose, and Figure 21 shows a typical north float hose station. Similar 2-inch galvanized pipe that used to serve the hose stations exists in the north float but is not in use.

Figure 20. Existing 2-inch hose station north of the ramp. The 2-inch flexible hose connection serves the north floats A, B, and C hose stations. The 2-inch pipe under the boardwalk main is abandoned in place.

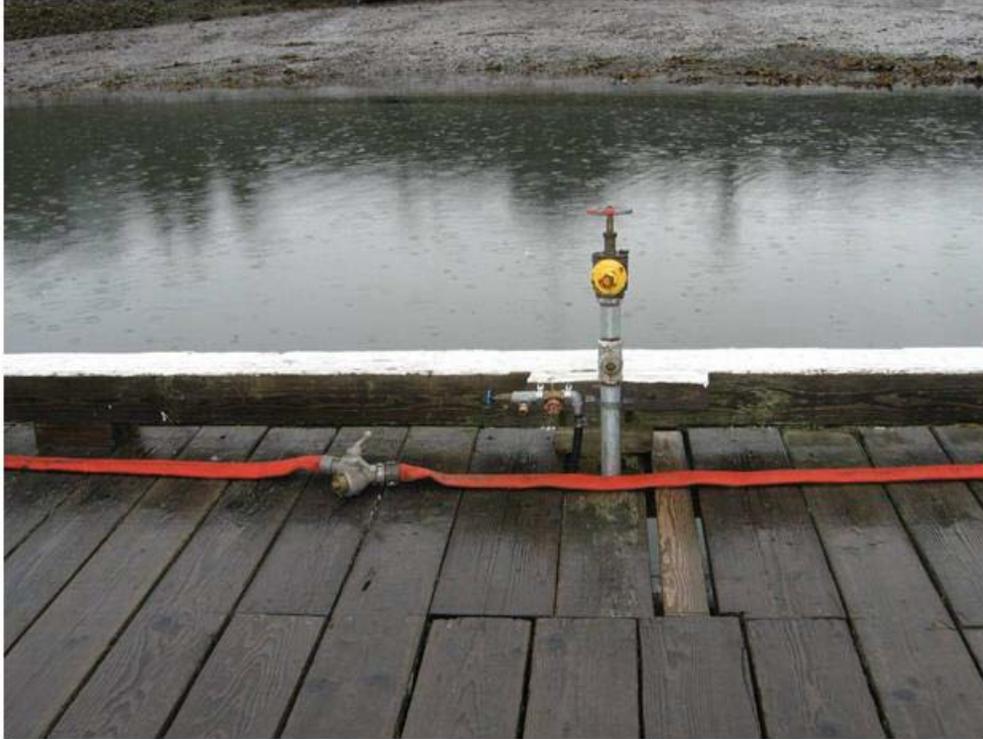
Figure 21. Typical north float hose station served by the flexible hose with the original vertical hose station abandoned in place.

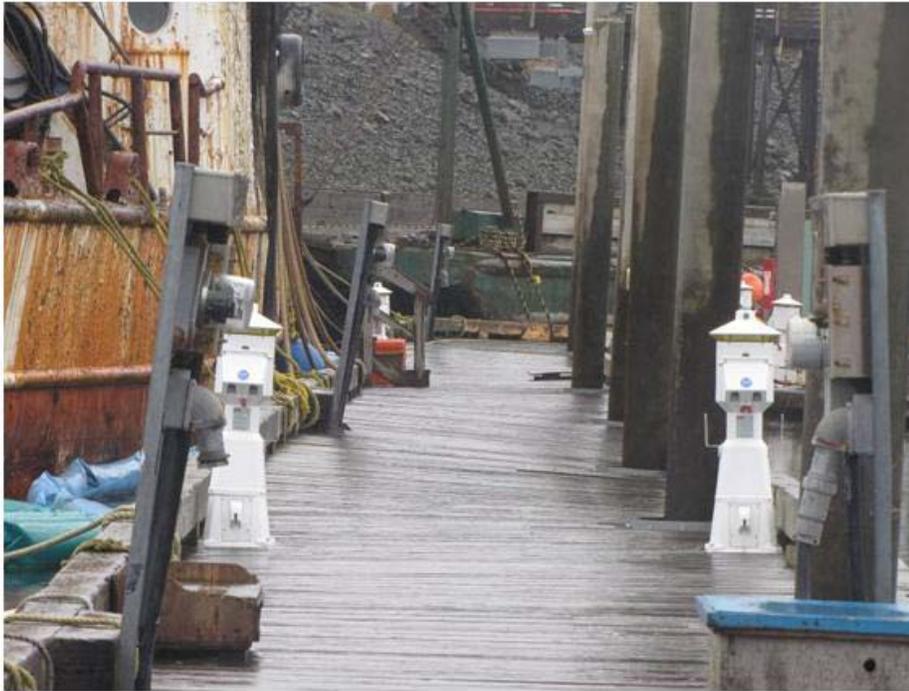
Figure A-8. Uneven floatation on main float

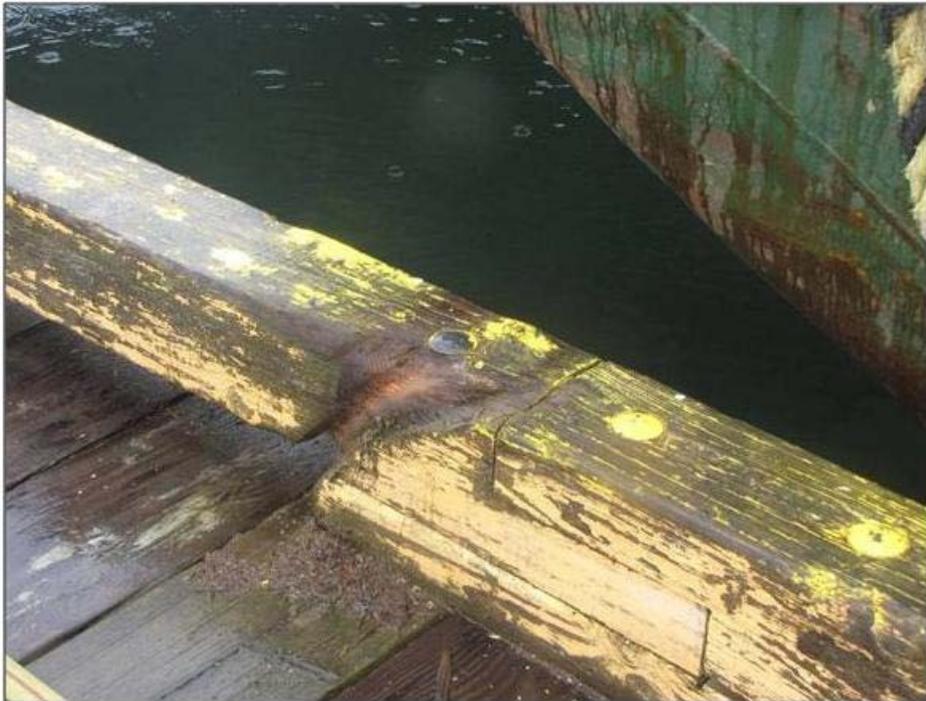
Figure A-12. Bull Rail on Transient Float

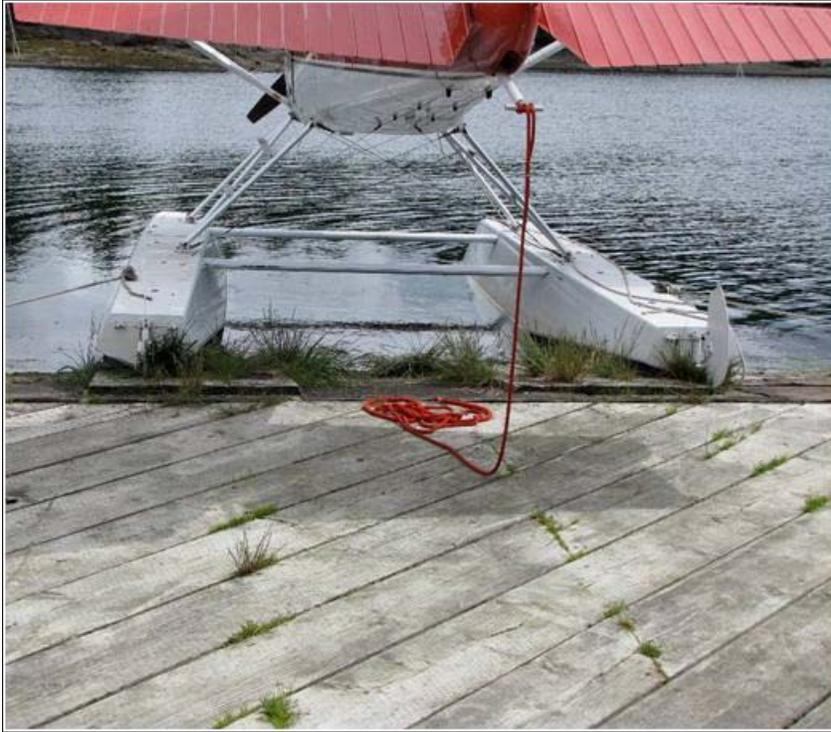
Figure A-13. Float Plane Dock. Note grass growing between decking and on ramp

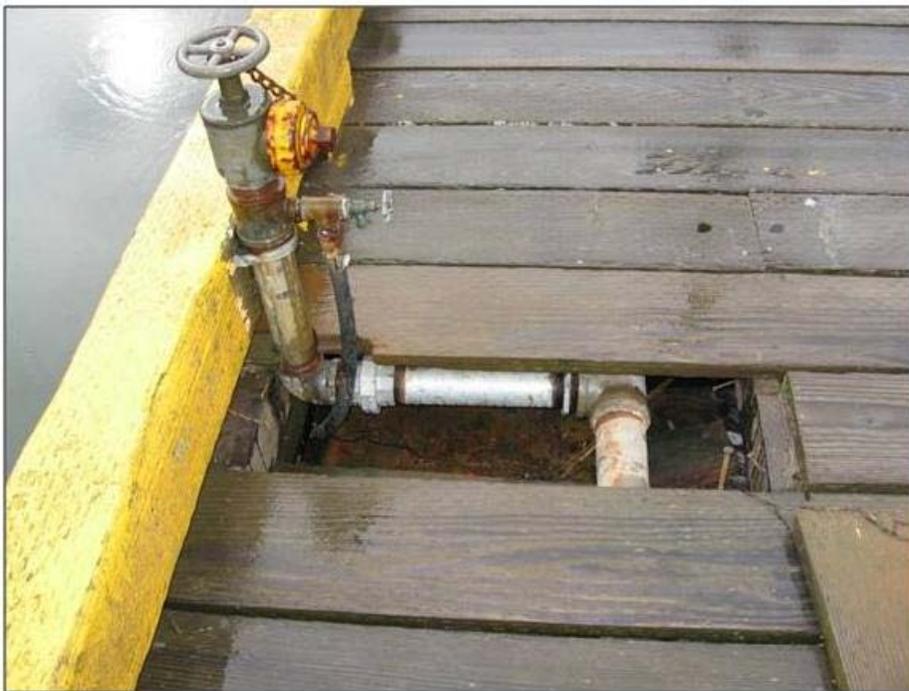
Figure A-17. Typical hose station. Hose station is served by the existing under the boardwalk 2-inch galvanized pipe with a 2-inch branch to the hose stations. This hose station shows a hose bibb with a 1-inch branch connection.

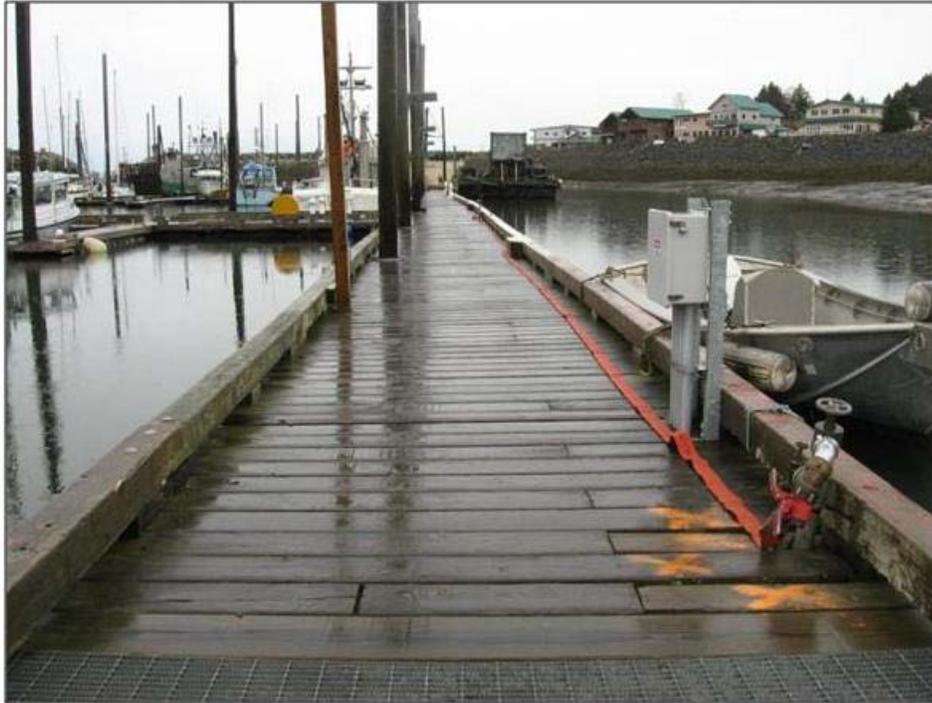
Figure A-18. North Main Float and Floats A, B and C existing hose stations and flexible main water supply.

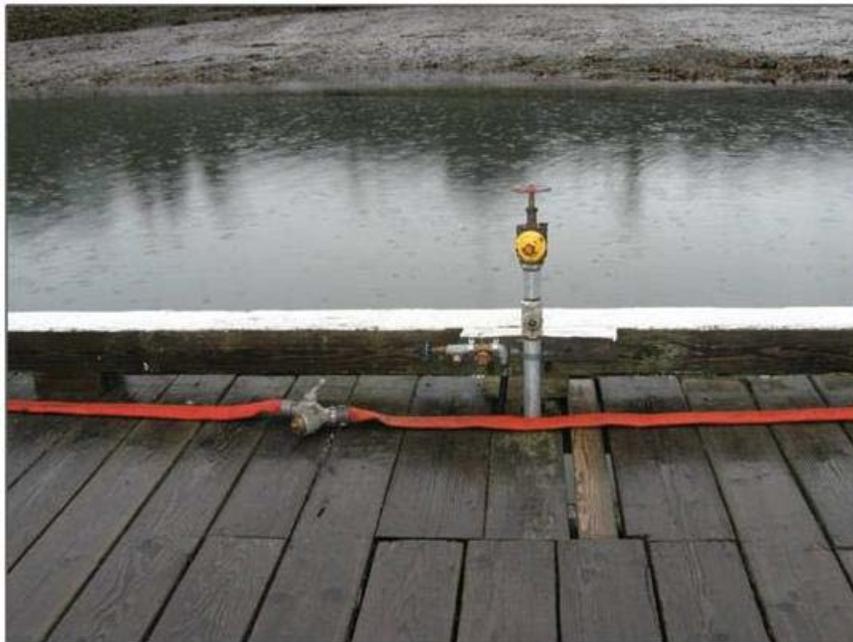
Figure A-19. Typical North Main Float hose station served by the flexible hose with the original vertical hose station abandoned in place.

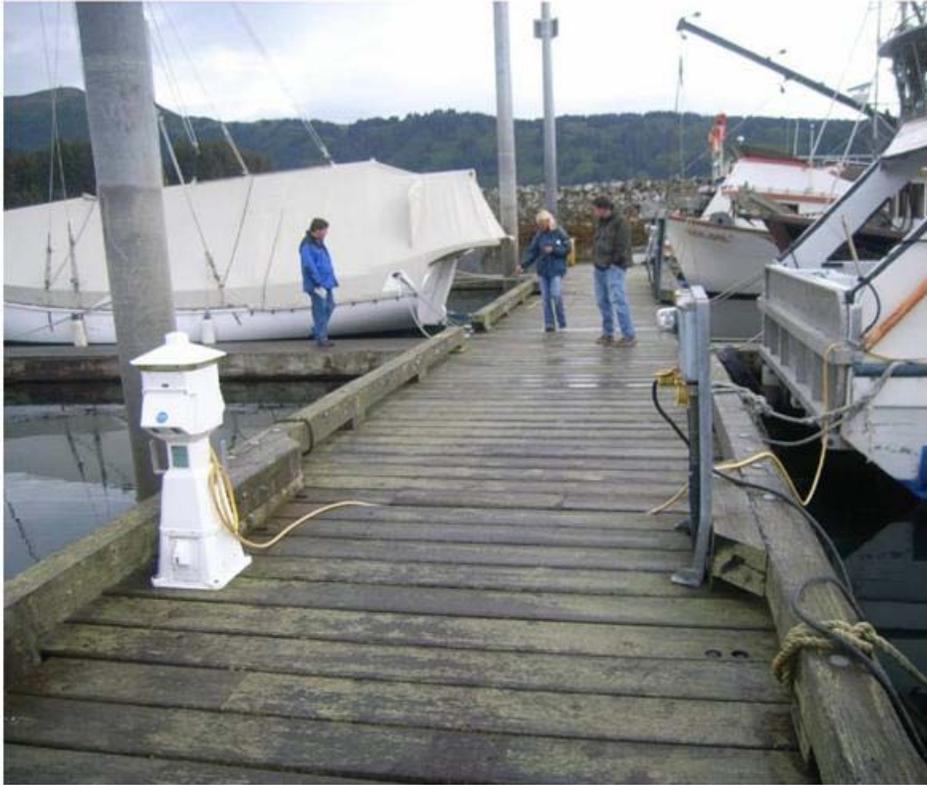
Figure A-23. A float

Float Improvement 2 is replacement of A float. This concept would replace the wooden float system with a similar wooden system. The A float is approximately 10 feet wide and 225 feet long with nine 42-foot finger floats. This float is part of the original harbor that was built in 1963. Continual maintenance has allowed the float to function; however, it is showing signs of wear. The decking has moss growing and the main float and finger float is weathering (Figure A-23 through Figure A-26). The wood piles have been replaced with steel piles and would not need replacing as part of this upgrade work. Figure A-27 and Table A-3 are a site plan and parametric cost estimate for this alternative, respectively.

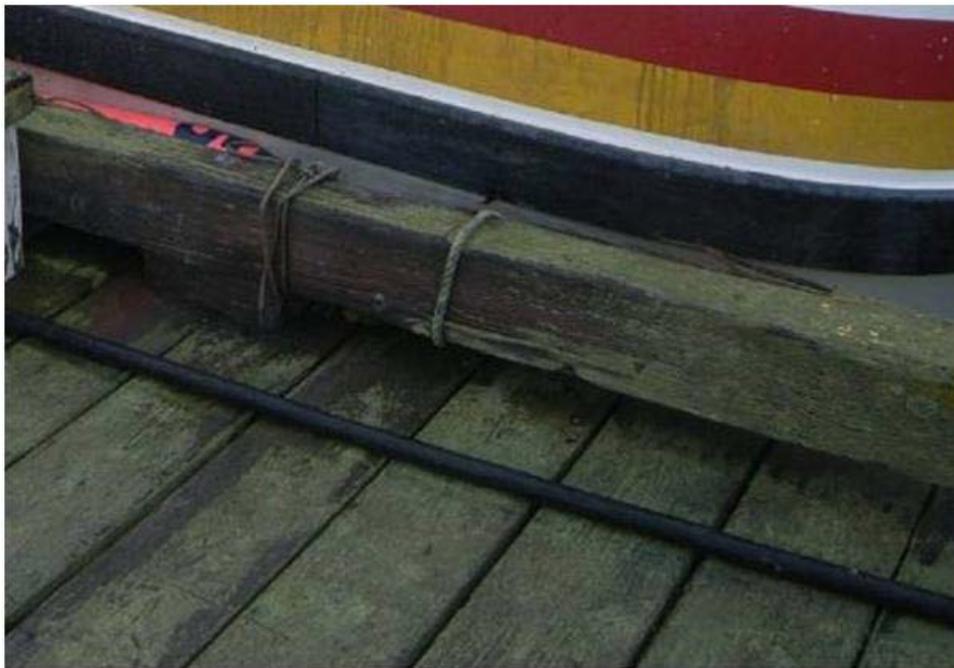
Figure A-24. Growth on Float and Bull Rail

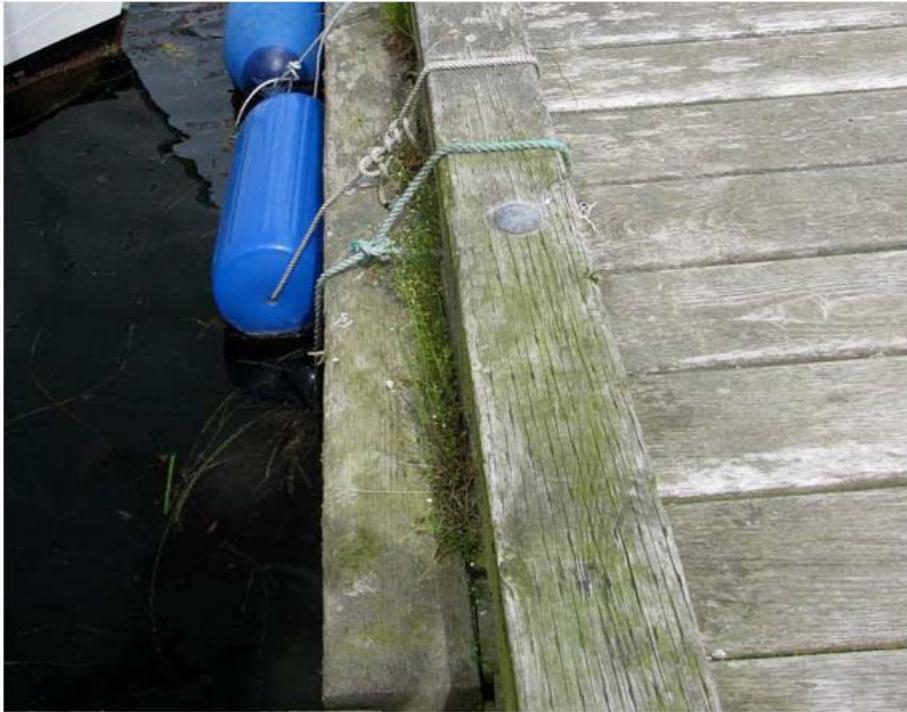
Figure A-25. Growth on bull rail and weathered wood

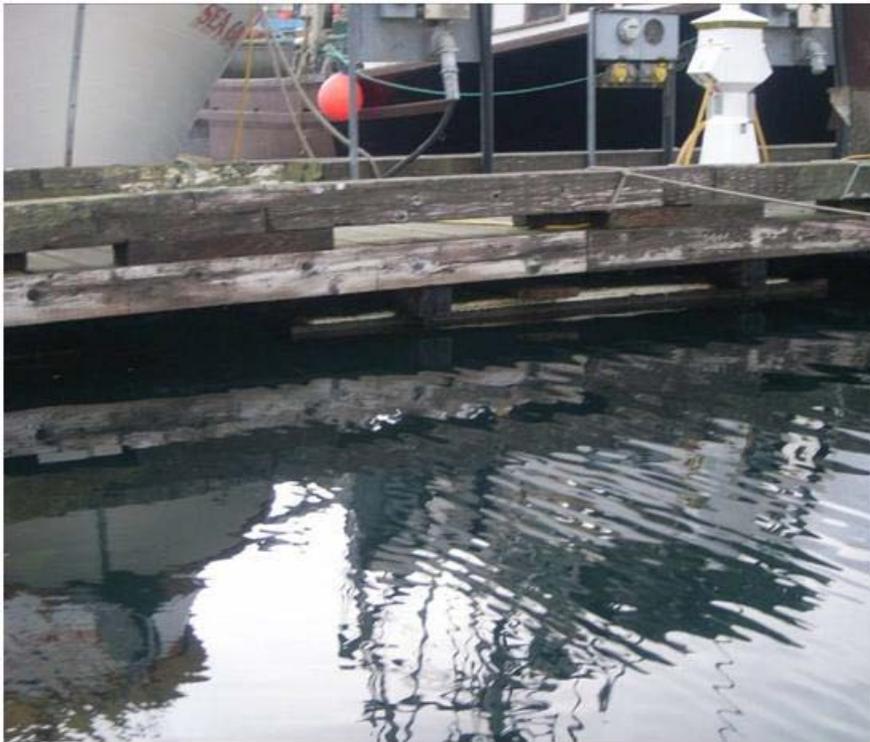
Figure A-26. Weathered Float

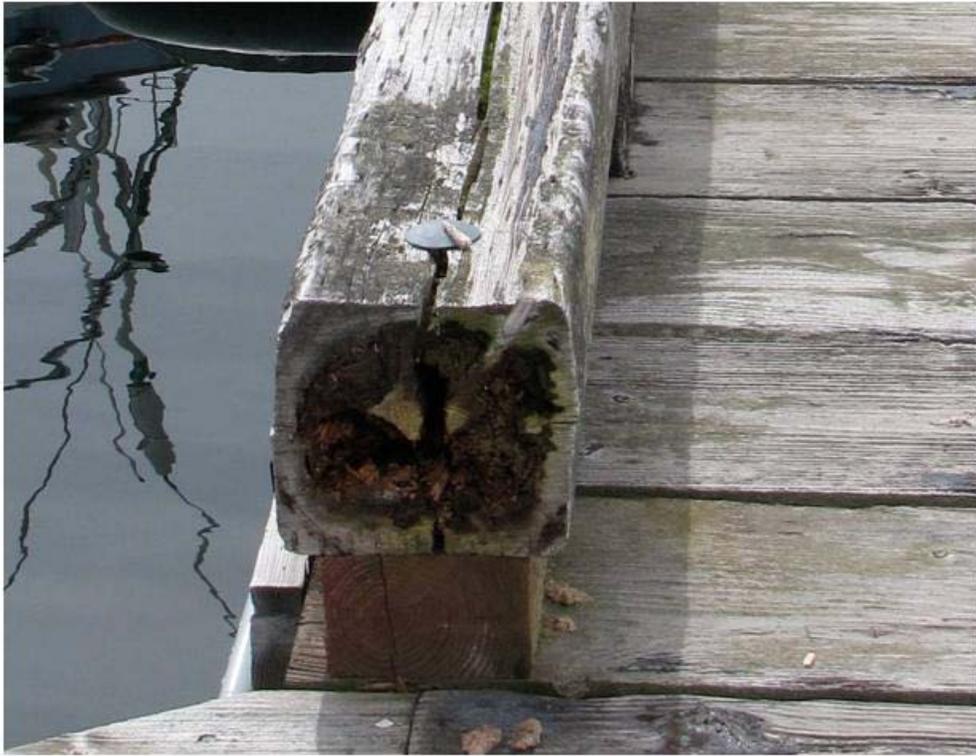
Float Improvement 3 is replacement of B float. This improvement would replace the wooden float system with a similar wooden float system. The finger floats will be replaced with floats similar to the existing finger floats, but hinged (Figure A-31). The B float is approximately 10 feet wide and 250 feet long with eighteen 32-foot finger floats. This float is part of the original harbor that was built in 1963. Continual maintenance has allowed the float to function; however, it is showing signs of extreme wear. The decking on this float was recently upgraded. According to one of the workers on the project, the wood sub structure was rotten, but the job was to replace only the decking, so good decking was put over rotting wood. The deck planks where the float was not upgraded have moss growing on them (Figure A-30). The bull rails are split, vegetation is growing in the splits, and there is rot observed on the ends (Figure A-28 through Figure A-30).

Figure A-29. Split and Rotting Bull Rail

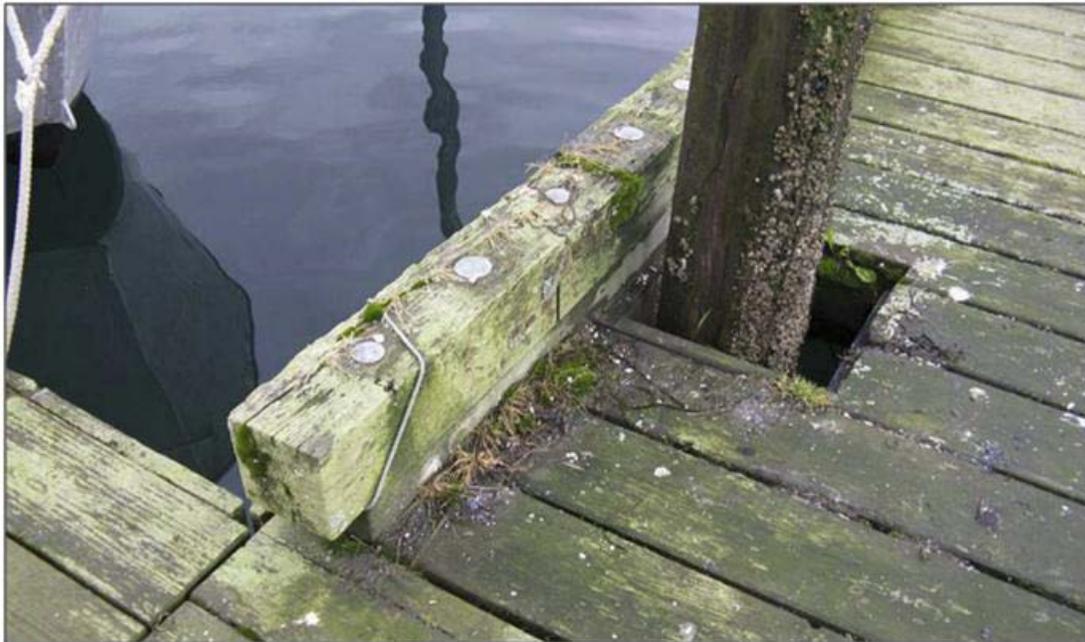
Figure A-33. C Dock Typical Deck and Bull Rail

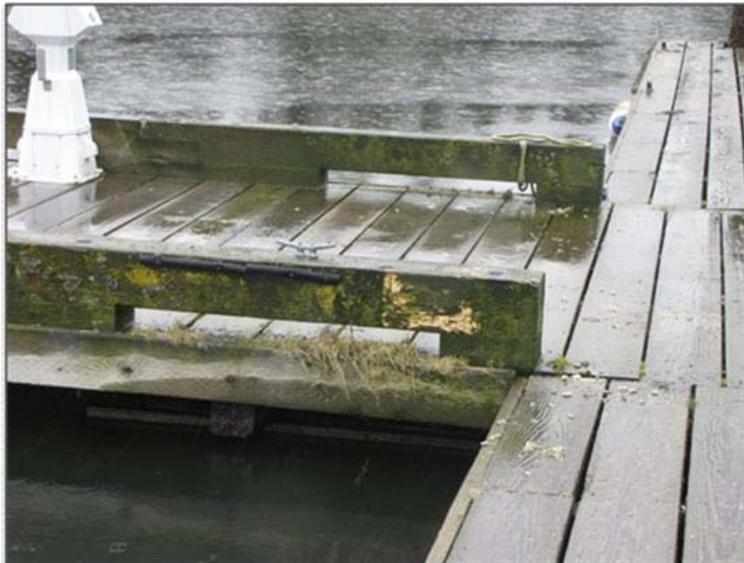
Figure A-44. Growth on decking and bull rail on E Float

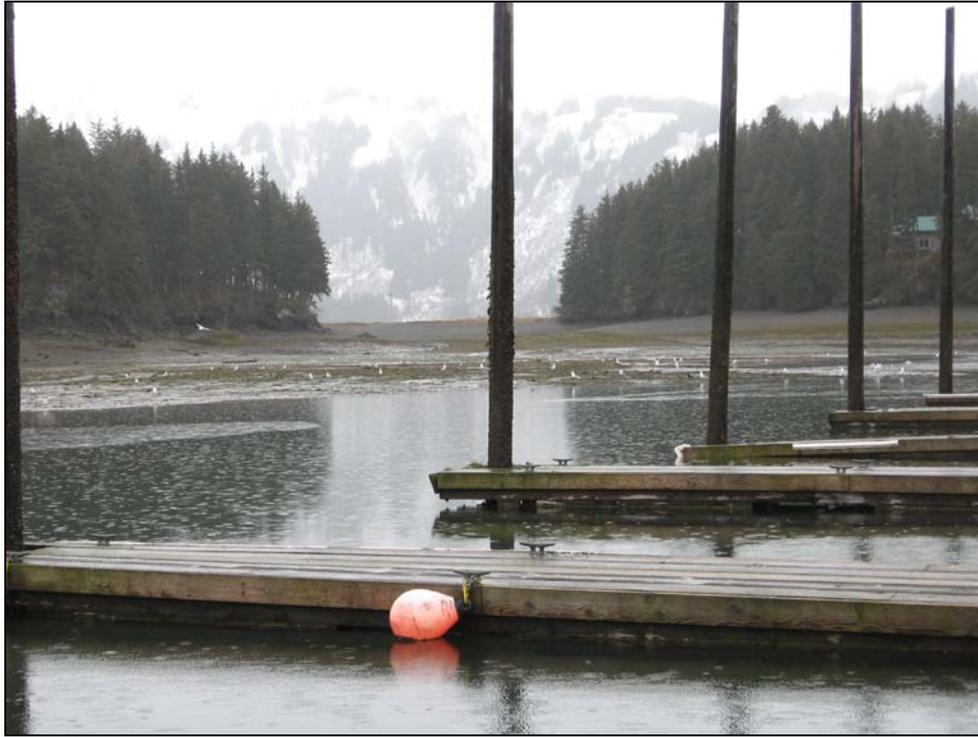
There are also harbor depth issues inside the harbor basin. Residents report that shoaling of the harbor has reduced the navigable depths and the usability of some of the floats. From C float southward, the harbor is shallower than the Federal harbor depth of 12 feet below MLLW. The areas in the locally maintained portion of the basin around the D and E floats in particular are reported to be too shallow. Residents report that the shoaling problem is getting worse every year and that shoaling is slowly cutting off use of the back of the harbor. When boats are moored at the ends of the floats nearest the breakwater, deeper draft vessels cannot navigate around them because the channel is too shallow and narrow. Figure B-5 and Figure B-6 shows the E float at low tide; Figure B-7 shows the harbor at high tide. Moorage on the D and E floats is limited to shallower draft vessels. Vessels can become stuck on the exposed ground during low tides and residents report pulling two boats off the shoals in the past few years.

Figure B-5. Exposed ground visible off of the E float at low tide

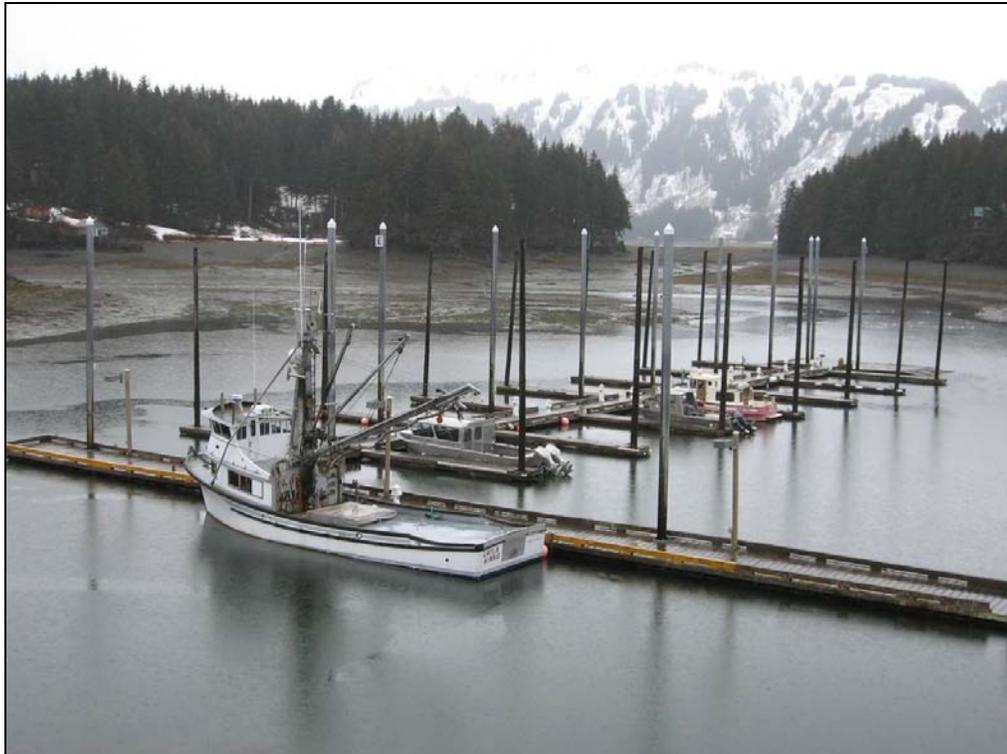
Figure B-6. Exposed ground visible at the end of the E float at low tide

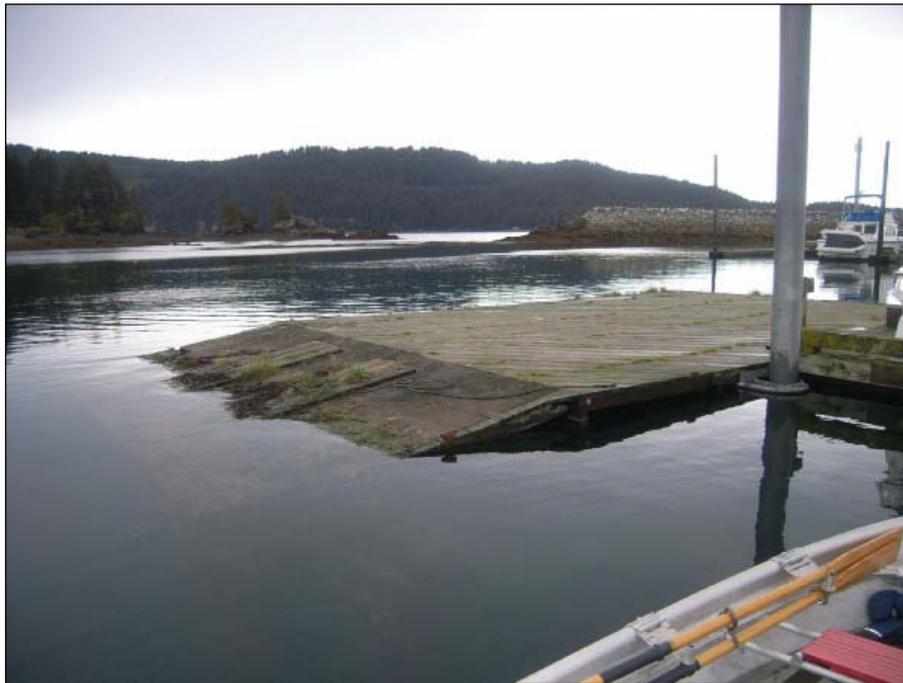
Figure B-9. Float Plane Dock

The float plane dock is in poor condition with rotting decking and slippery deck surface. Also, planes in the harbor create a safety concern as it is difficult to accommodate both planes and boats within a relatively small harbor basin. Boat and plane traffic do not have enough maneuvering room when both are in the harbor. The location of the plane dock is near where the harbor is shallower and shoaling is a problem. This means that, based on depth, there is limited maneuvering room for vessels at this location. Float planes tied off to the dock further restrict the area that vessels have to travel within the harbor. However, the harbor basin is the only place where a float plane dock could be located. Locations outside of the breakwater do not offer the wave protection necessary to keep the planes safe while they are tied off.

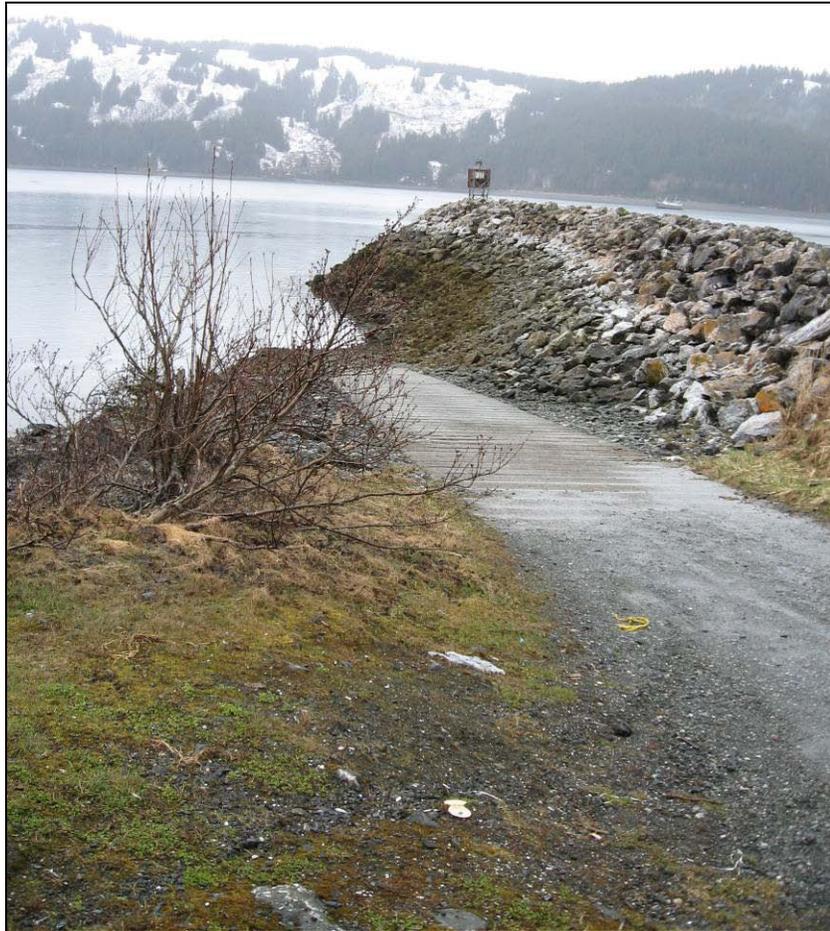
Figure B-10. Harbor Boat Launch Ramp

There is a concrete boat launch ramp located at the north end of the harbor, shown in Figure B-10. The boat launch is available for regular trailered boat launching and recovery. This ramp appears to be in satisfactory condition. The major use for this boat ramp is to launch and retrieve smaller vessels whose owners have trailers available for this purpose. The city charges \$5.50 per ramp use with prior notice to the city, \$27.50 for a season pass (May through September or October through April), or \$10.00 per ramp use without prior notification to the city or harbormaster. A boater with annual moorage in Seldovia receives two free ramp uses per year.

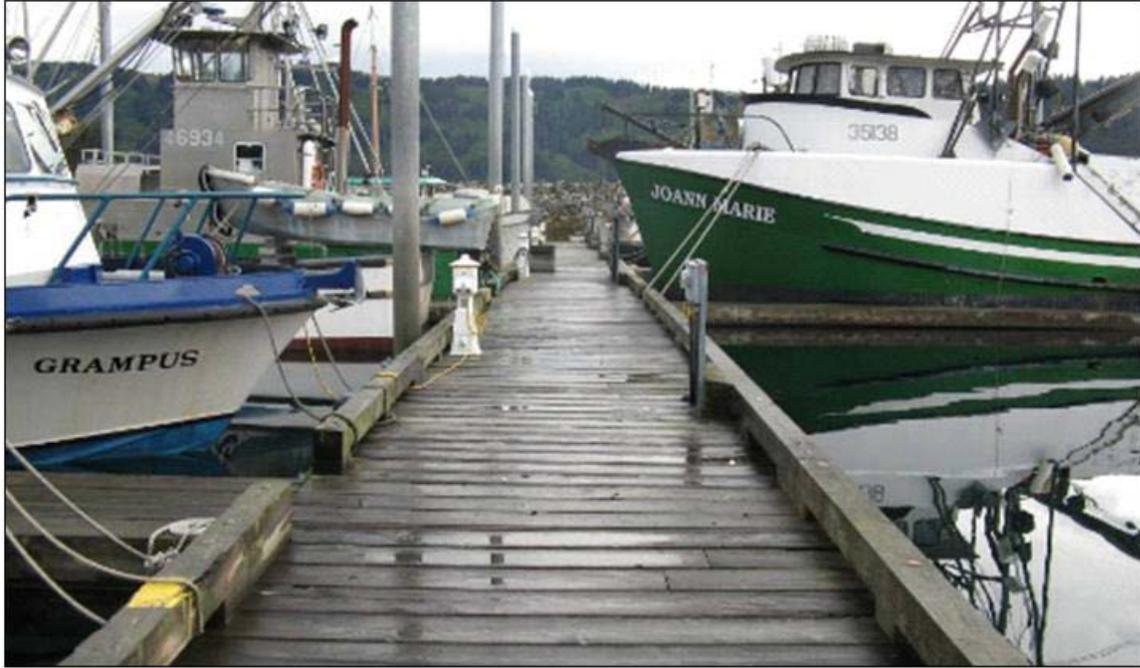
A Dock has worn decking and bull rails. Both appear solid, but have a fair amount of moss, wear marks, and cracking. In some areas, the bull rail has vegetation growing out of cracks.

Figure D-5. A Dock Showing Decking and Bull Rail Condition

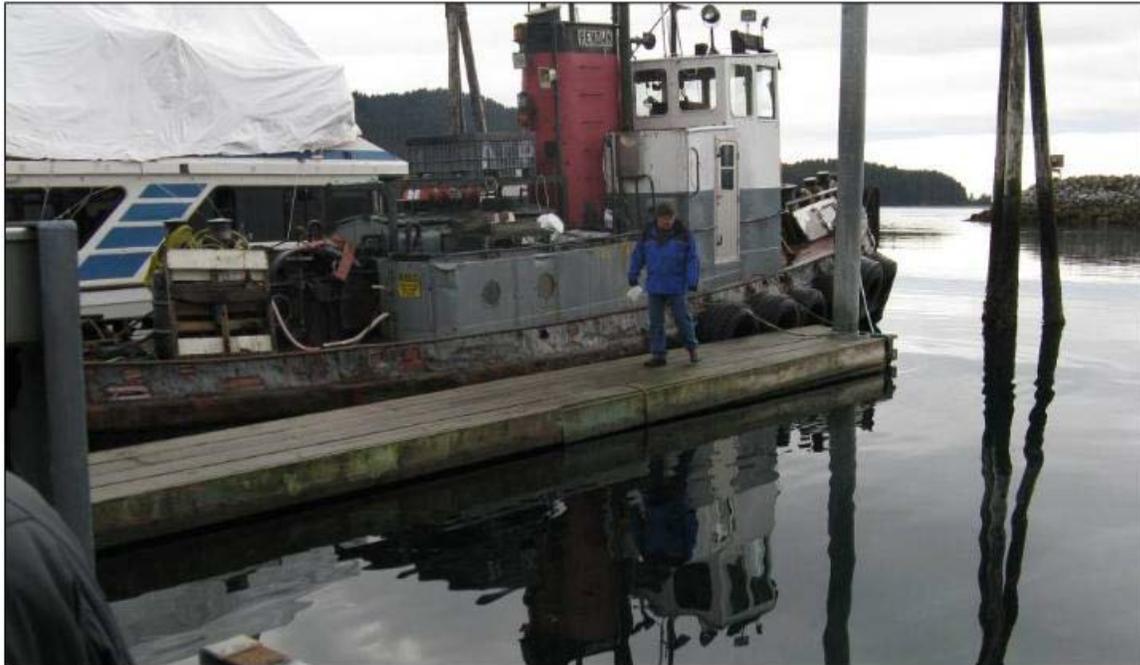
The finger piers are fastened using a pin system leaving the fingers to not be stable. The slippery nature of the decking in combination with the finger pier instability provides for a potential safety hazard. The float is in need of 3 light standards and 3 30 Amp service pillars. There are 2 groups of piling (three piling each) that are not utilized and can be removed.

Figure D-6. A Dock Typical Finger Pier

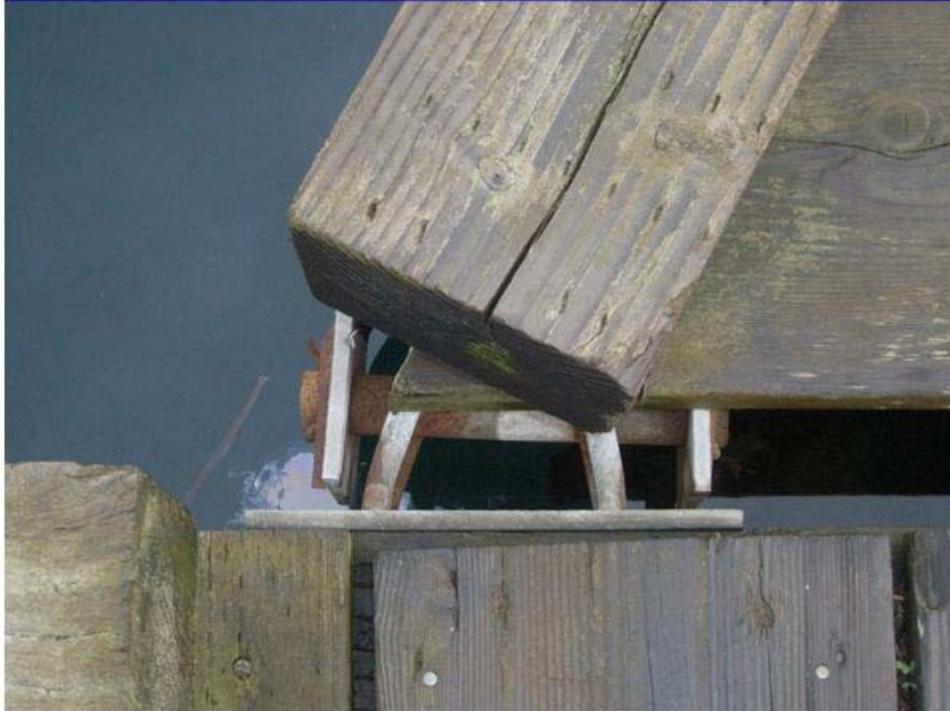
Figure D-7. Typical Finger Pier Pin Connection
