SELDOVIA BOAT HARBOR IMPROVEMENTS
TECHNICAL REPORT

FEBRUARY 2011

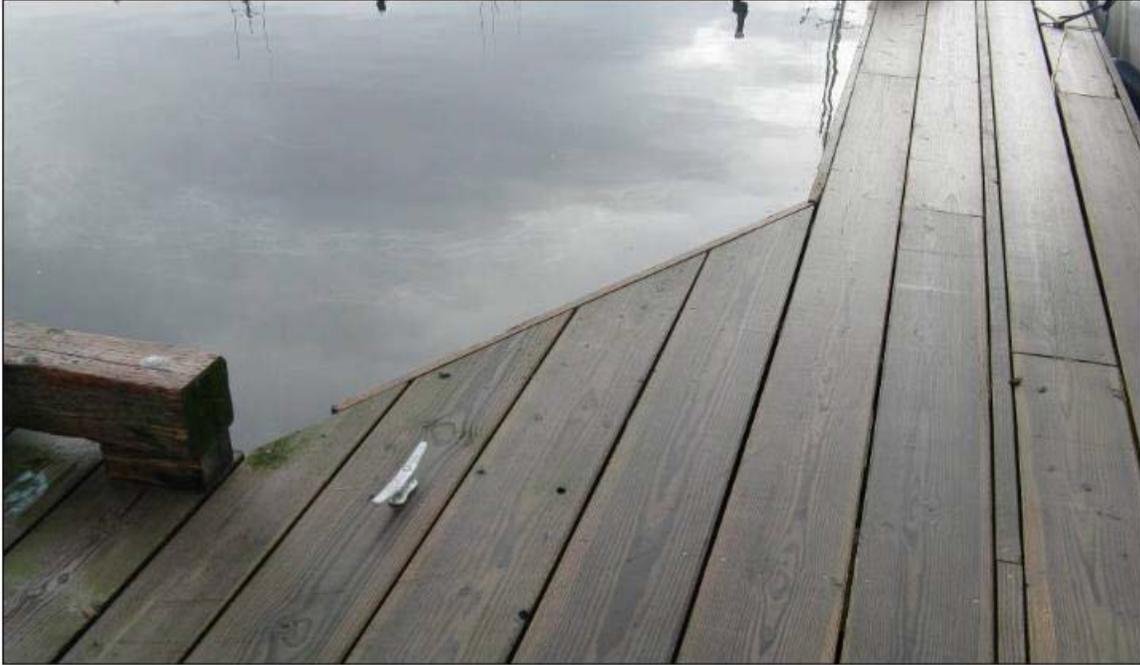
B Dock has worn decking and bull rails. Both appear solid, but have a fair amount of moss, wear marks, and cracking. Some sections of B Dock have been replaced. The finger piers have a solid connection that is integrated into the main run of B Dock. This provides a stable finger pier. The city commented the fillet that is integrated into the finger pier connection does not allow vessels to back into their slips. Two piles that were to be installed are missing. Two wooden piles need to be removed. The electrical system on B Dock is satisfactory.

Figure D-8. B Dock Finger Pier

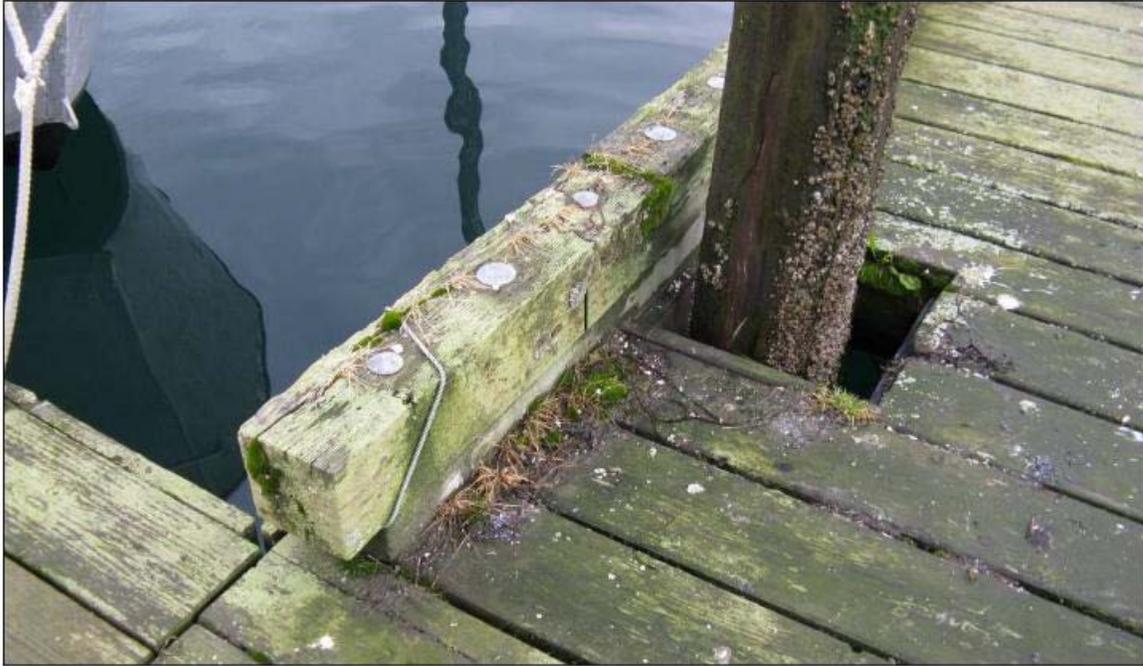
C Dock has worn decking and bull rails. Both appear solid, but have a fair amount of moss, wear marks, and cracking. In some areas, the bull rail has vegetation growing out of cracks. The finger piers are fastened using a pin system leaving the fingers to not be stable. The

slippery nature of the decking in combination with the finger pier instability provides for a potential safety hazard. 3 of the new metal piles are missing. 21 wood piles need to be removed. The city reports that vessels cannot pass the end of C Dock at low tide when a boat is moored at the end because the water is too shallow.

Figure D-10. C Dock Typical Deck and Bull Rail

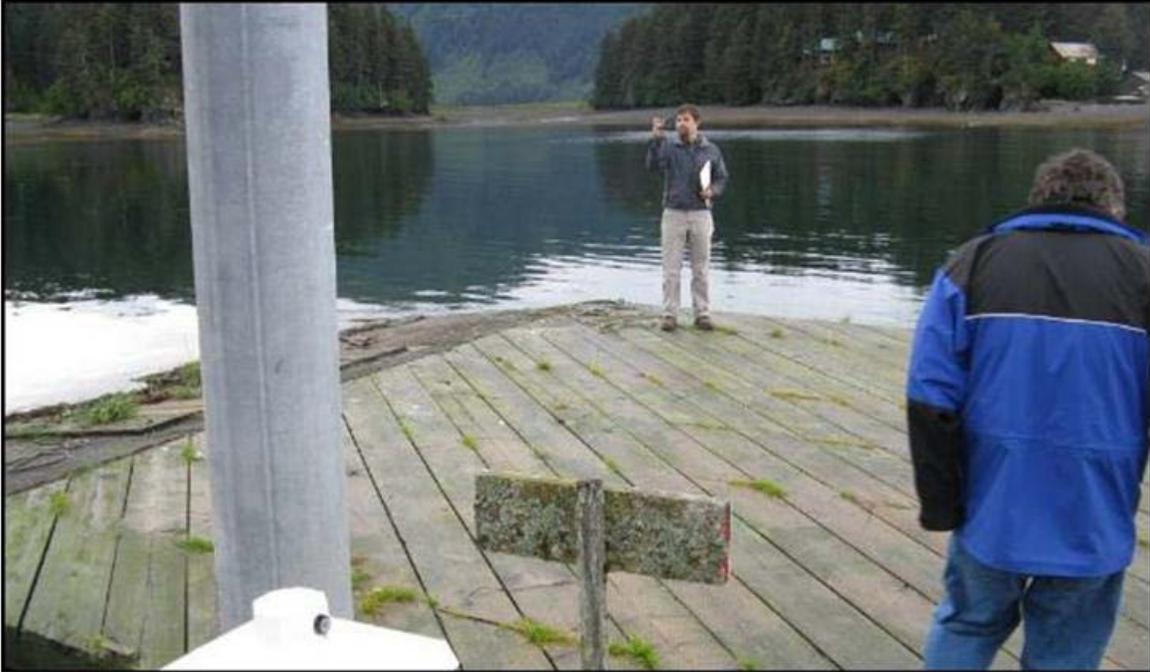
E Dock has worn decking and bull rails. Both appear solid, but do have a fair amount of moss, wear marks, and cracking. The finger piers are fastened using a pin system leaving the fingers to not be stable. The slippery nature of the decking in combination with the finger pier instability provides for a potential safety hazard. Some of the new metal piles are missing. 14 wood piles need to be removed. E dock needs lighting. The floatplane dock attached to the outside end of E dock is very worn and needs replacing.

Figure D-12. Float Plane Dock

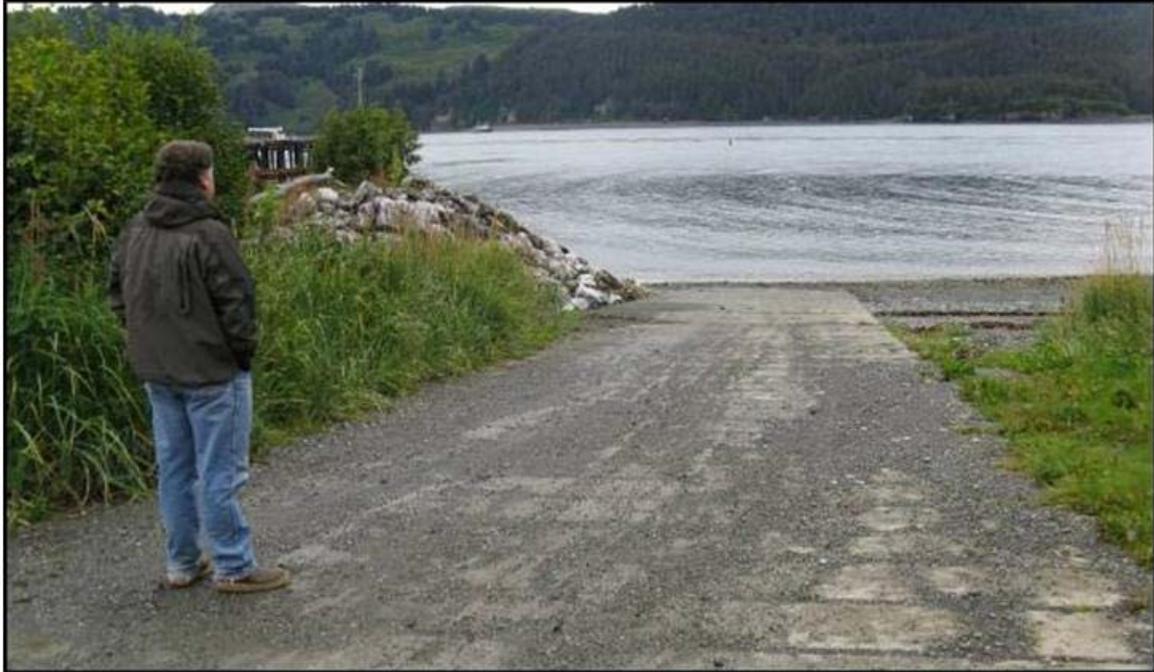
The community boat launch facilities appear to be in satisfactory condition with the city reporting no issues. There are two launches. The large vessel launch is to the north of the harbor and the City dock. The city operates a tractor and trailer to haul larger vessels out of the water. The inner harbor boat launch is at the northern end of the boat harbor. This launch is available for regular trailered boat launching and recovery. Neither launch facility has a dock.

Figure D-13. Large Vessel Launch

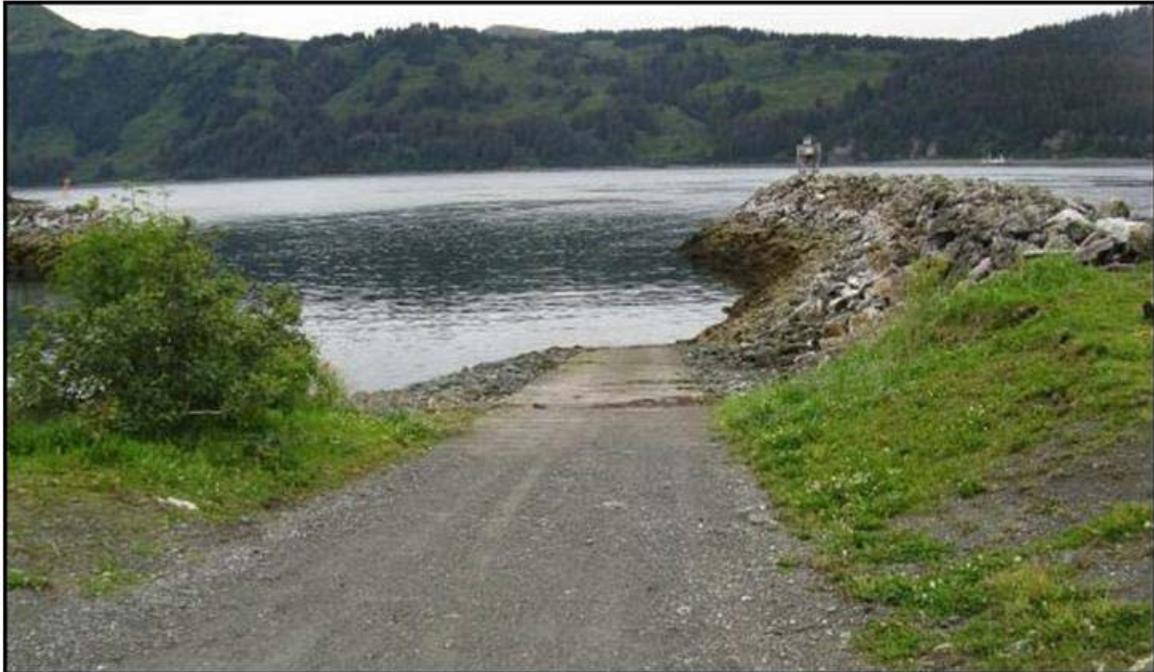
Figure D-14. Inner Harbor Boat Launch

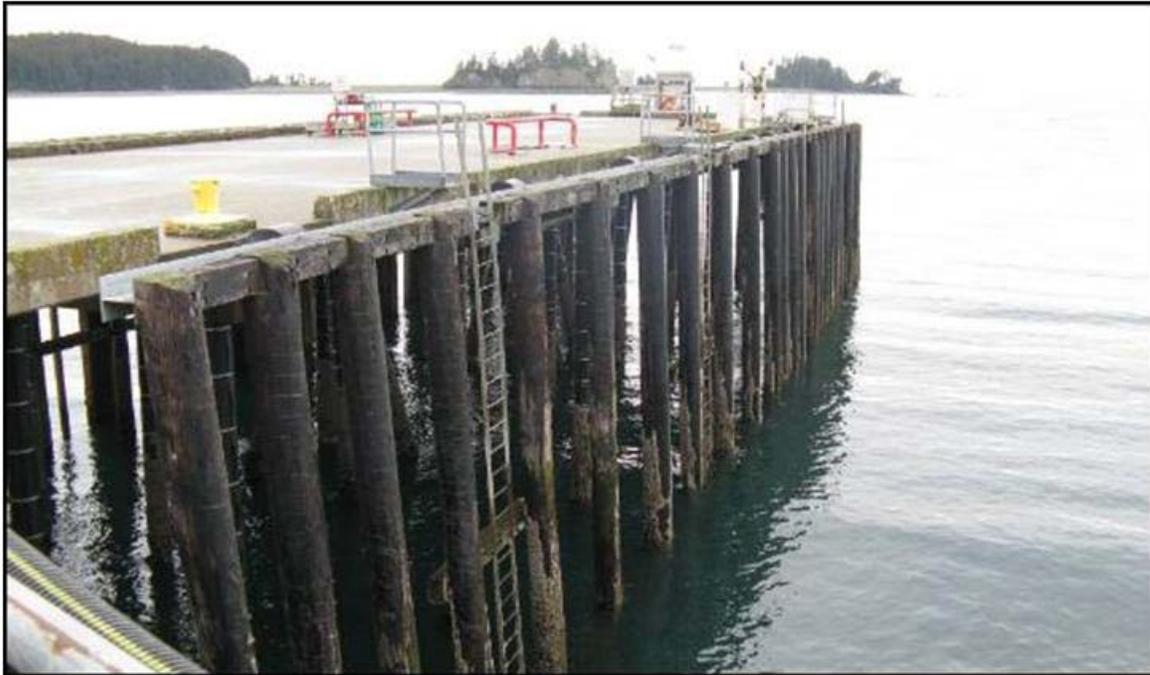
The city has their main dock located to the north of the boat harbor. Recent upgrades have improved the dock electrical system and have rehabilitated and/or wrapped several piling to extend their structural life span. The gangway utilized by the Alaska Marine Highway

System (AMHS) is in poor condition, as well as the safety net that stretches out below the gangway. The city stated they are working with the AMHS and others on a plan to replace/fix these two issues.

Figure D-15. City Dock

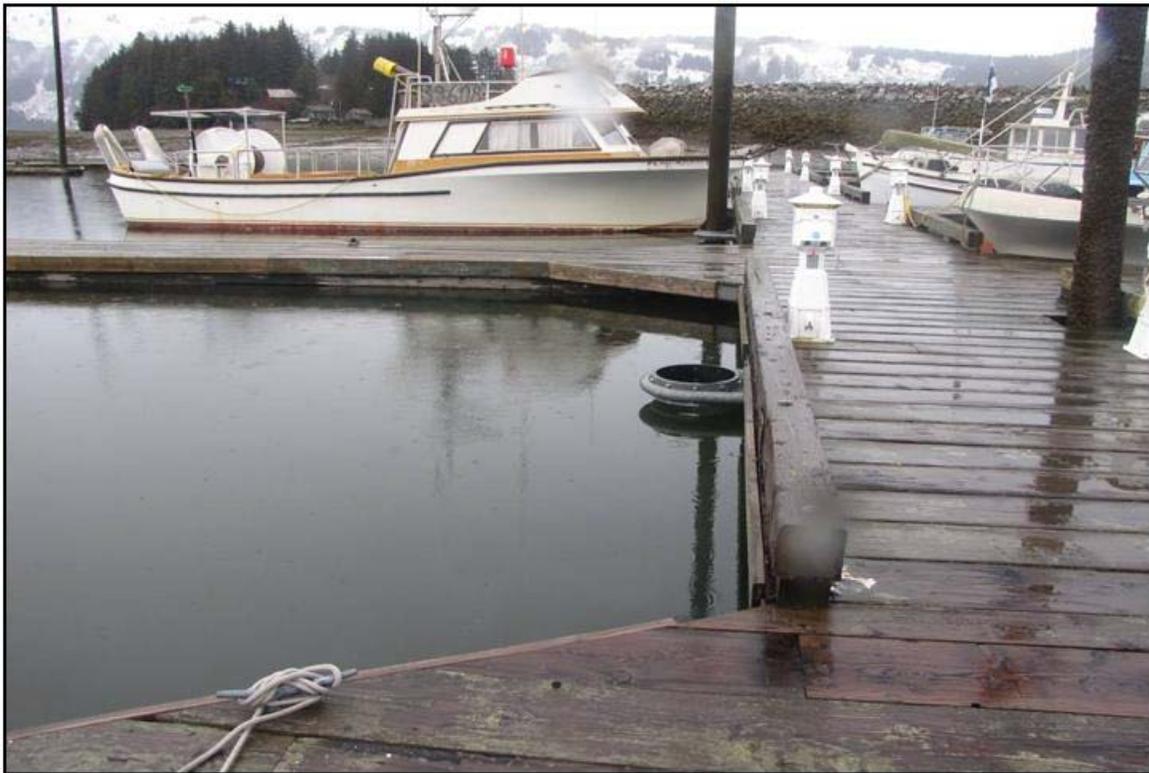
Pilings – As previously mentioned, the harbor had some upgrades already completed. Many of the harbor's wood piling have been replaced with modern aluminum pile. However, as the city reports, several of the new piling were not able to be placed. Resident Jim Hopkins worked on the project to replace the piling and reported that several of the locations for new piling were located on material that was far too rocky to achieve an adequate pile depth. In a few instances, there was no penetration at all. He said the pile driving record was on file with the city. Mr. Hopkins also stated that in order to drive the remainder of the pilings, a drill rig would likely be needed.

Figure D-23. The empty pile collar shows where a steel pile could not be driven because of rock

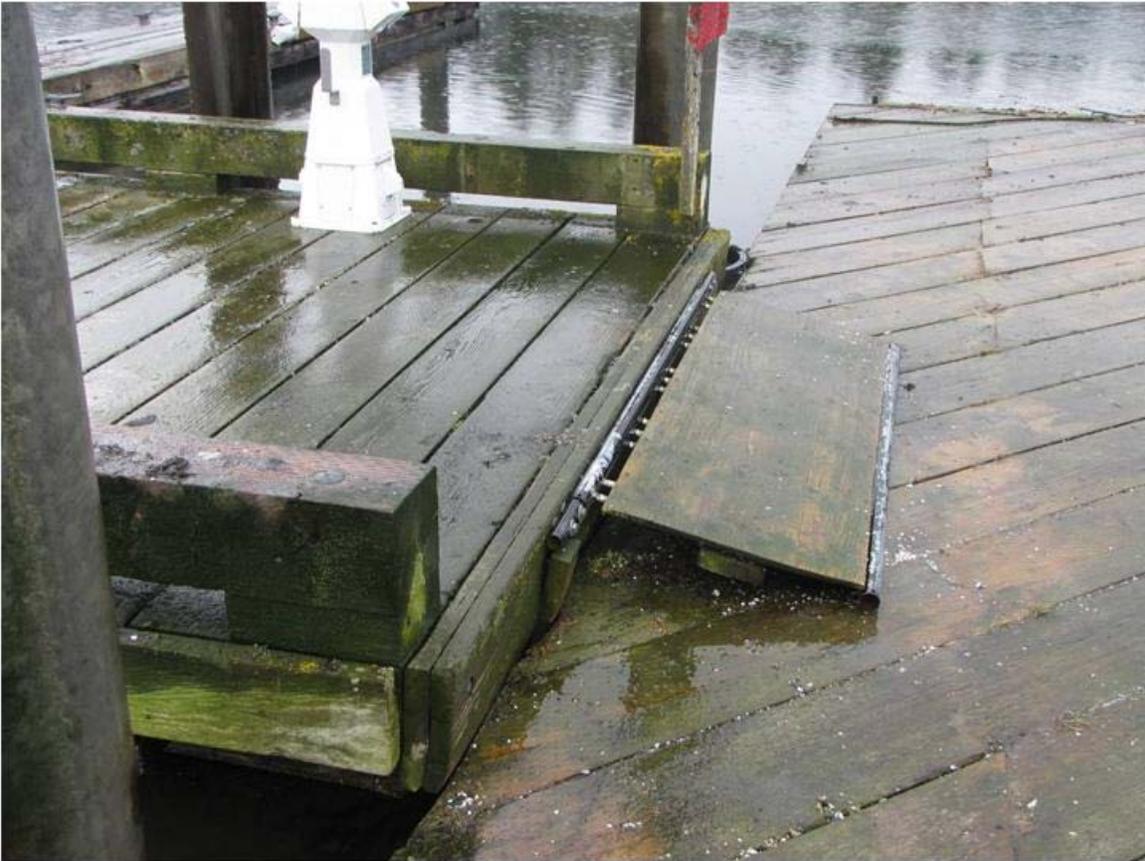
Figure D-29. Transition from E dock to the float plane dock

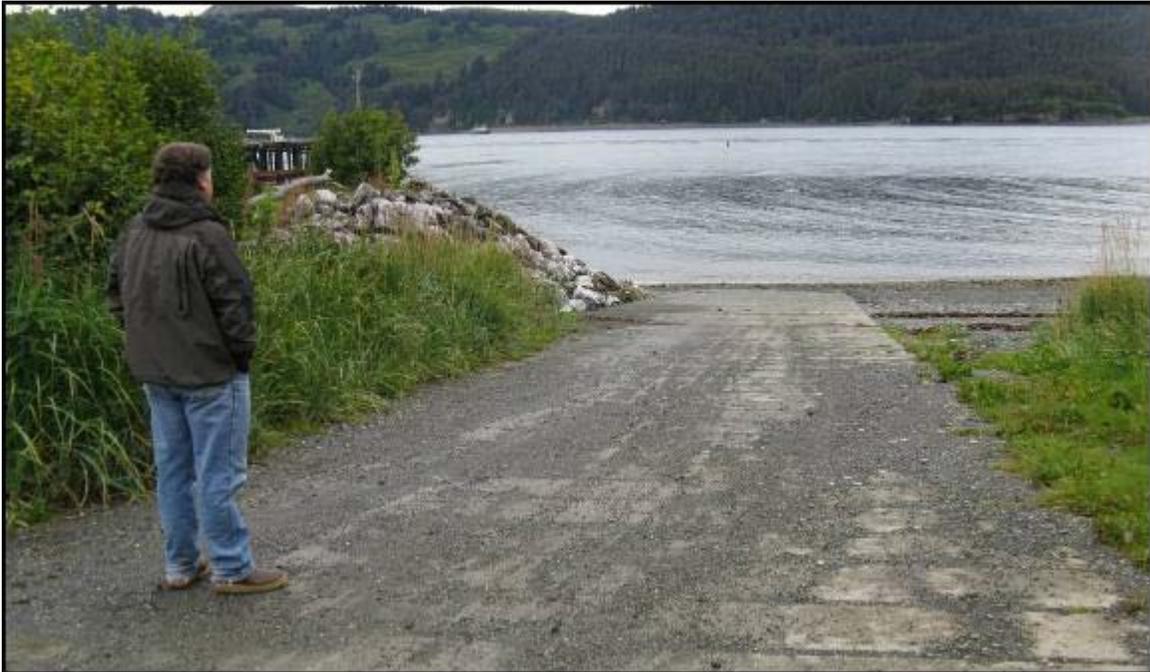
Boat Launches - The community boat launch facilities appear to be in satisfactory condition with the city reporting no issues. There are two launches. The large vessel launch is to the north of the harbor and the City dock. The city operates a tractor and trailer to haul larger vessels out of the water. The inner harbor boat launch is at the northern end of the boat harbor. This launch is available for regular trailered boat launching and recovery. Neither launch facility has a dock.

Figure D-30. Large vessel launch

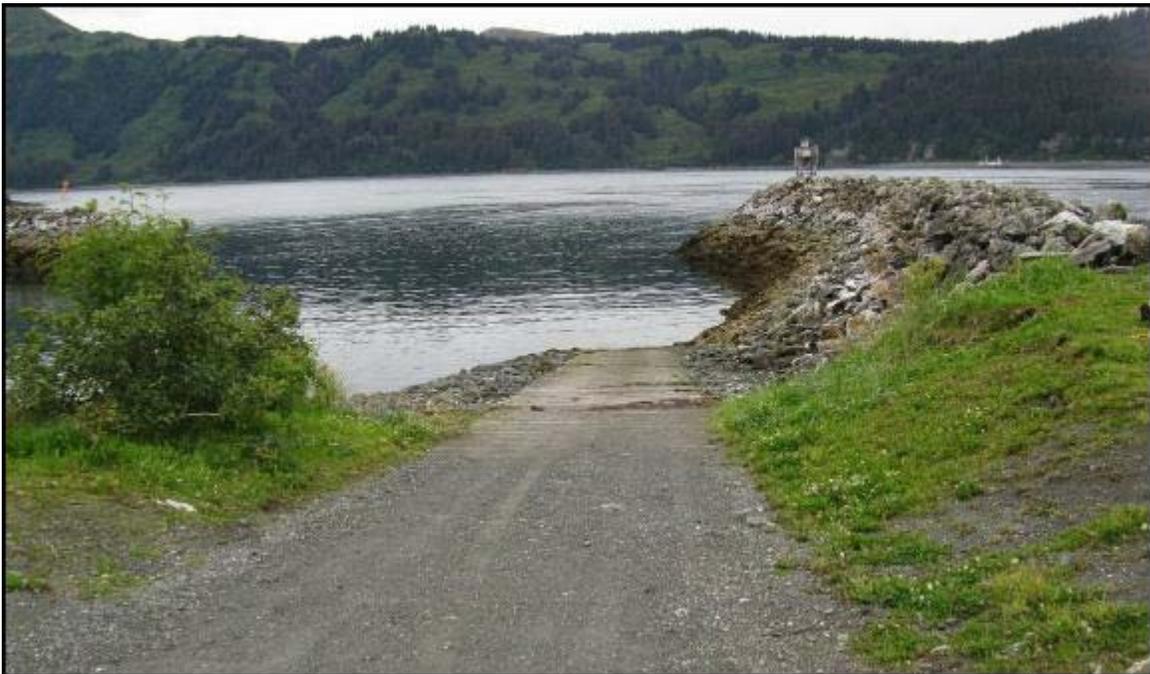
Figure D-31. Inner harbor boat launch

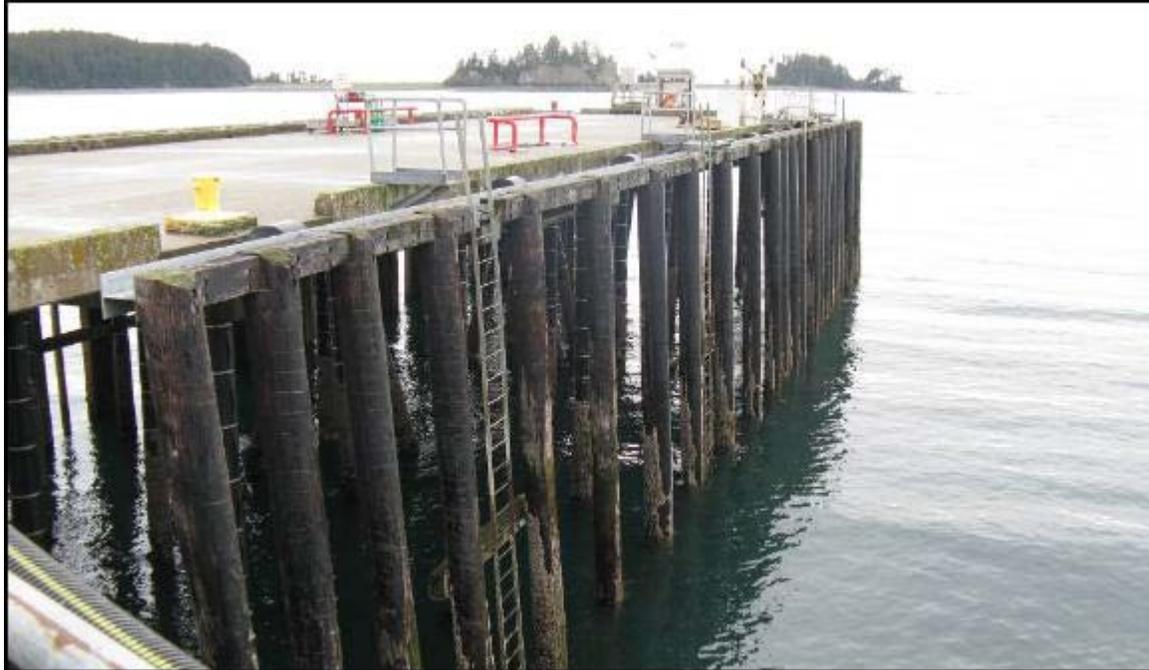
City Dock - The main dock located to the north of the boat harbor. The gangway utilized by the Alaska Marine Highway System (AMHS) is in poor condition, as well as the safety net

that stretches out below the gangway. The city stated they are working with the AMHS and others on a plan to replace/fix these two issues.

Figure D-32. City Dock

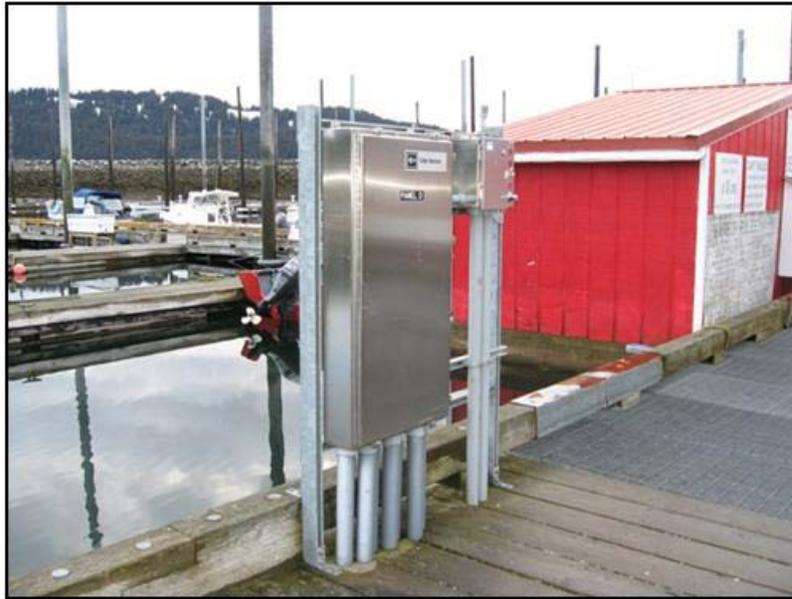
Power distribution system on Floats A, B, C, D and E consist of 208/120 VAC, 3 phase, and 240/480 VAC, 3 phase distributed from panel boards located at various locations on the floats. Lighting system consist of pole mounted area lighting and lighting pedestals. Power distribution is via flexible cables from the panels to the loads. See Figure D-33 through Figure D-36.

Figure D-33. An electrical panel near the gangway

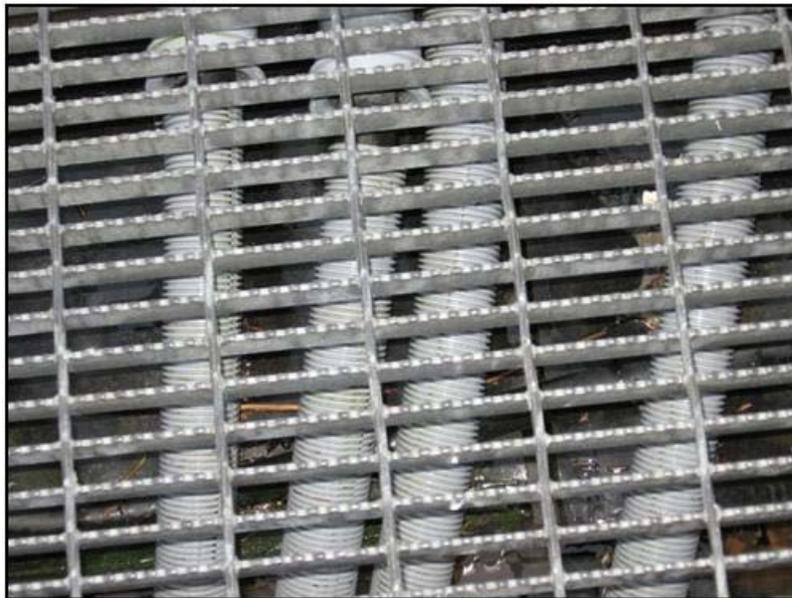
Figure D-34. Examples of wiring conduit

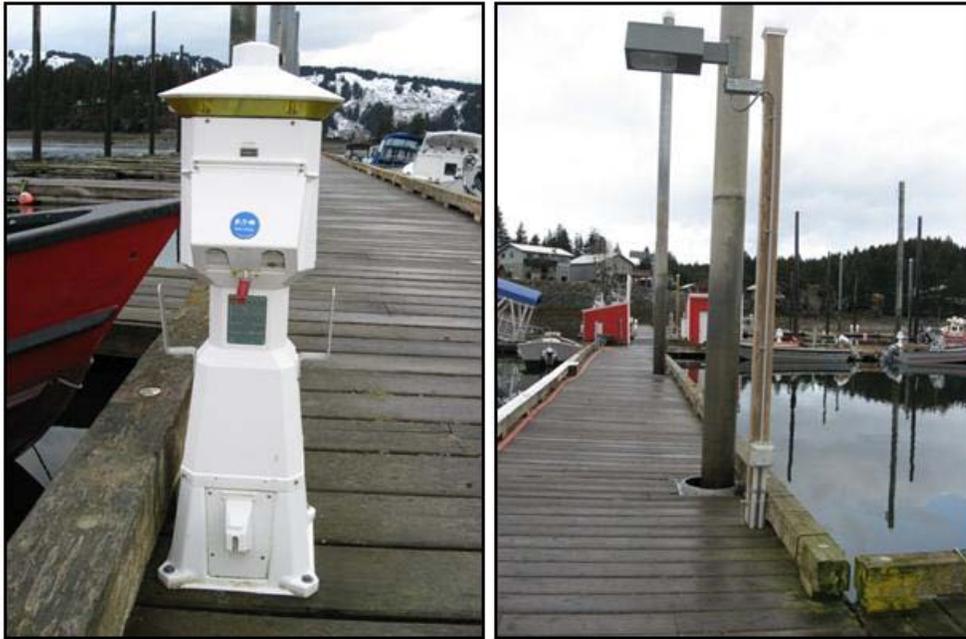
Figure D-35. Examples of overhead lighting and electric pedestals

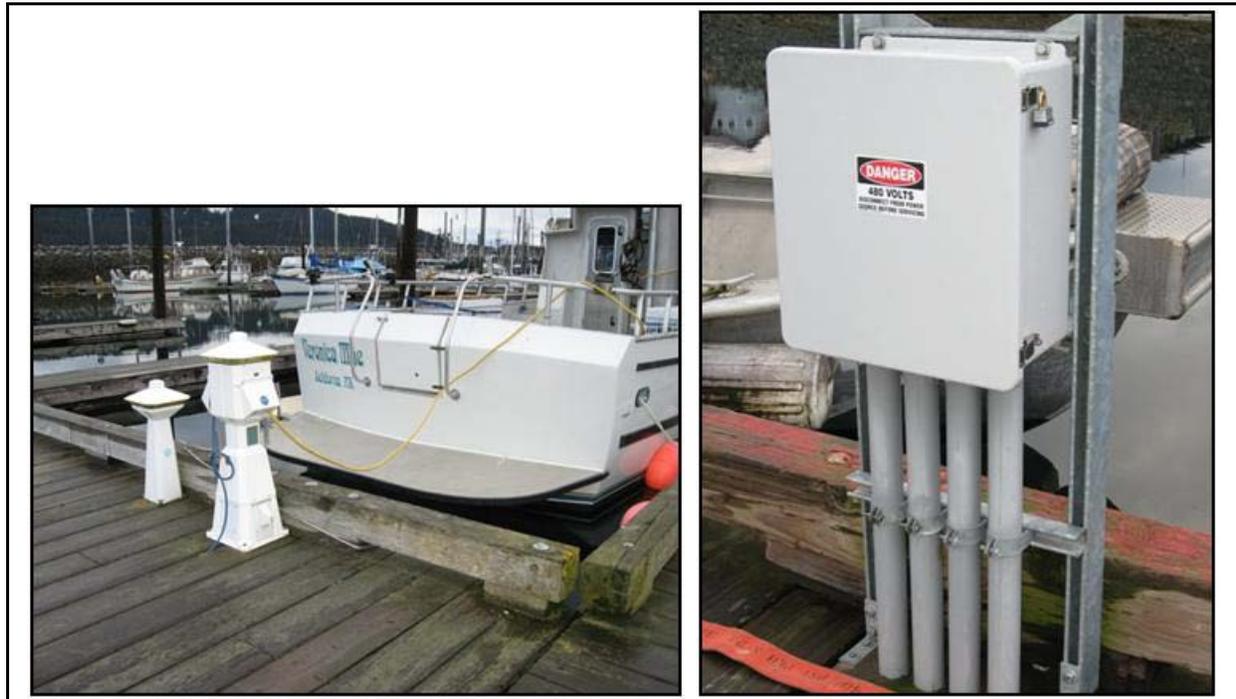
Figure D-36. Other electrical pedestals and panels

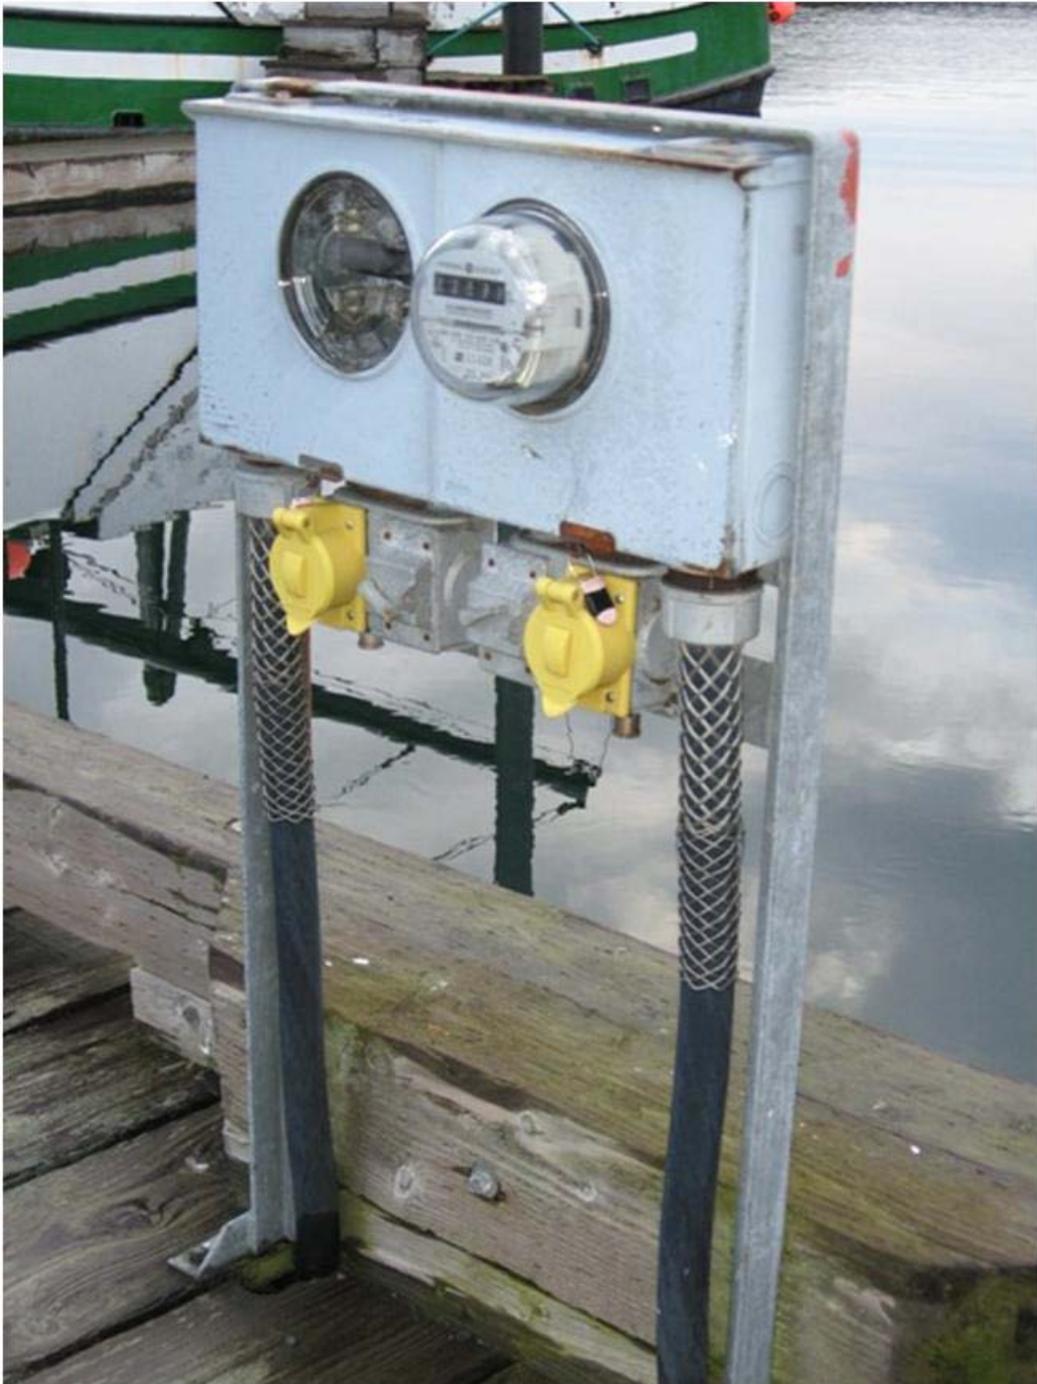
Figure D-38. An older pedestal along the main dock

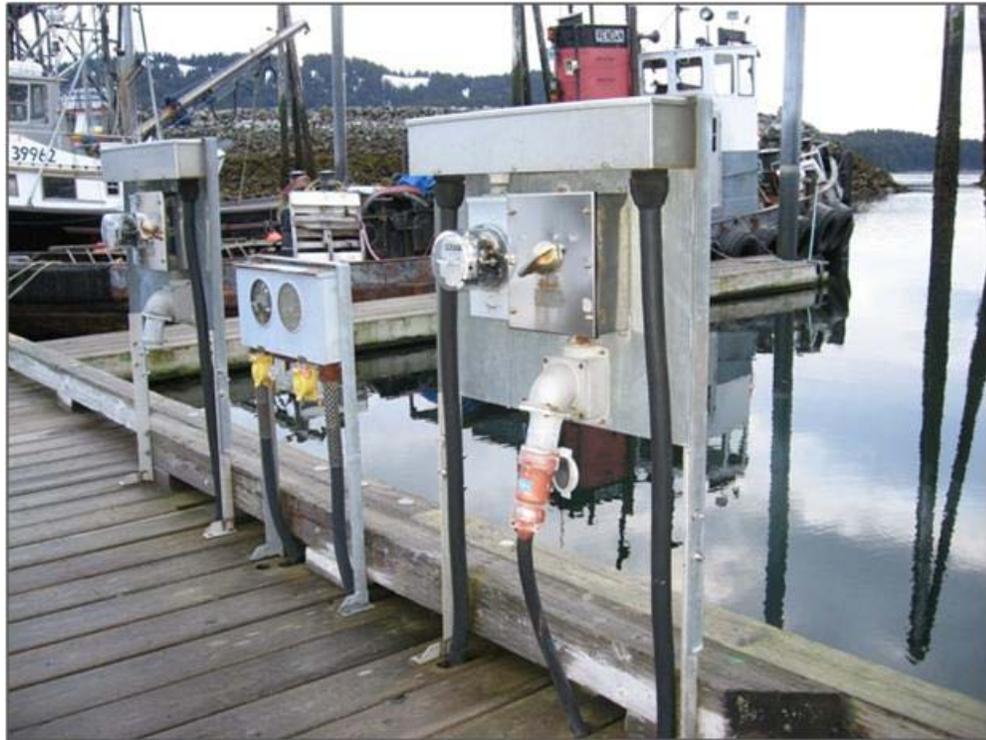
Figure D-39. Older pedestals along the A dock

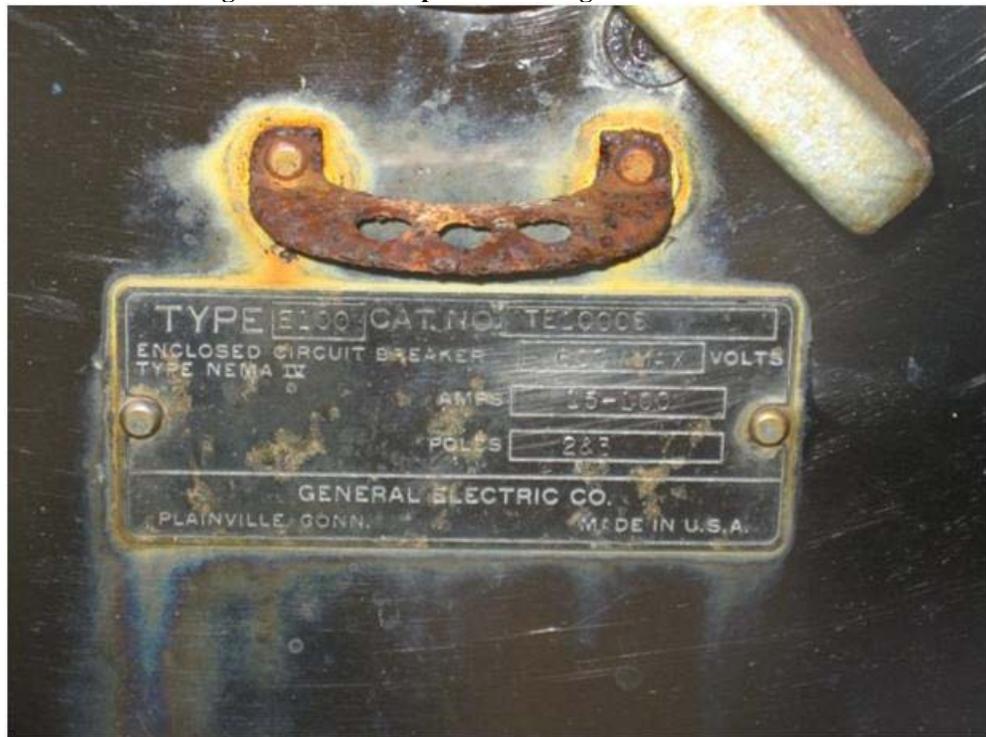
Figure D-40. Manufacturer plate on an older circuit breaker

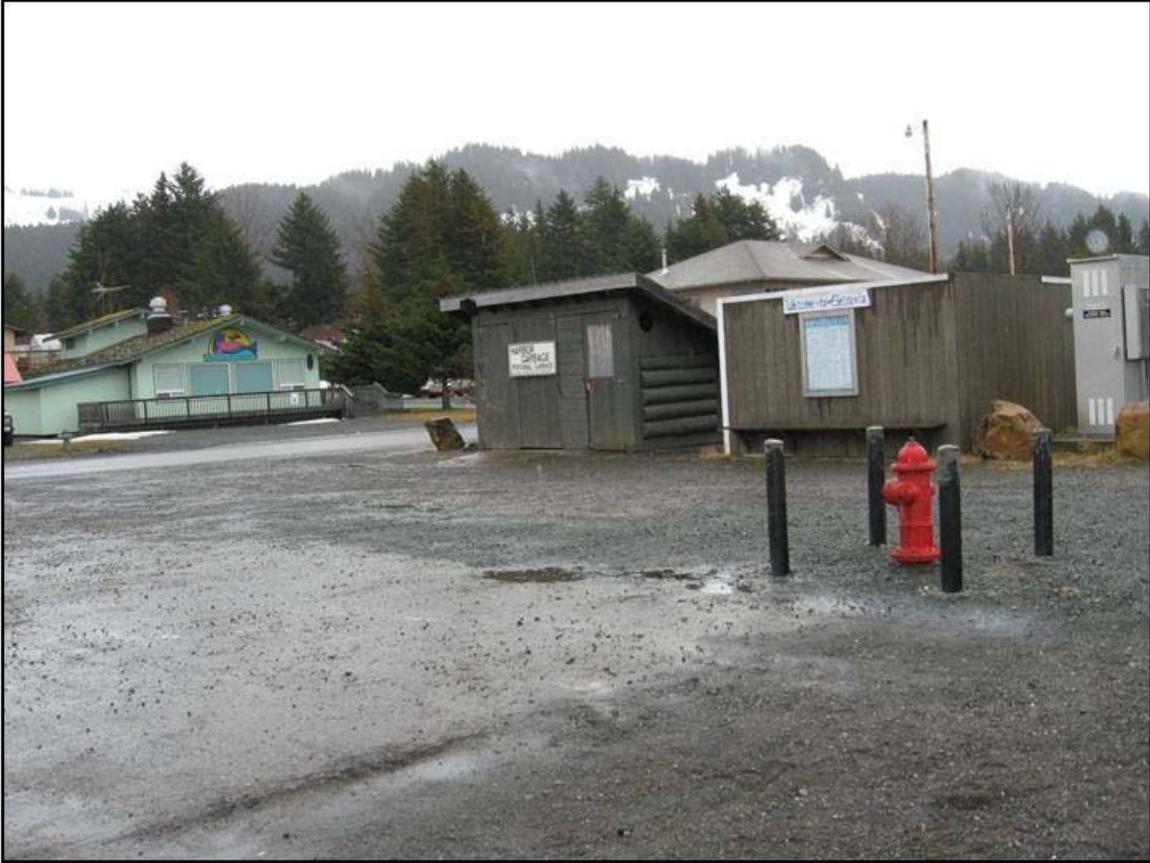
Figure D-41. The recently installed fire hydrant where the new 2" Polyethylene pipe branched off to serve the harbor water requirements.

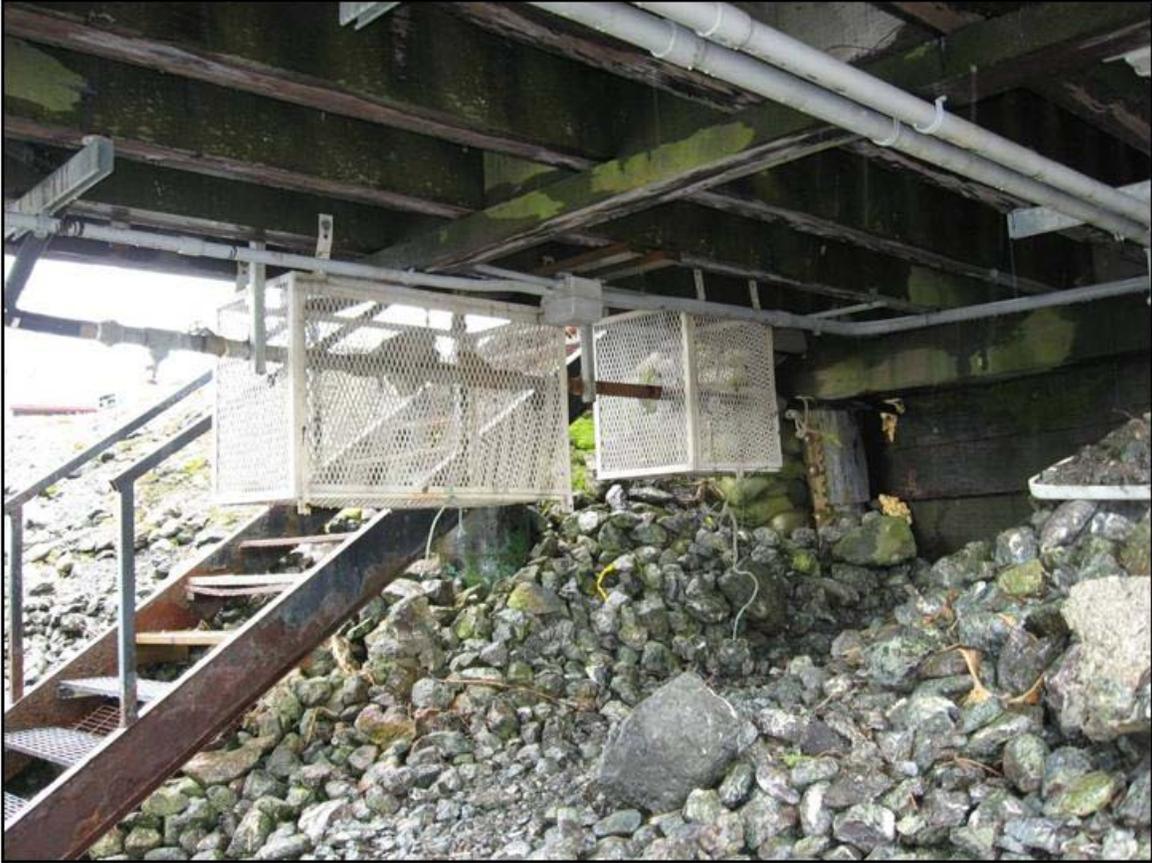
Figure D-42. The valve train consists of a 2" meter (inside right enclosure), check valve, backflow preventer (inside left enclosure), hose connection and a shut off valve.

Access to the water meter requires stepping off the stairs to the sloped rocky area. Water meter gauge can only be read on this side of the meter.

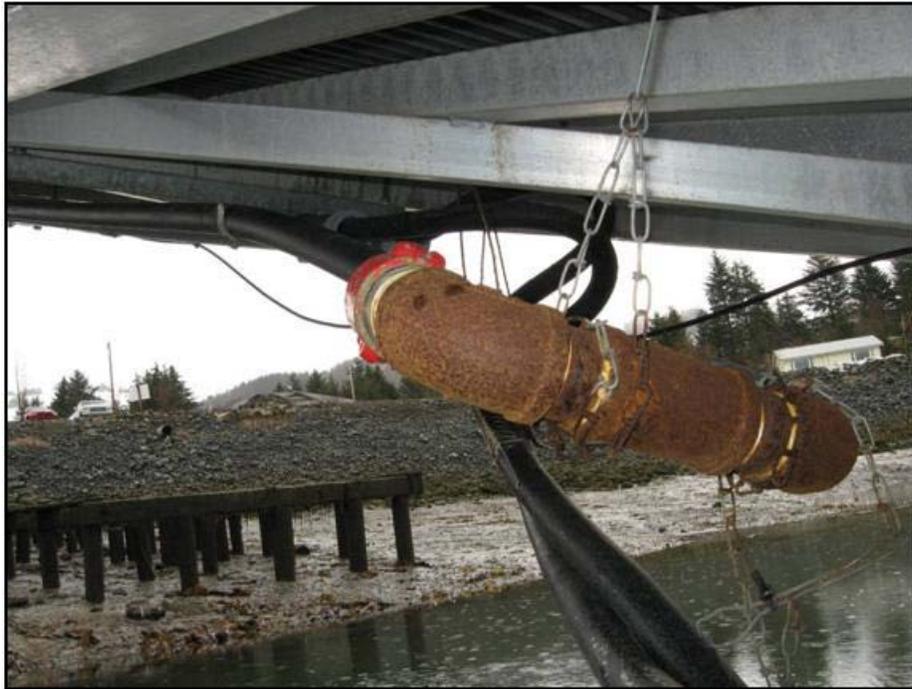
Figure D-43. The 2" polypropylene pipe with a tee connection and capped ends awaiting final connections to the hose station.

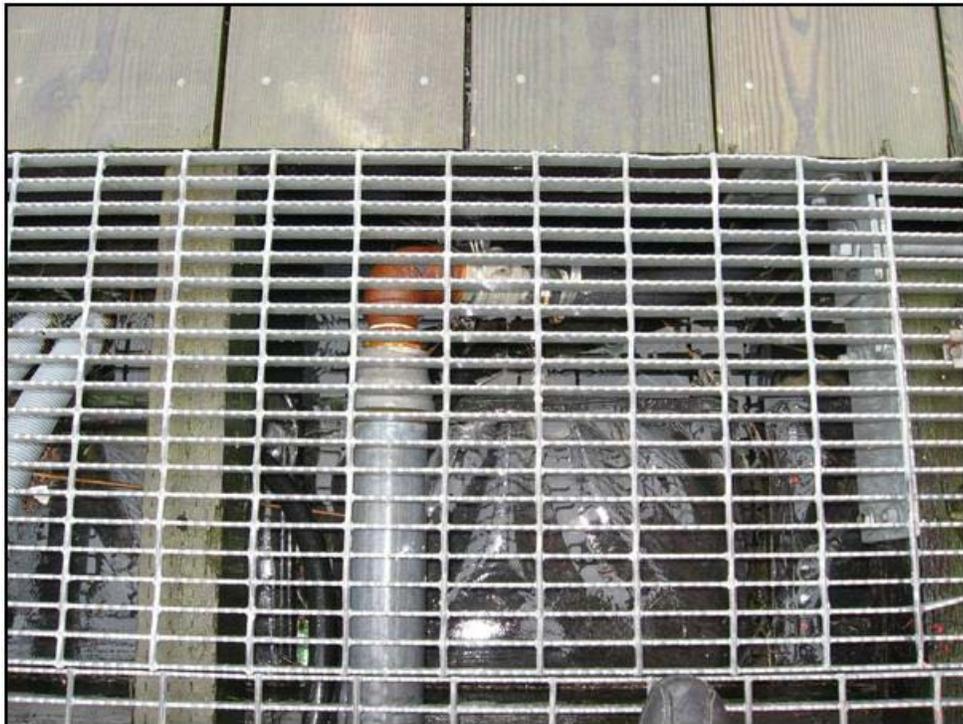
Figure D-44. Existing 2" pipe main serving the south float.

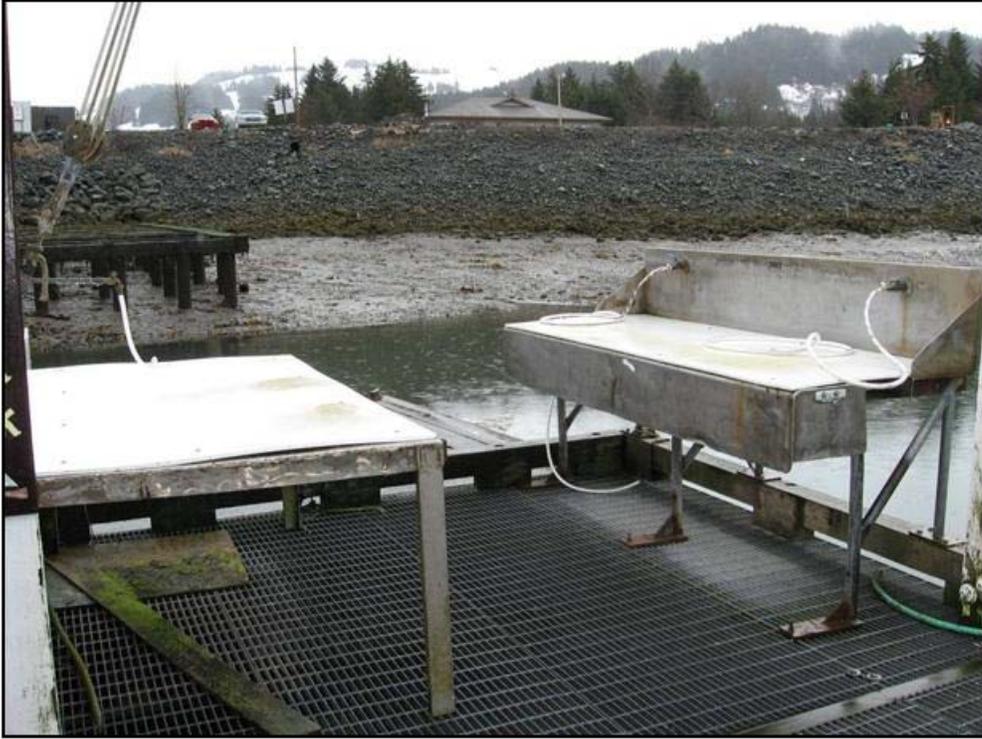
Figure D-45. Fish washing area on the south float near float D junction.

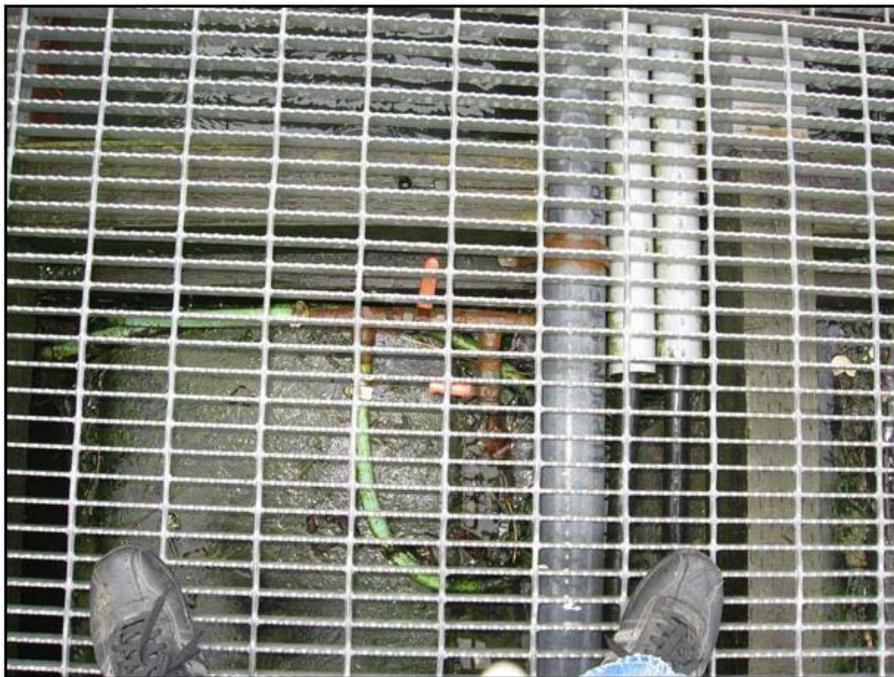
Figure D-46. 1" pipe branch off 2" main under boardwalk grate serving the fish wash area.

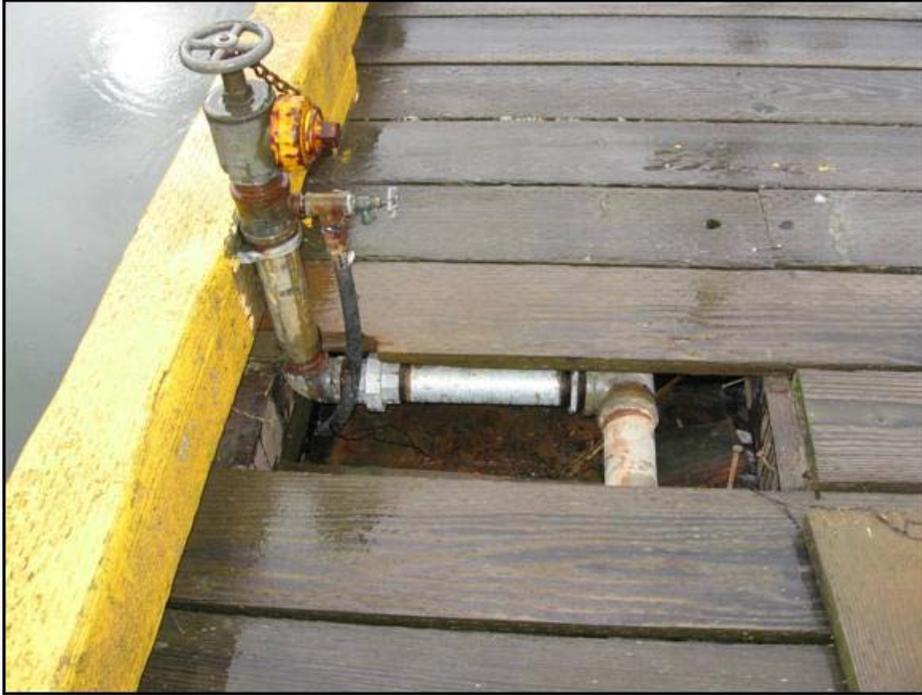
Figure D-47. Hose stations on the south floats are served by the existing under the boardwalk 2" galvanized pipe with a 2" branch to the hose stations. A 1" valved flexible pipe branch extends the hose to floats D and E fingers.

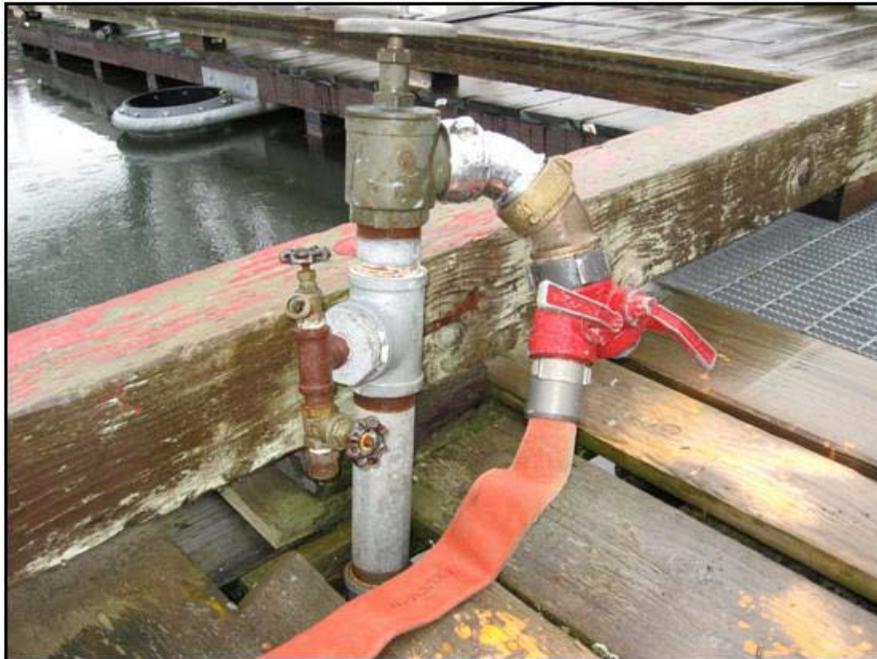
Figure D-48. Existing 2" hose station north of the ramp. The hose station 2" flexible hose connection serving north floats A, B and C hose stations. The 2" pipe under the boardwalk main is abandoned in place.

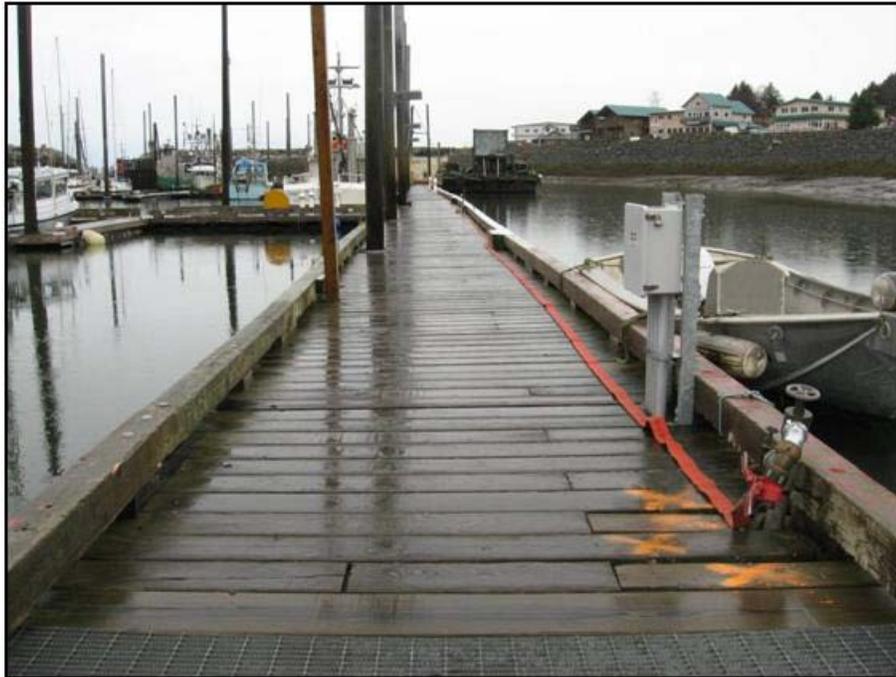
Figure D-49. Main float and Floats A, B and C hose stations flexible main water supply.

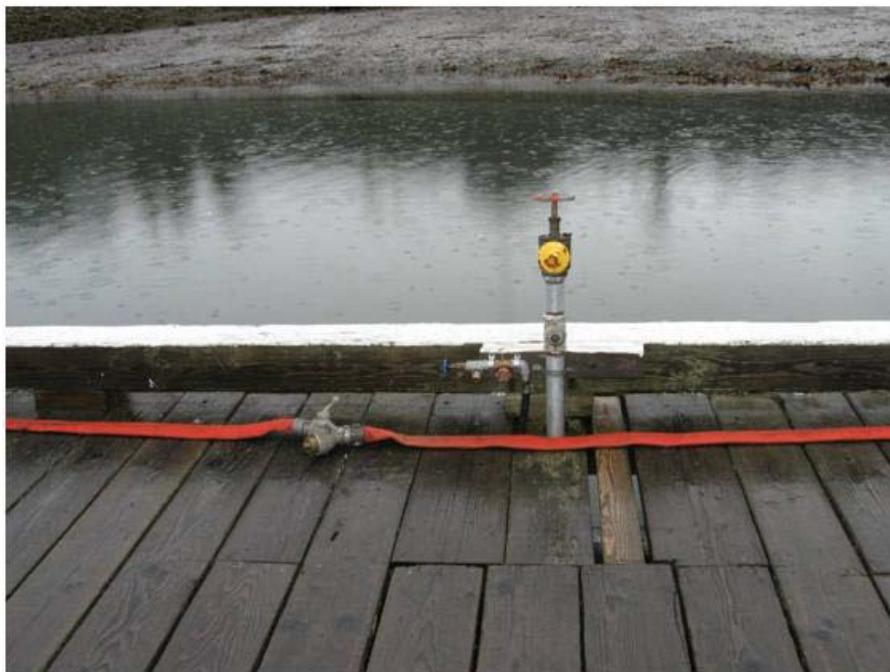
Figure D-50. Typical north float hose station served by the flexible hose with the original vertical hose station abandoned in place.
