SELDOVIA BOAT HARBOR IMPROVEMENTS
TECHNICAL REPORT

FEBRUARY 2011

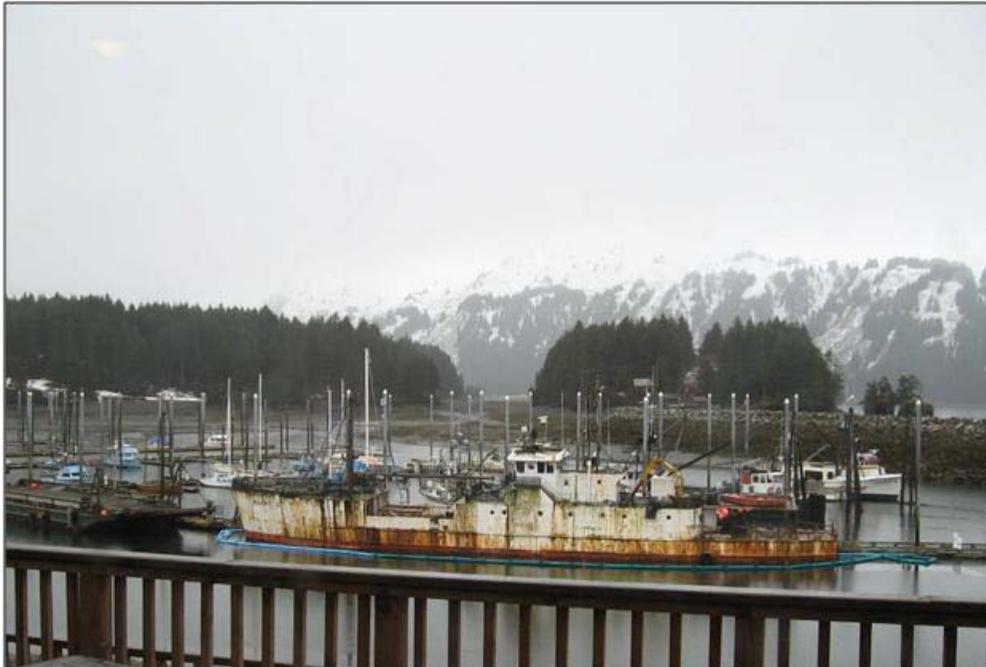
removed on May 13-17, 2010. Some residents were concerned that the Husky II was a safety hazard in the harbor. Tim Dillon reports that he has already made a deal with the Seldovia Village Tribe to allow them to use that space to moor their new fast ferry. The Tribe recently received permits to construct a dock for their ferry, but Tim Dillon stated that the vessel cannot be stored at that dock overnight and will need to seek refuge in the harbor.

Figure D-56. The Husky II is a large derelict vessel moored along the main float
