# Rasmus Enge Memorial Bridge Evaluation

## Task 1—Condition Assessment

Prepared for:  
City of Petersburg  
P.O. Box 329  
Petersburg, Alaska 99833

APRIL 2012

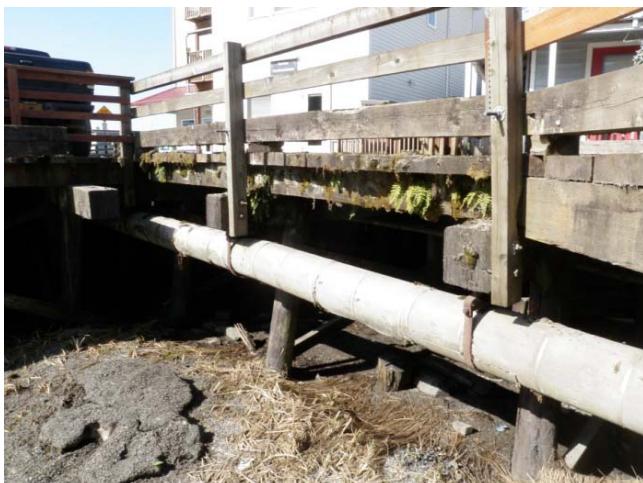
US profile of structure/utility pipe near FE abutment.

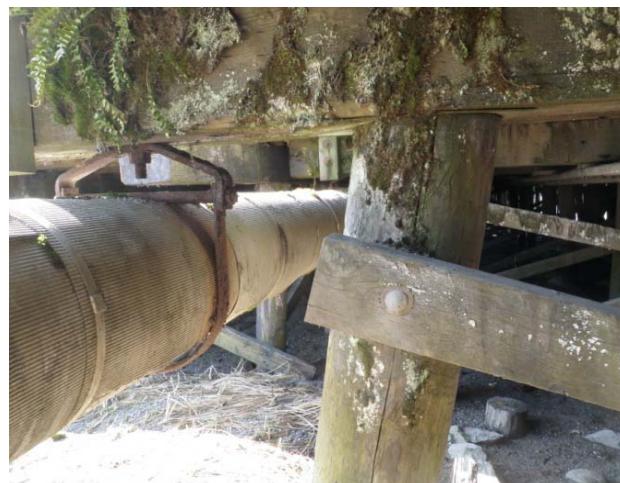
Typical surface growth on piles and pile caps.

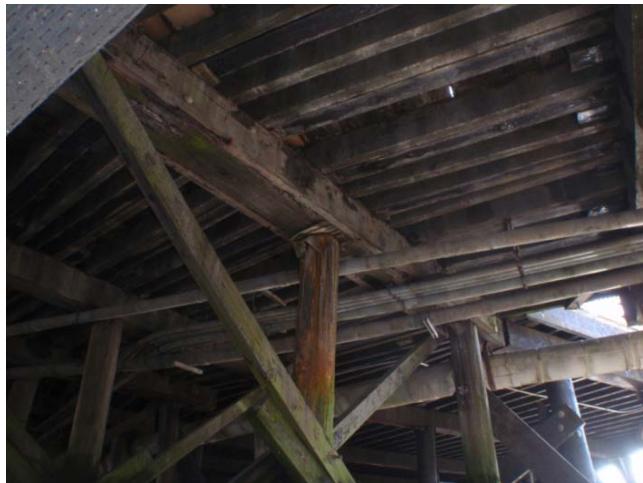
Pile B at Bent #15 split top w/no visible treatment.

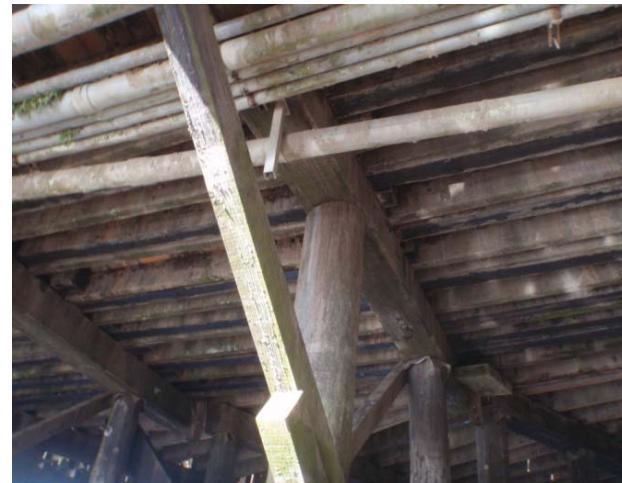
Typical piles w/o visible treatment on upper half.

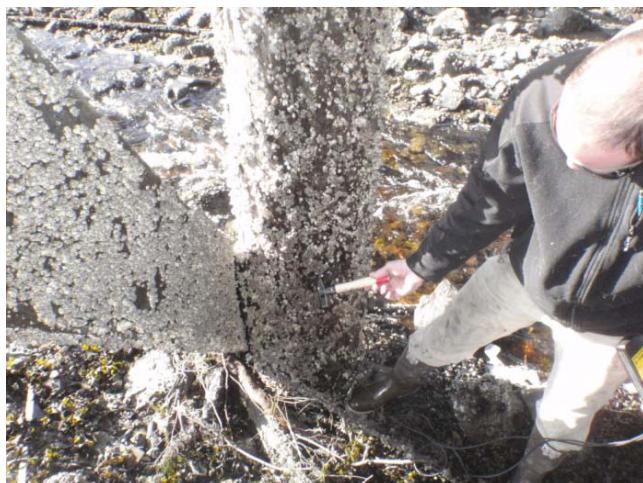
Hole in Pile C at Bent #10.

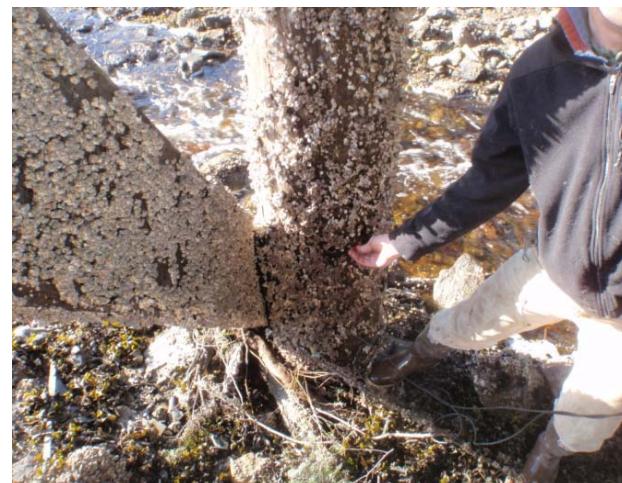
Hole in Pile C at Bent #10 (hammer inside pile).

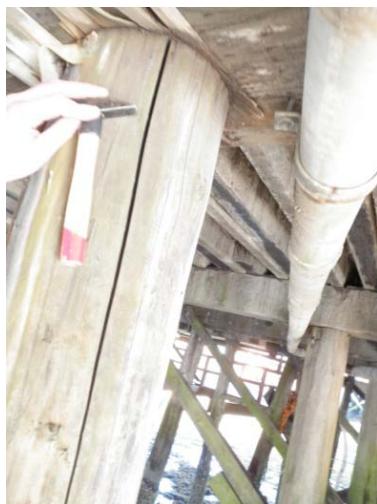
Moderate split in Pile C at Bent #20.

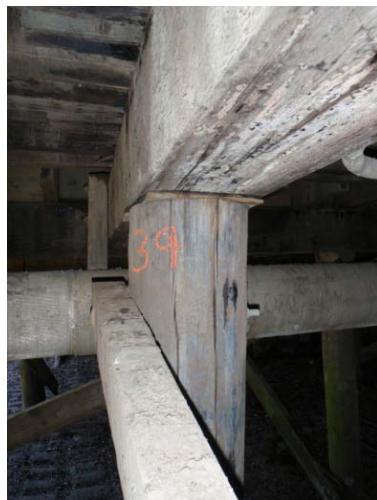
Moderate splits in Pile B at Bent #39.

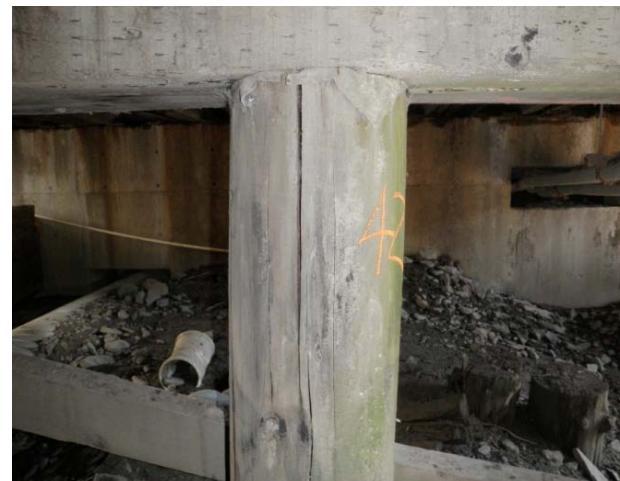
Moderate split in Pile B at Bent #42.

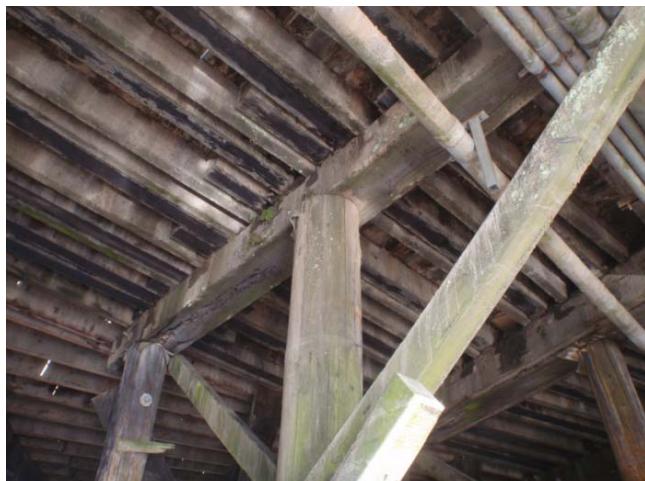
Typical surface fungus and mold growth.

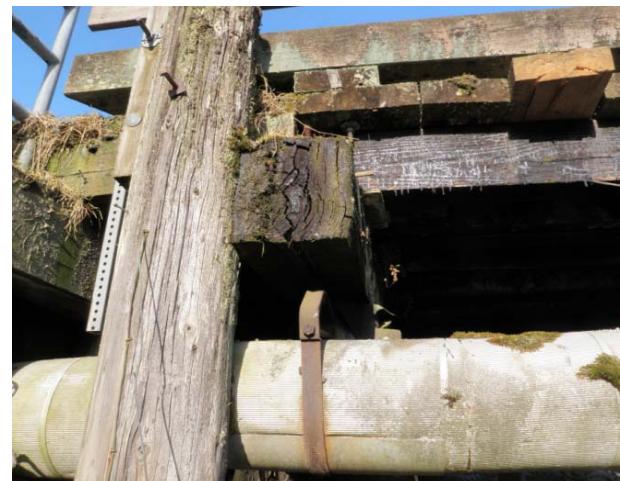
LARGE SPLIT THRU CENTER OF PILE CAP UPSTREAM SIDE, 4-FT LONG  
 4x6 CROSS BRACING SHOWS SMALL CHECKING, OVERALL GOOD CONDITION  
 PILE B NOT IN CONTACT WITH PILE CAP  
 UNISTRUTS ARE RUSTED  
 NOTE ALL CAPS WERE TESTED @ BOTTOM 1/2 OF CAP

Split US end of pile cap at Bent #2.

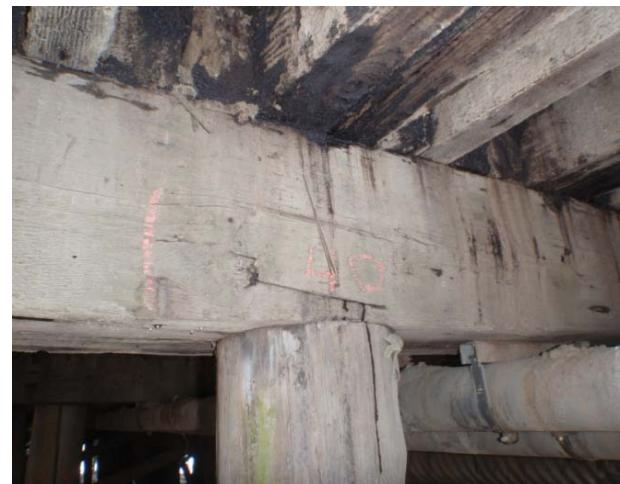
Crushing pile cap at Bent #40, pile B.

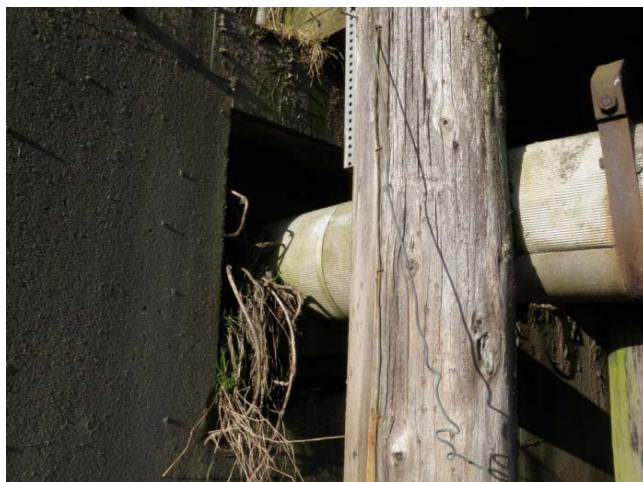
Utilities at NE abutment.

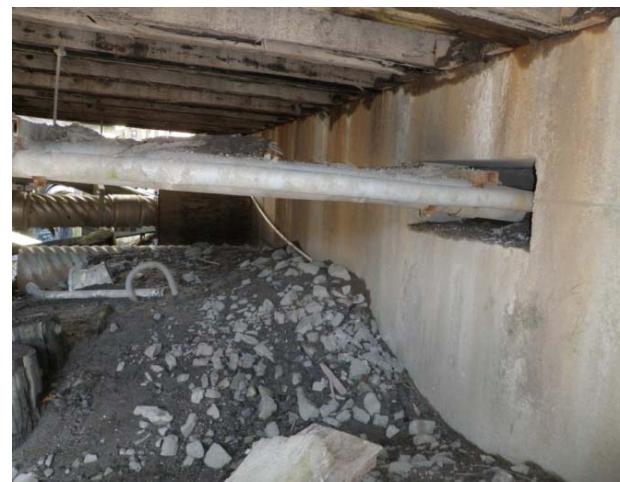
Utilities at FE abutment.

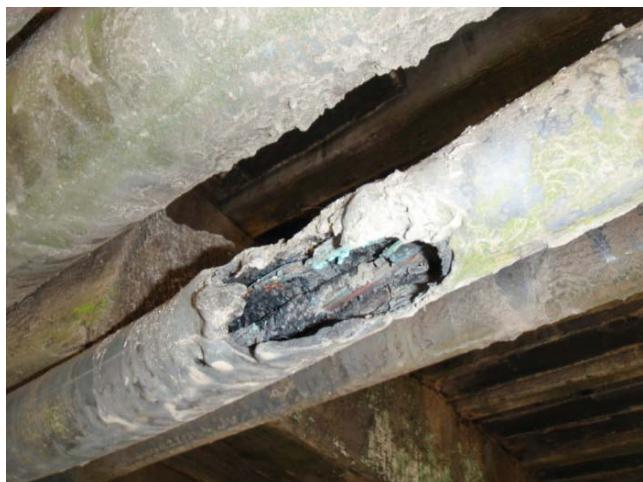
Melted conduit/wiring by NE abutment.
