FINAL REPORT
BULK FUEL FACILITY ASSESSMENT
VARIOUS LOCATIONS, ALASKA
CONTRACT TFSADNC17D0001, DELIVERY ORDER 20342918F00012

MARCH 2019

Prepared for:
Denali Commission
510 L Street, Suite 410
Anchorage, AK 99501

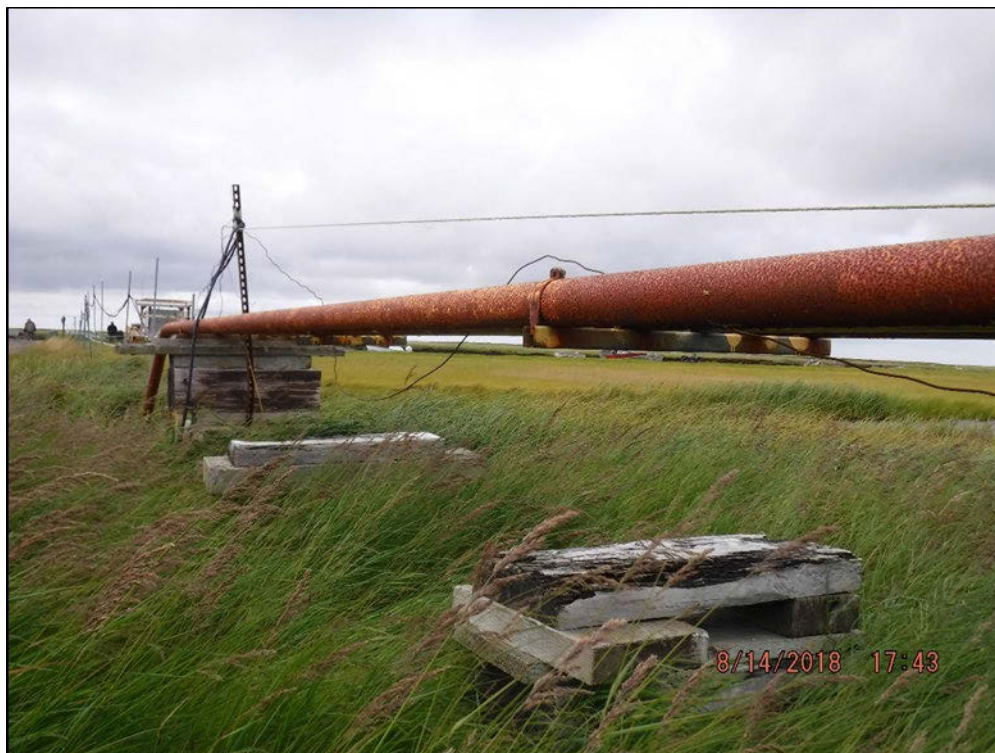
Photograph 11: Unsupported pipe run. Note partial cribbing.

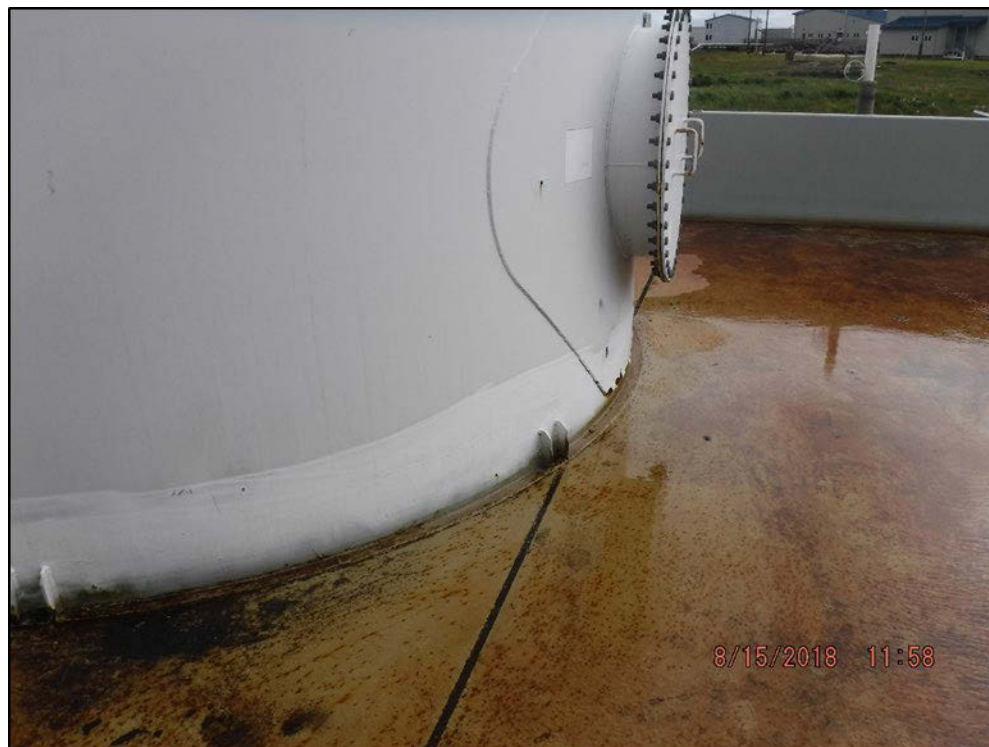
Photograph 4: Looking at standing water in containment and repainted tank bottom.

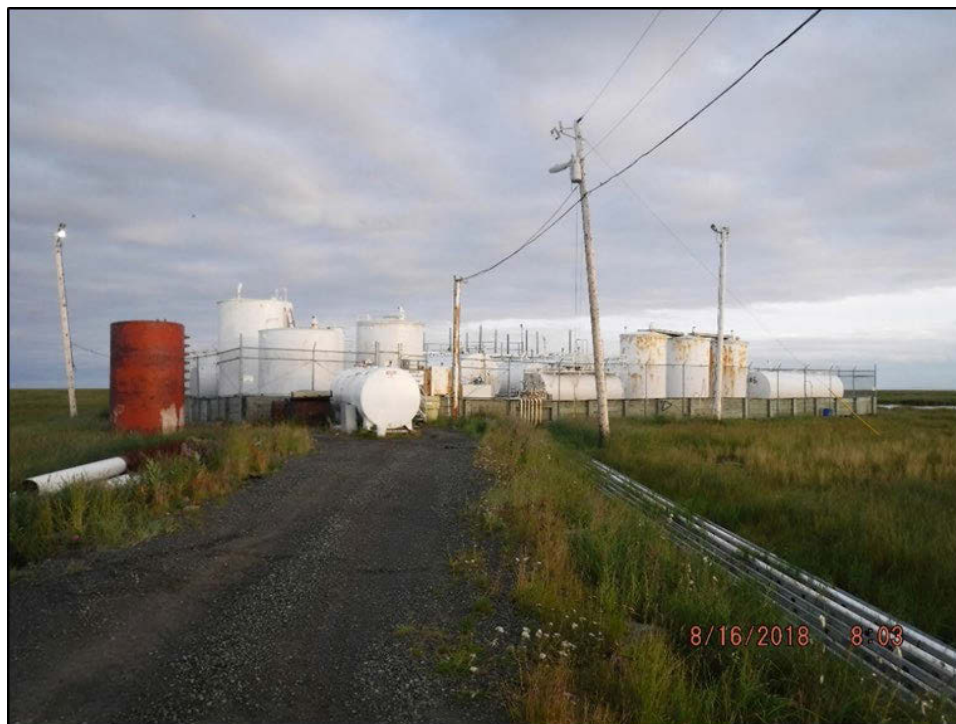
Photograph 2: Looking west at the Chefnorak Bulk Fuel Facility. Note leaning timber utility poles.

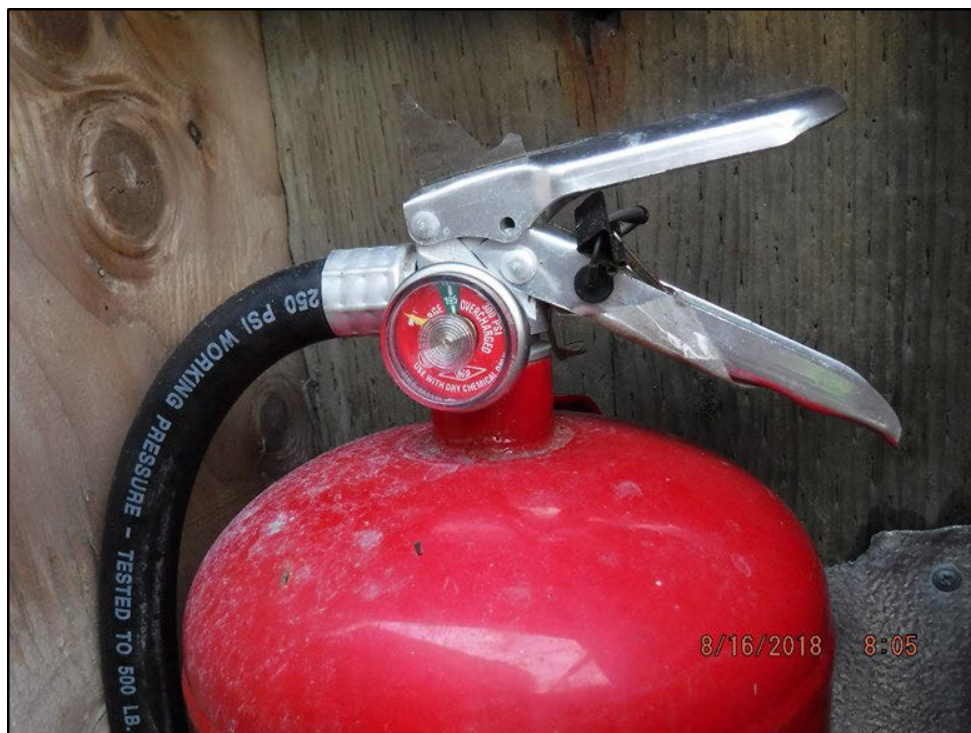
Photograph 7: Looking at undercharged fire extinguisher.

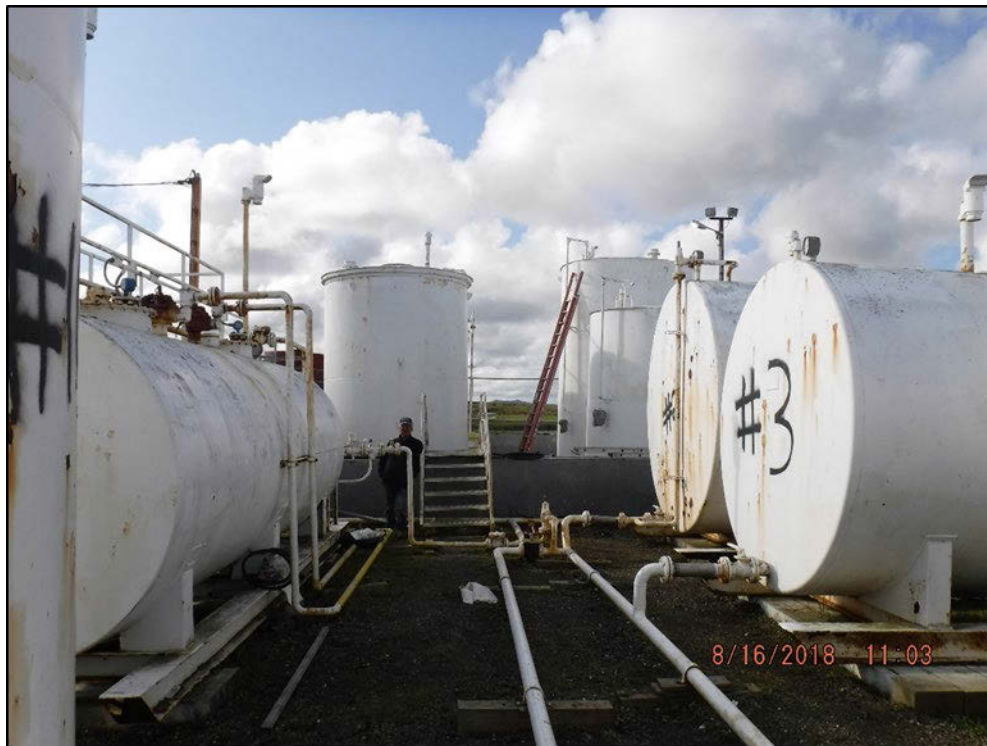
The tanks and piping in the CNC cell are in fair to poor condition. The tanks show evidence of scraping and repainting. Rust blooms of varying severity are present. Heavy paint flaking is present on the bottoms of several tanks (Appendix B3, Photograph 10). The tops of vertical tanks are not welded and require the gaps to be filled by the tank farm staff with caulking (Appendix B3, Photograph 12).

Photograph 10: Looking south in the CNC tank farm cell.

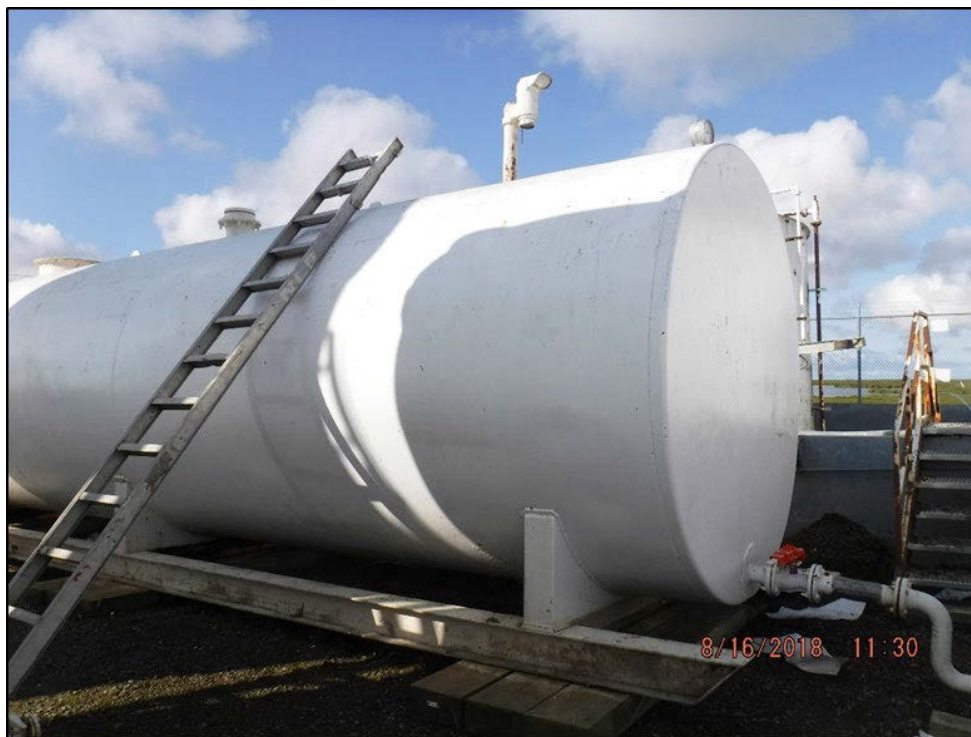
The tanks and piping in the City cell are in fair condition. Recent painting has helped mitigate weathering to the tanks (Appendix B3, Photograph 11).

Photograph 11: Looking west at Tank #1 that was recently painted.

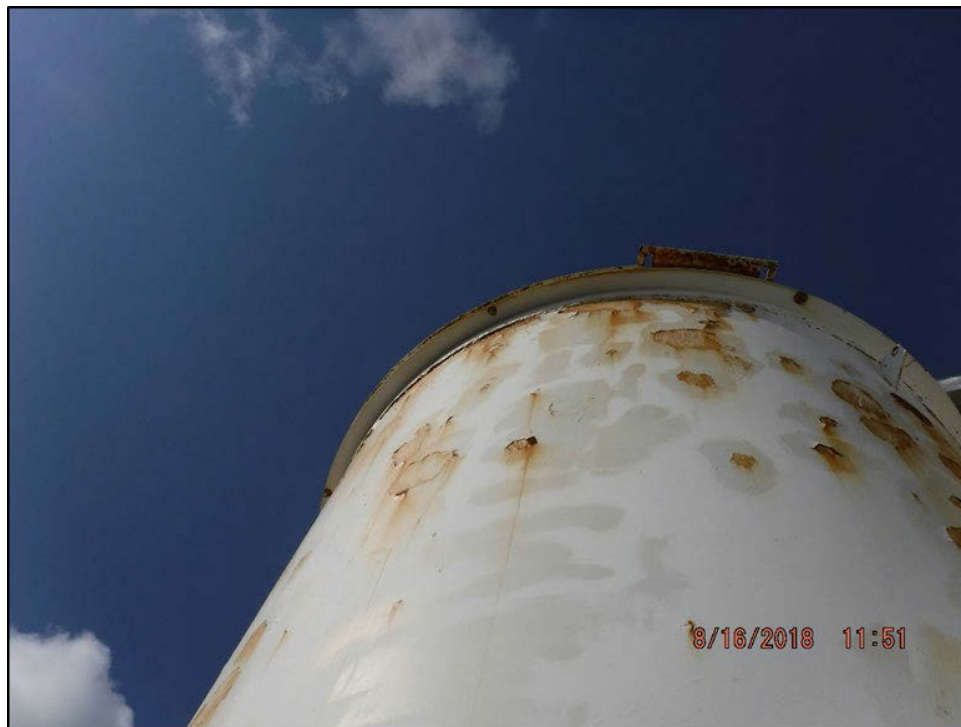
Photograph 12: Looking up at Tank #12. Note the caulking used to seal gap along tank rim.

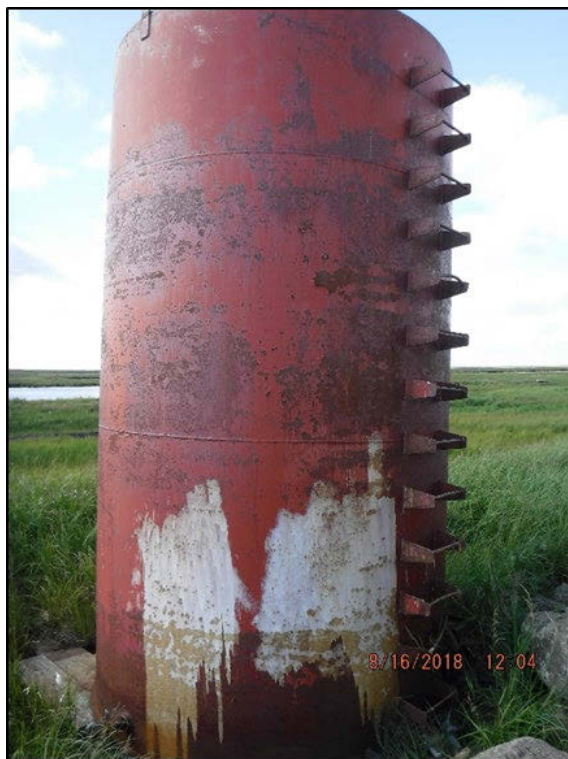
Photograph 16: Looking southeast at the 5,000-gallon contingency tank outside of containment.

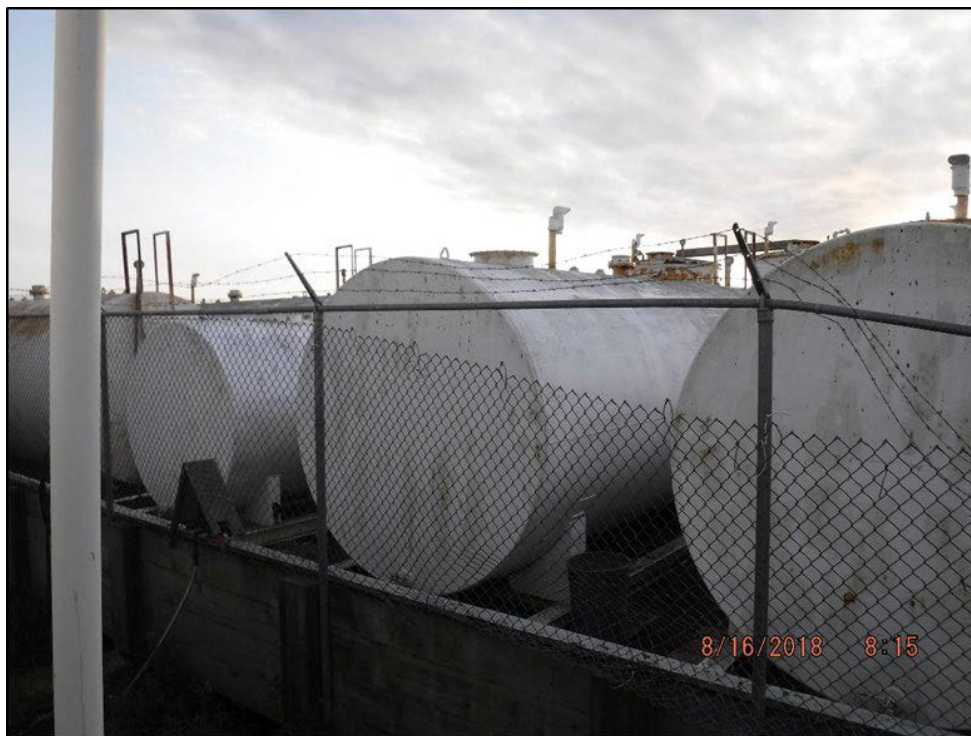
Photograph 17: Looking east at the compromised security fence.

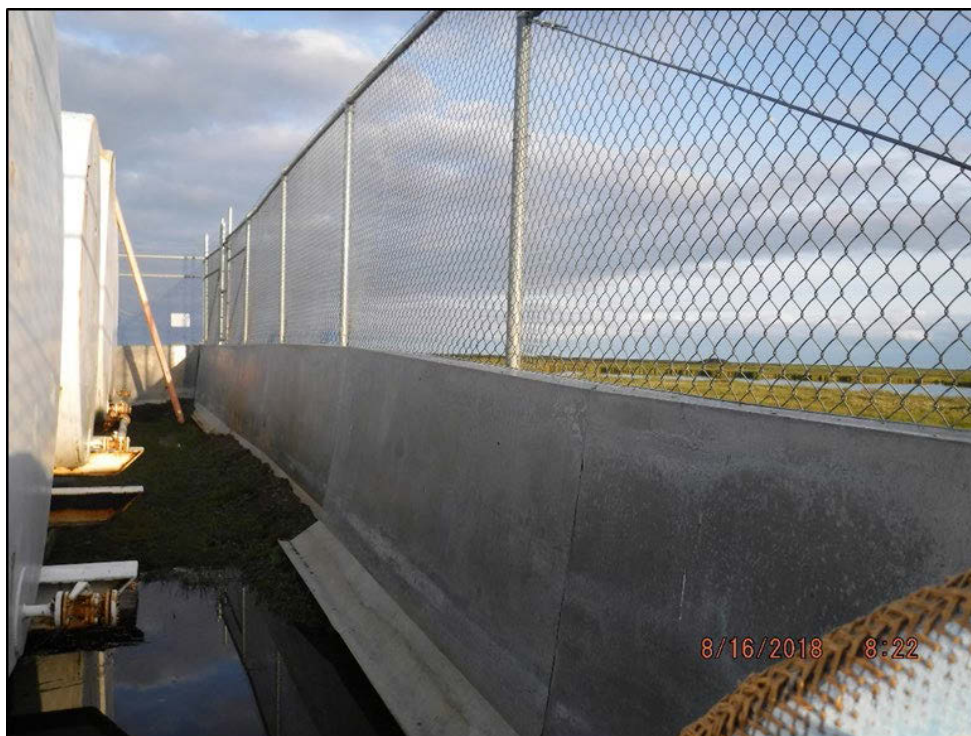
Photograph 18: Looking south along the west wall. Note where fill has subsided below the previously buried sheet metal wing.

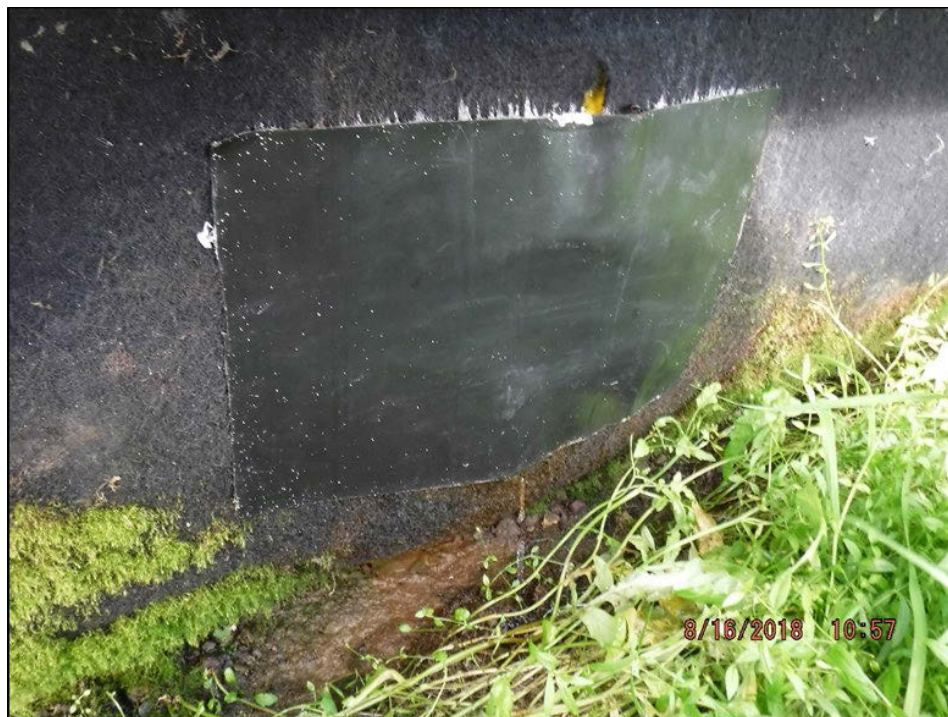
Photograph 19: Patched tear in liner material. Note water actively dripping.

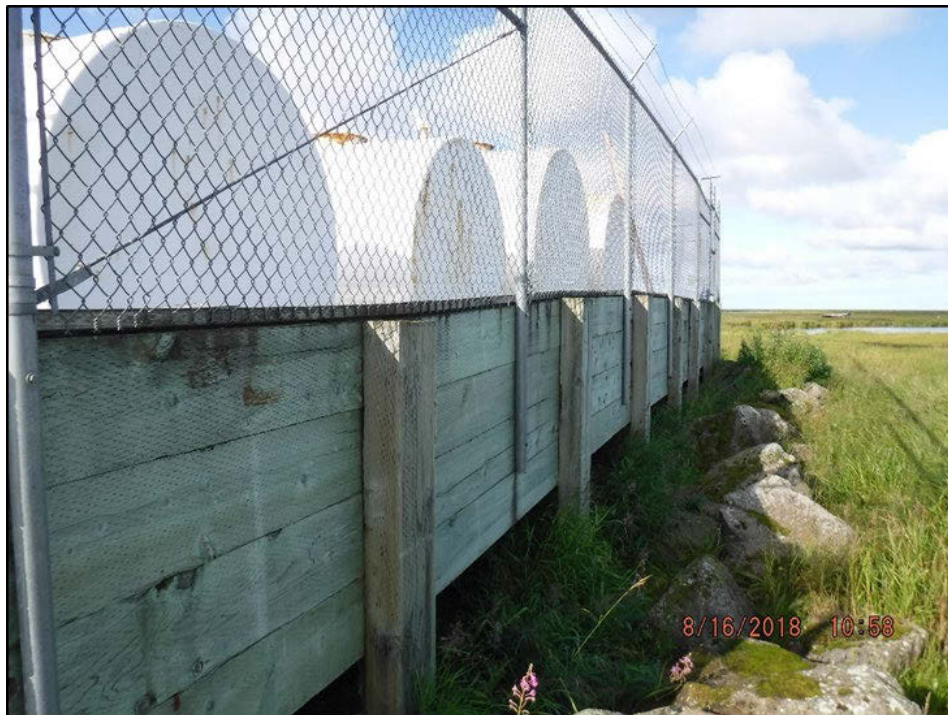
Photograph 22: Looking west along the north side of the tank containment wall. Note gap of exposed liner beneath lowest horizontal timber.

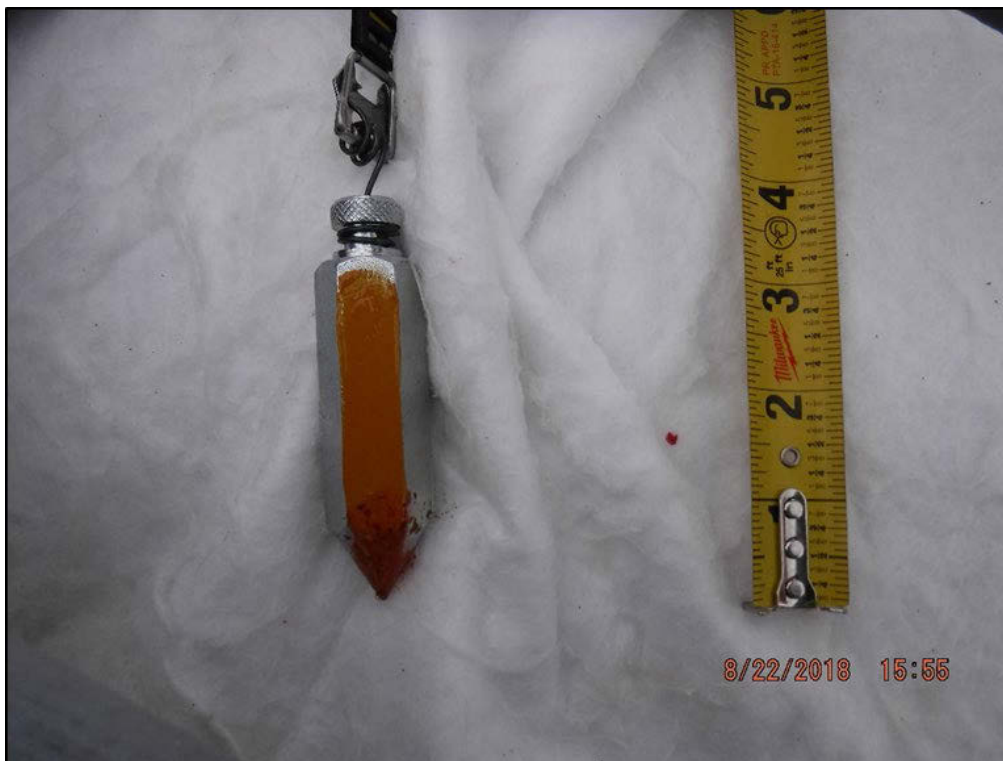
Photograph 4: Plumb bob with water indicating paste after being dropped into Tank S1.

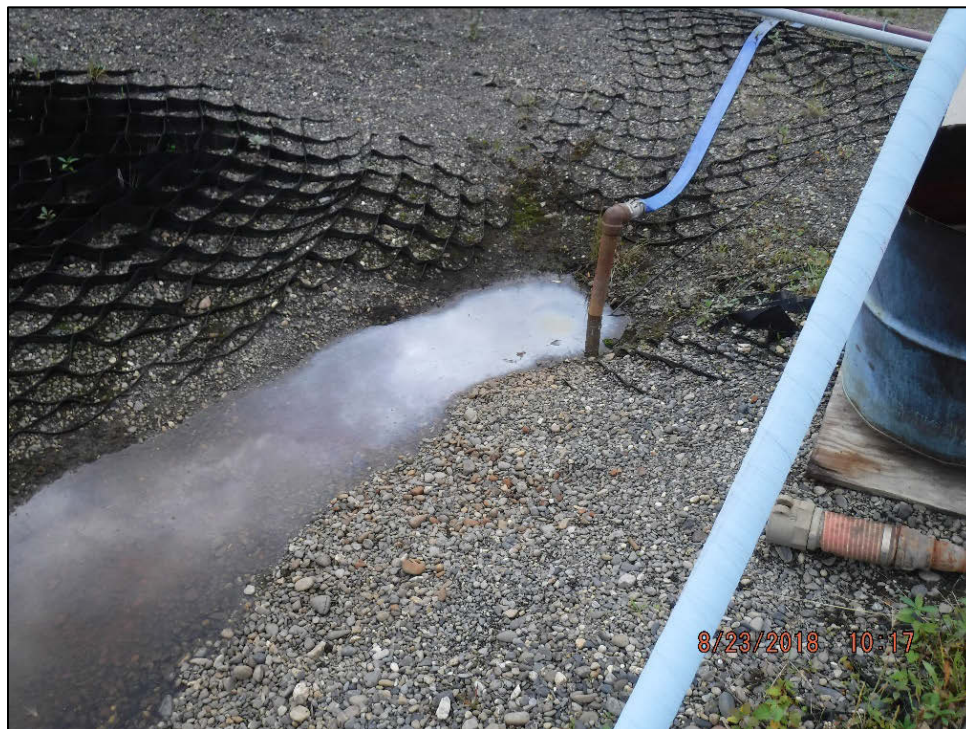
Photograph 12: Petroleum sheen seen within dike by fueling header on 23 August 2018.

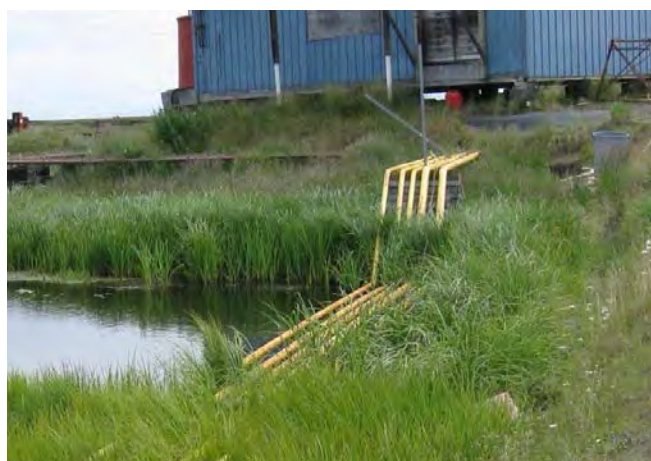
Pipe coating condition during 2010 inspection

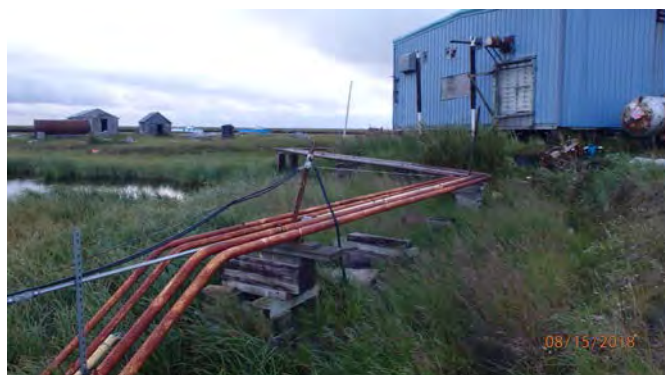
Same pipe during 2018 inspection showing complete coating failure.

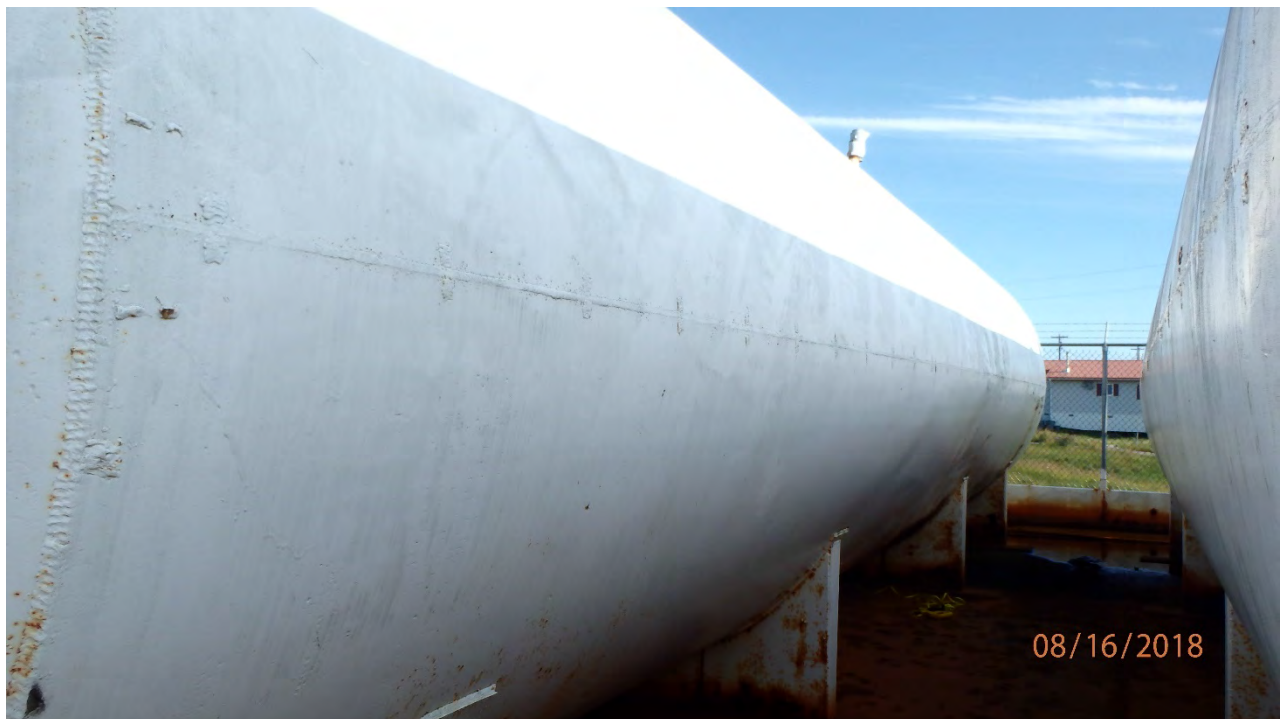
FIGURE 8: NON-STANDARD SHELL CONSTRUCTION FOR TANK 12. LONG SEAM WELDS ONLY, SHELL IS FABRICATED FROM 6 PLATES MEASURING 5.25 FEET BY 42.5 FEET LONG.

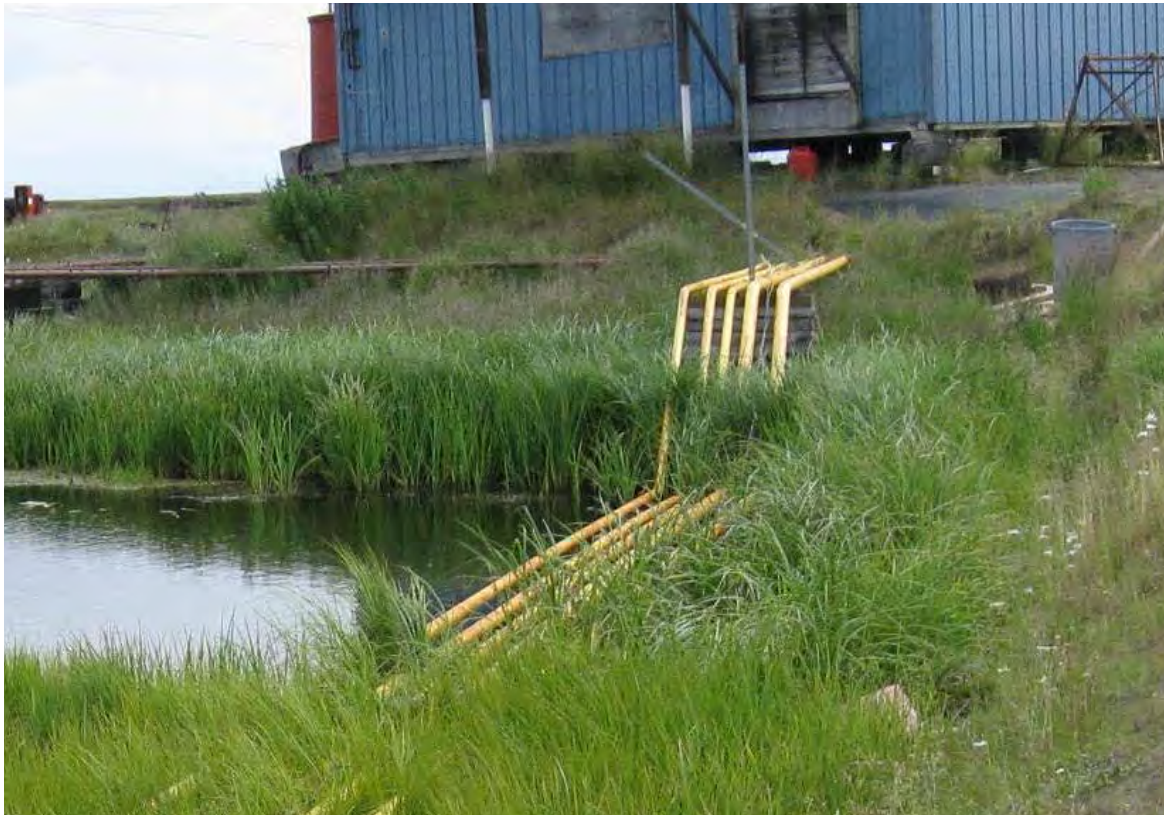
FIGURE 14: CARGO AND SERVICE PIPING CONDITION, 2010.

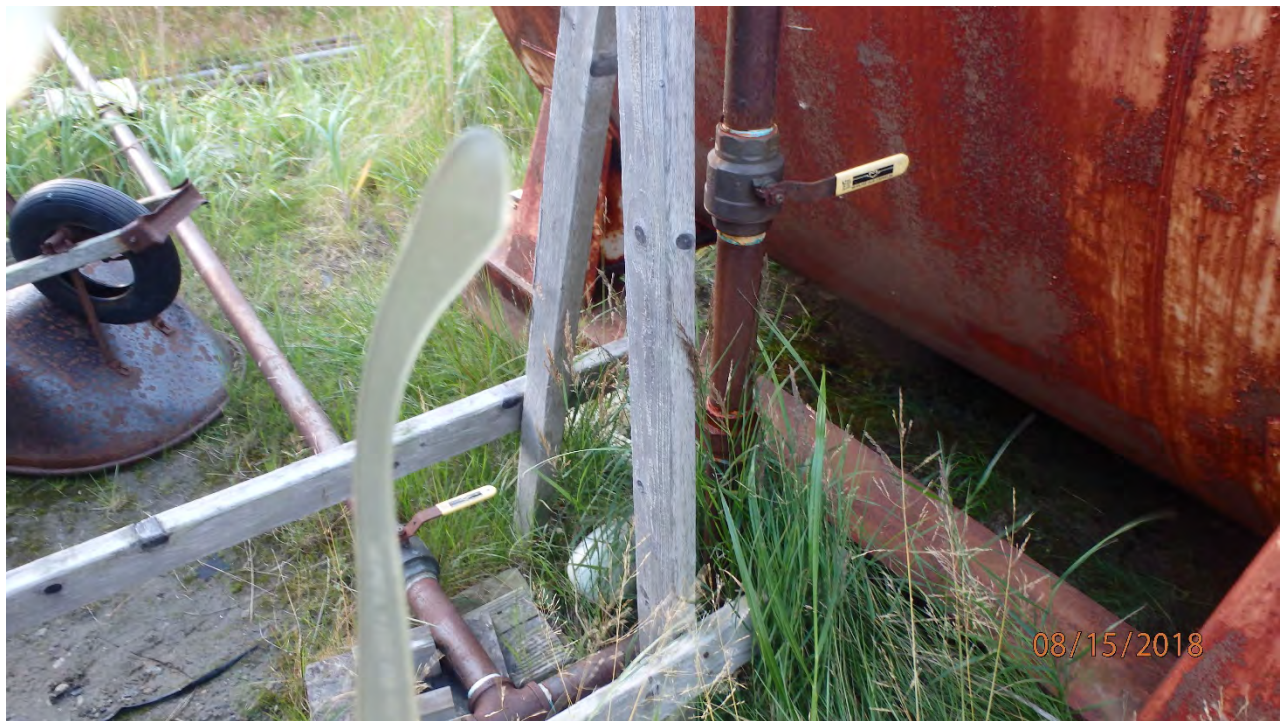
FIGURE 23: 2 BRASS VALVES IN FUEL SERVICE AT SECONDARY DISPENSER AND COUNCIL TANK.

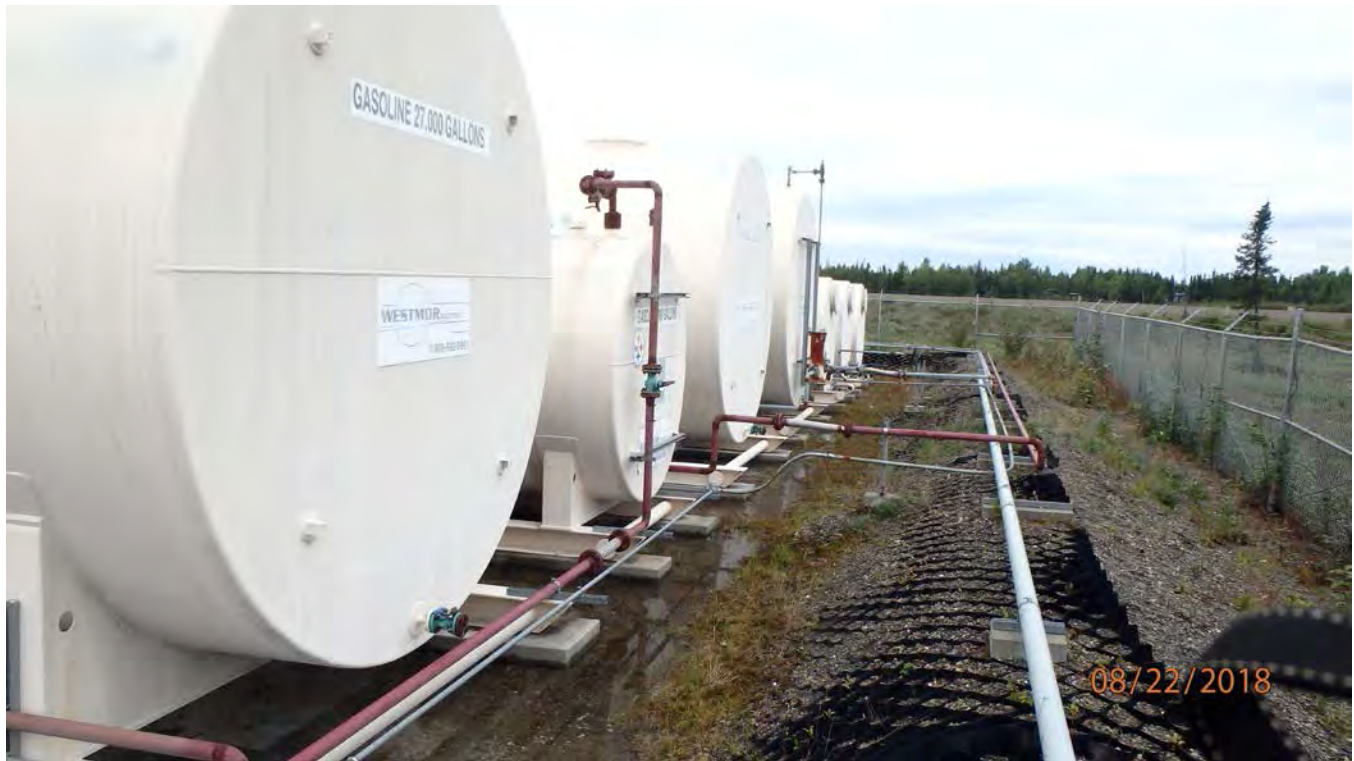
The piping systems are coated with Devoe Speedenamel 4318, which is suitable for atmospheric service but has weathered and failed at all welds, fittings and flanges. The straight runs of pipe are showing damage to the coating as well, in the form of cracking.

General piping condition

1. Recoat all external tank and piping surfaces using a suitable exterior coating system per manufacturer's recommendations. Coating materials should be resistant to ultra violet (UV) degradation and suitable for industrial-type service. Ensure that all welds, fittings, and crevices such as those present at pipe supports are properly coated. Perform surface preparation in accordance with industry standards and manufacturer's requirements to maximize coating performance.

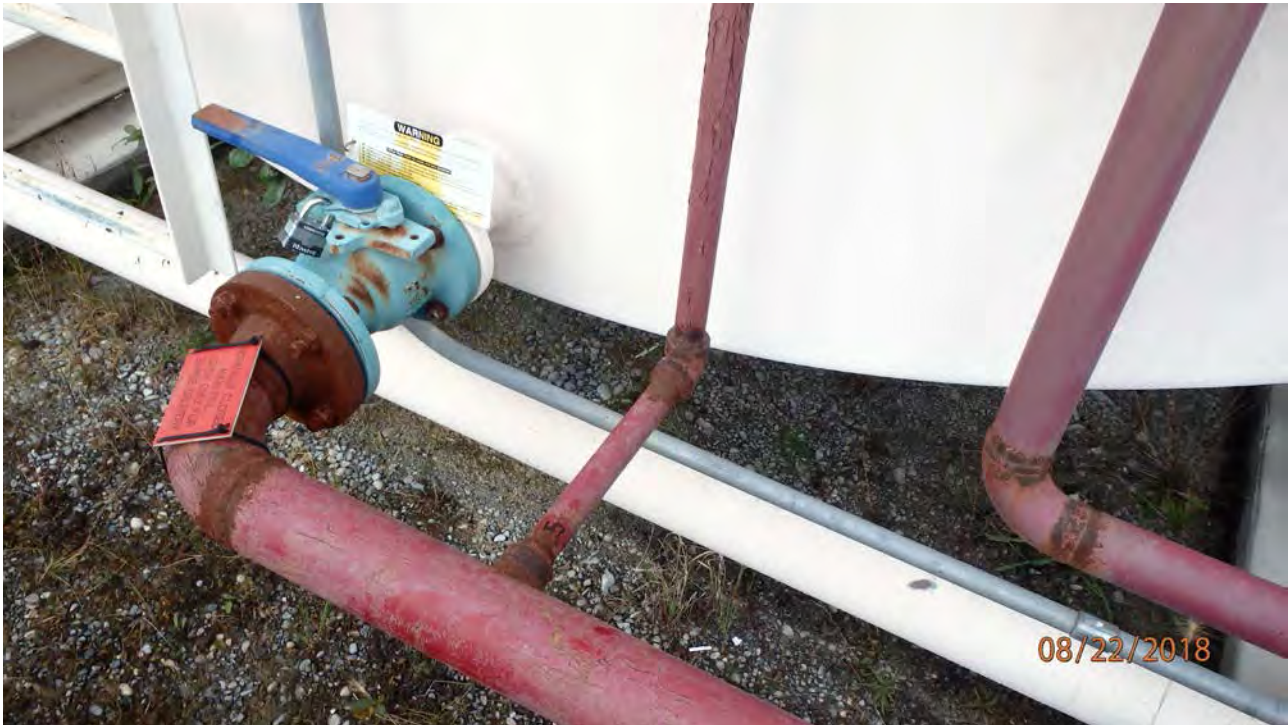
Typical gasoline piping condition.

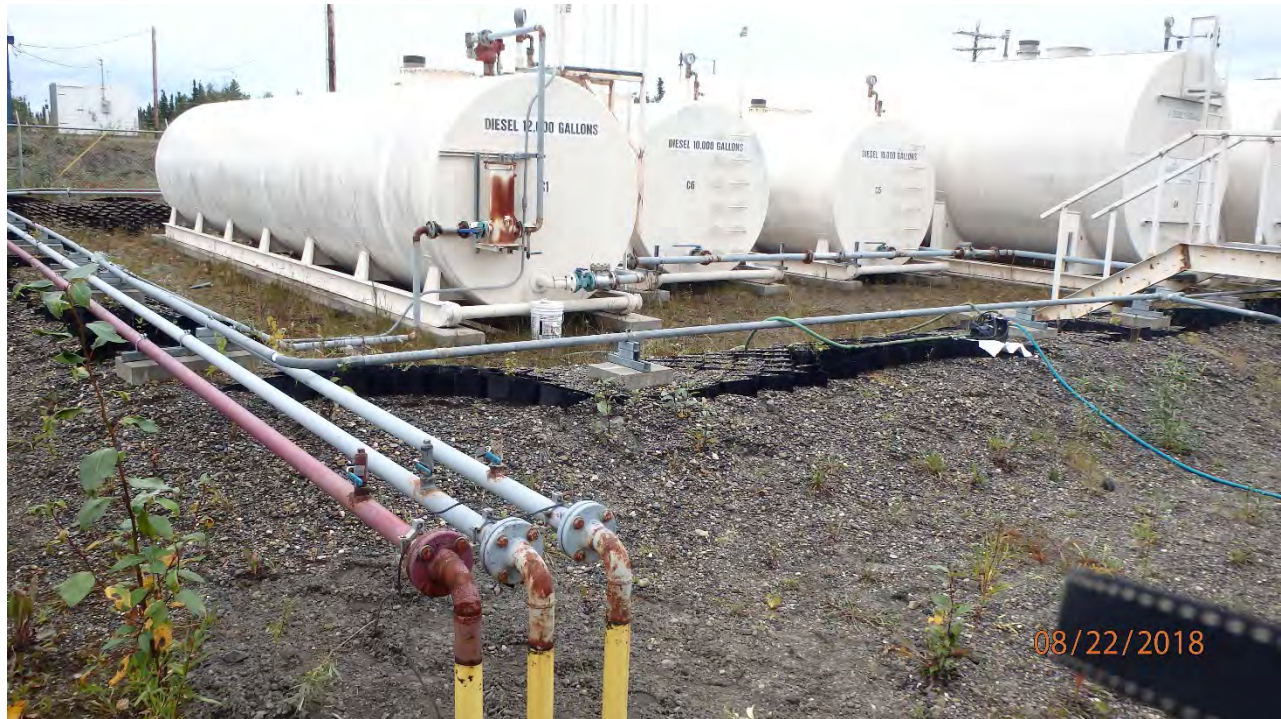
FIGURE 1: THREE REFURBISHED DIESEL TANKS FROM THE ORIGINAL TANK FARM (C5, C6 AND S1)

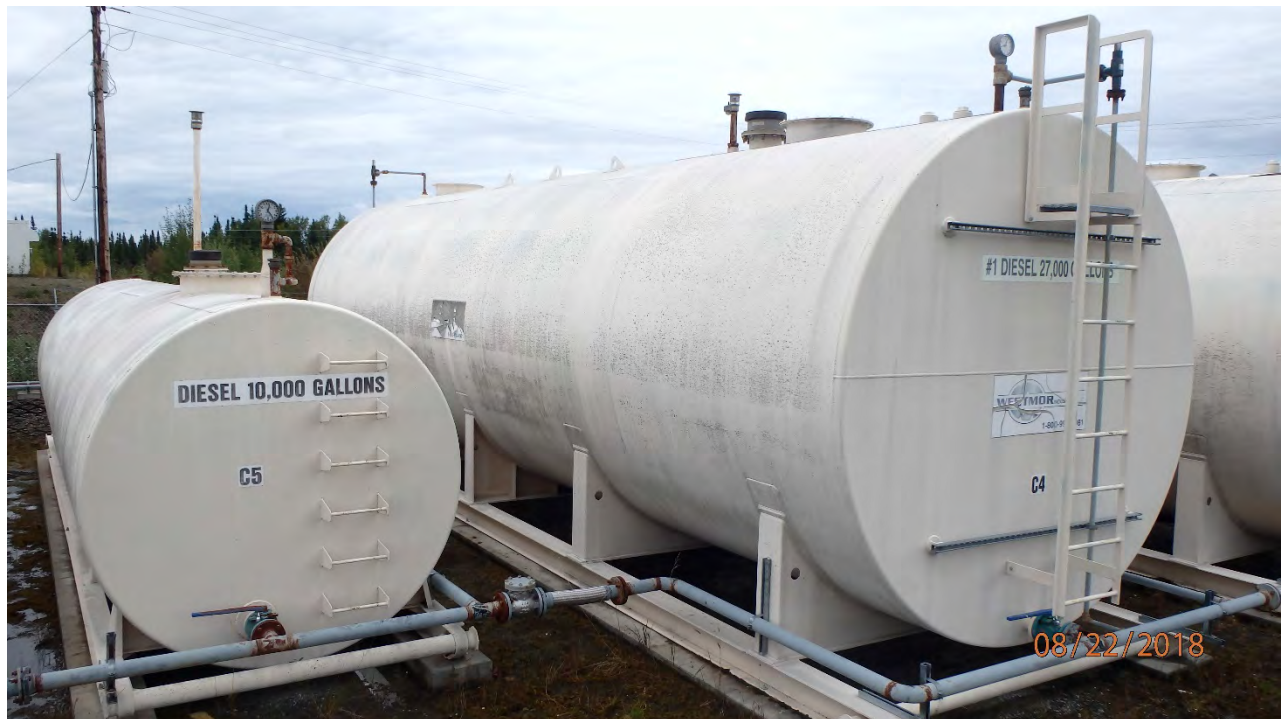
FIGURE 2: NEW DIESEL TANK (C4)

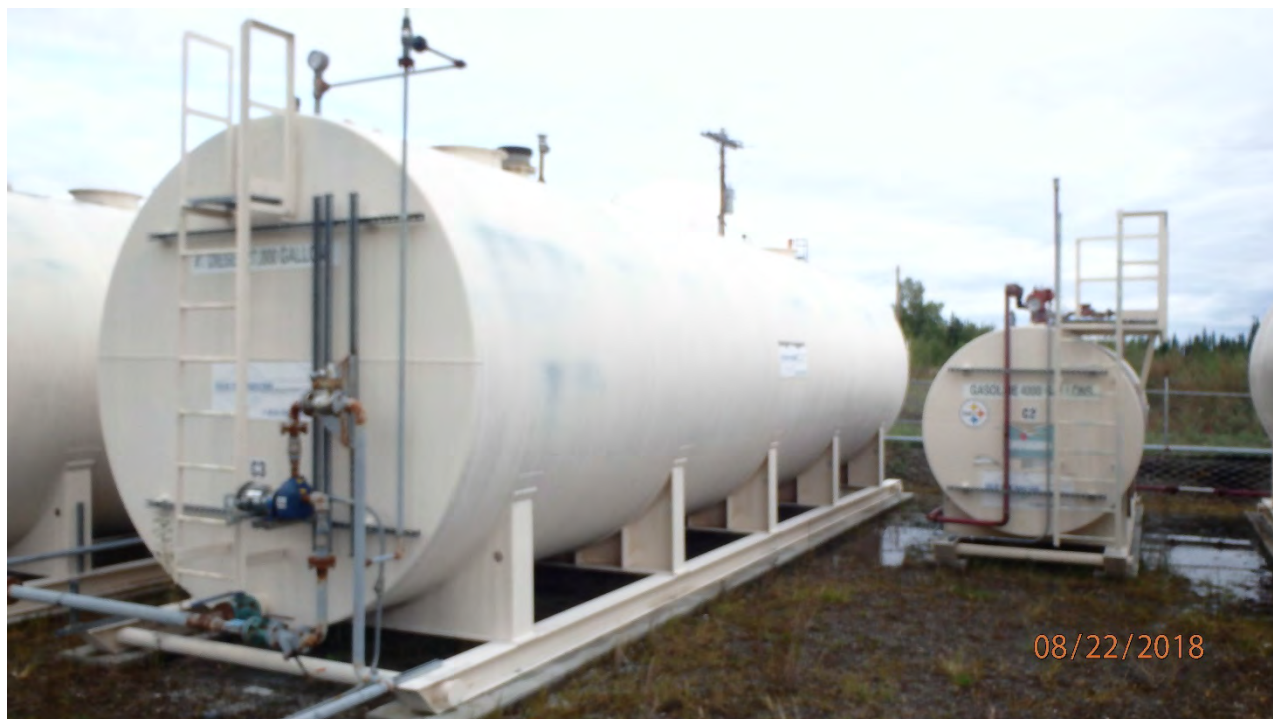
FIGURE 3: NEW DIESEL TANK LEFT (C3), NEW GASOLINE DISPENSING TANK RIGHT (C2)

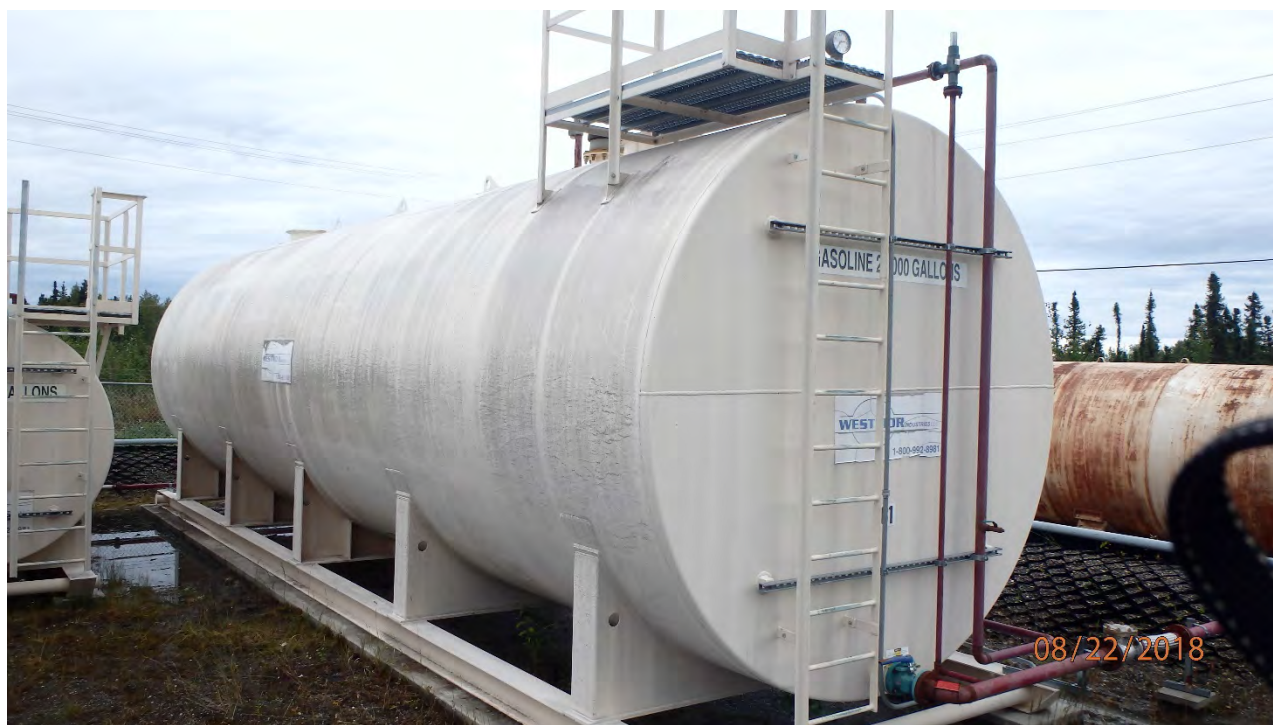
FIGURE 4: NEW GASOLINE DISPENSING TANK RIGHT (C1), CONTINGENCY TANK IN BACKGROUND.

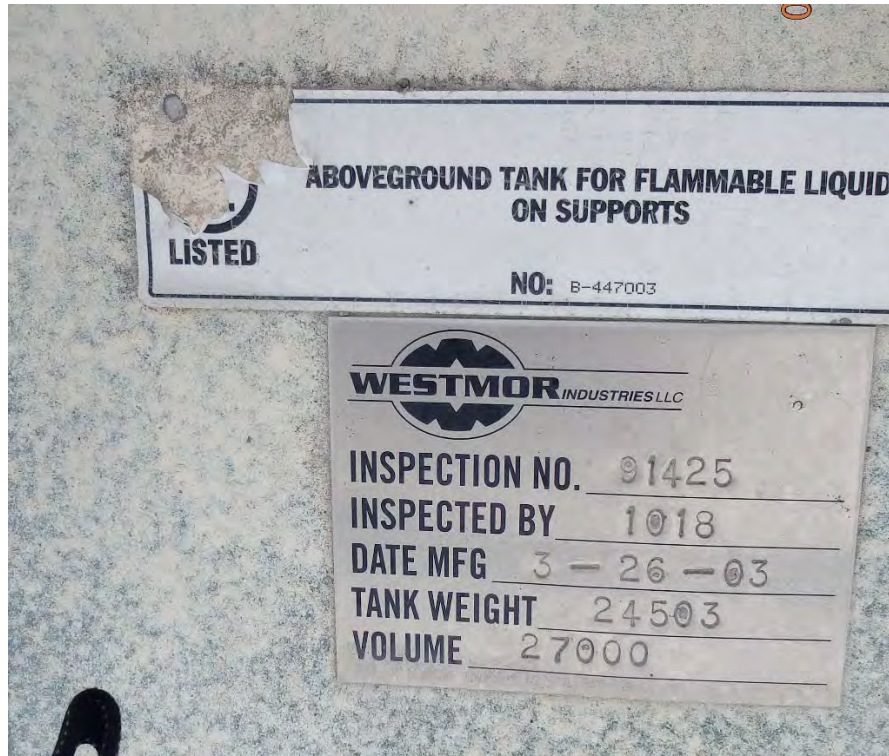
FIGURE 6: UL LISTING INFORMATION FOR TANK C1, GASOLINE STORAGE TANK

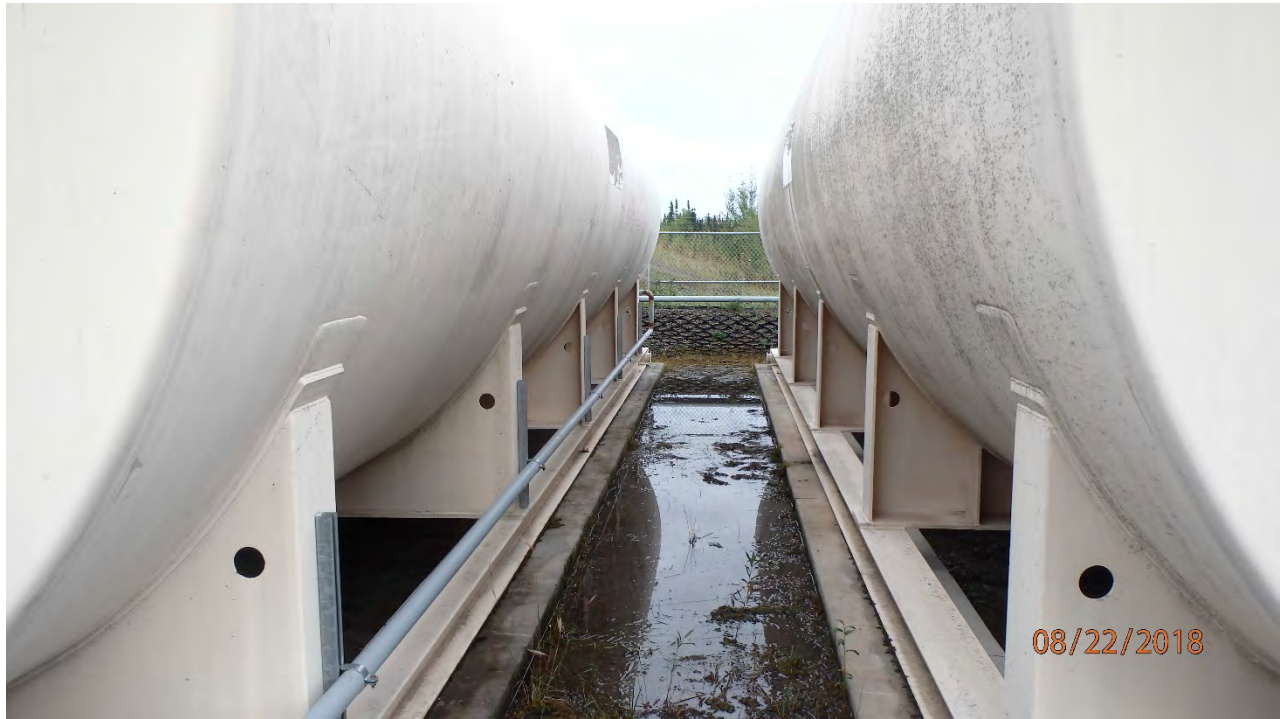
FIGURE 9: TYPICAL TANK SUPPORTS AND CONCRETE PIER FOUNDATIONS.

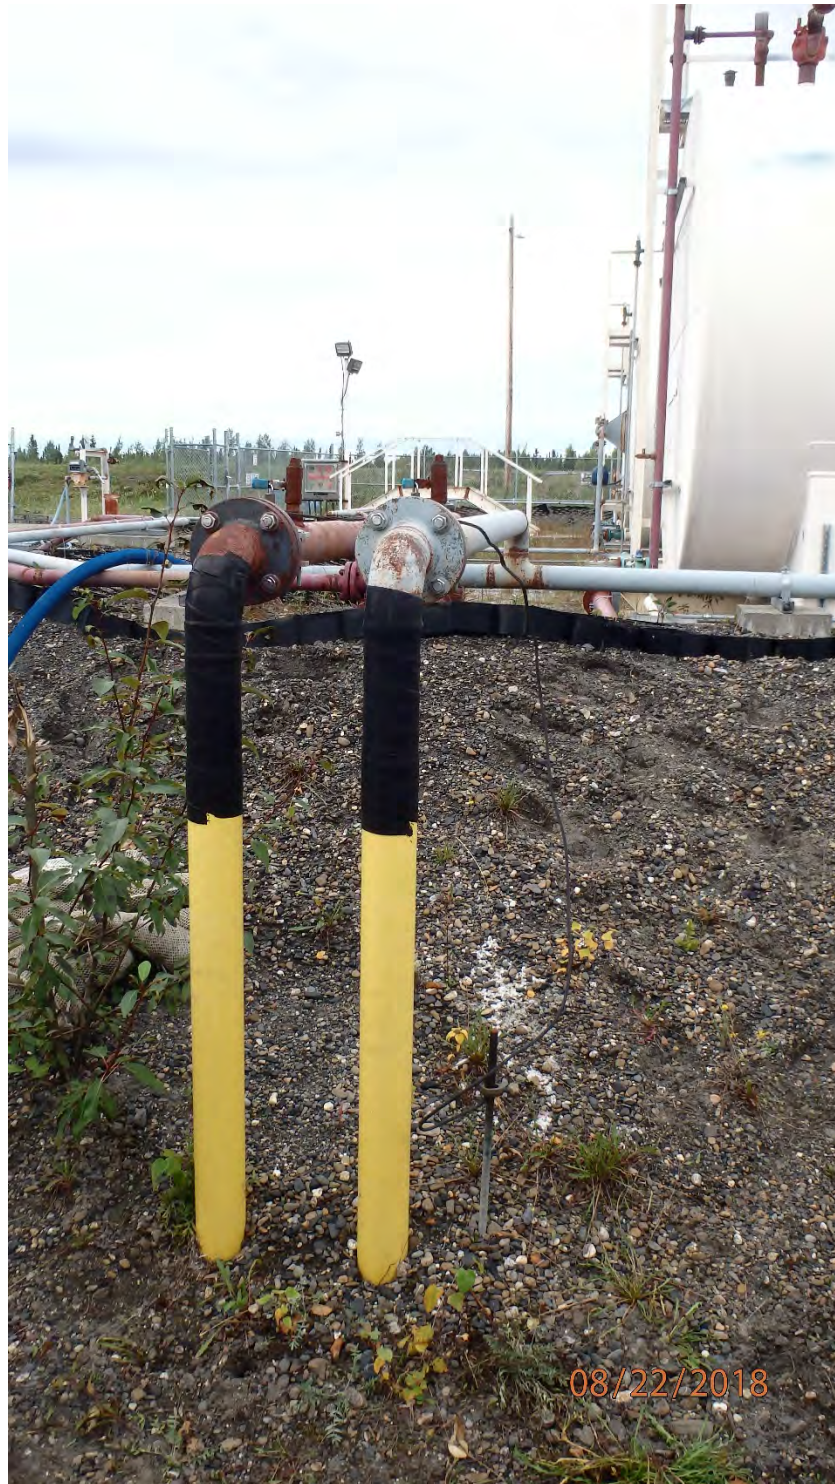
FIGURE 10: 3-INCH BARGE HEADER RISERS IN TANK FARM. GASOLINE ON LEFT, DIESEL ON RIGHT. GROUNDING ROD CONNECTED TO TANK FARM SIDE OF ISOLATION FLANGES.
