FINAL REPORT
BULK FUEL FACILITY ASSESSMENT
VARIOUS LOCATIONS, ALASKA
CONTRACT TFSADNC17D0001, DELIVERY ORDER 20342918F00012

MARCH 2019

Prepared for:
Denali Commission
510 L Street, Suite 410
Anchorage, AK 99501

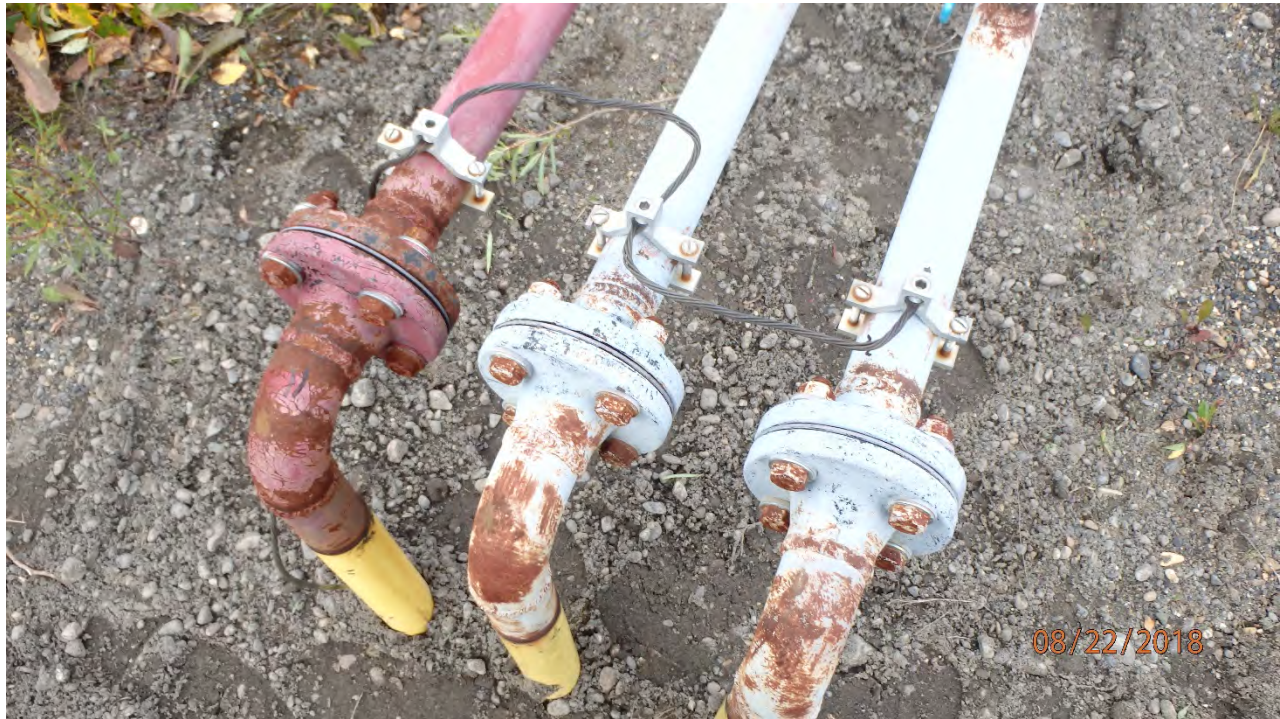
FIGURE 11: 2-INCH SERVICE LINE RISERS IN TANK FARM. GASOLINE ON LEFT, DIESEL (X2) ON RIGHT. GROUNDING ROD CONNECTED TO TANK FARM SIDE OF ISOLATION FLANGES.

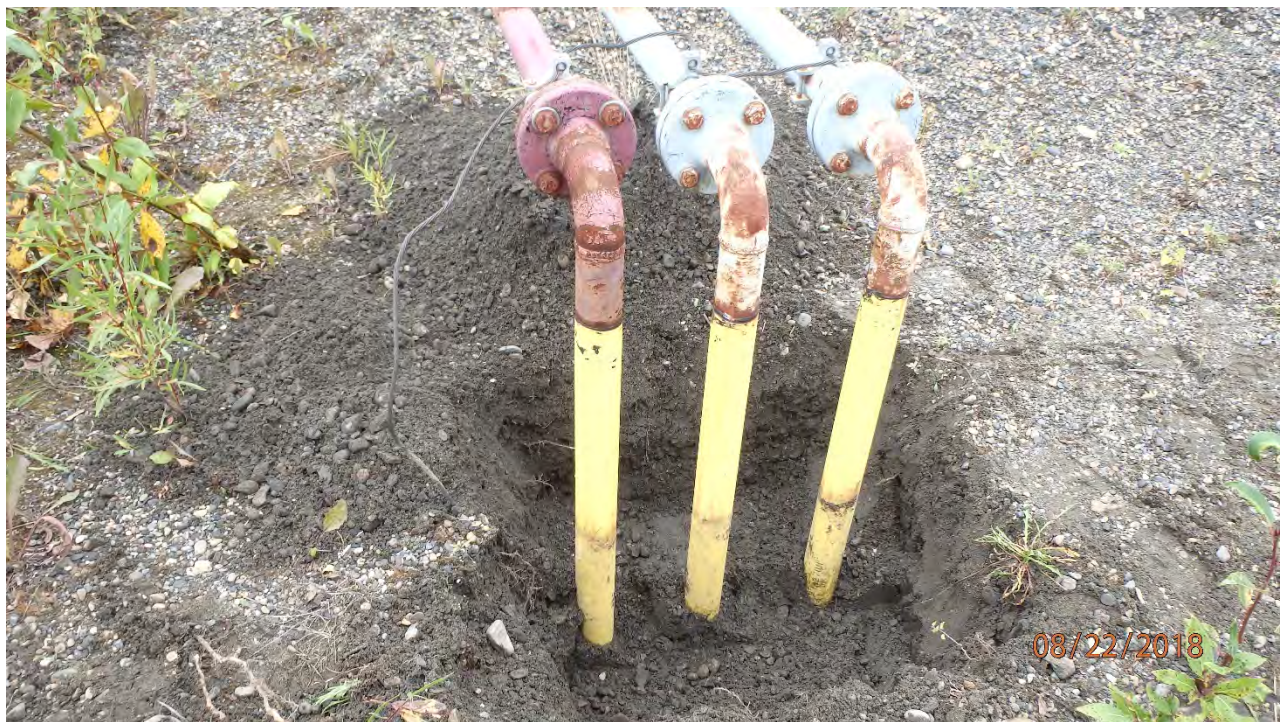
FIGURE 12: 2-INCH SERVICE LINE RISERS IN TANK FARM. GASOLINE ON LEFT, DIESEL (X2) ON RIGHT. 18-INCH DEEP EXCAVATION TO ASSESS COATING CONDITION.

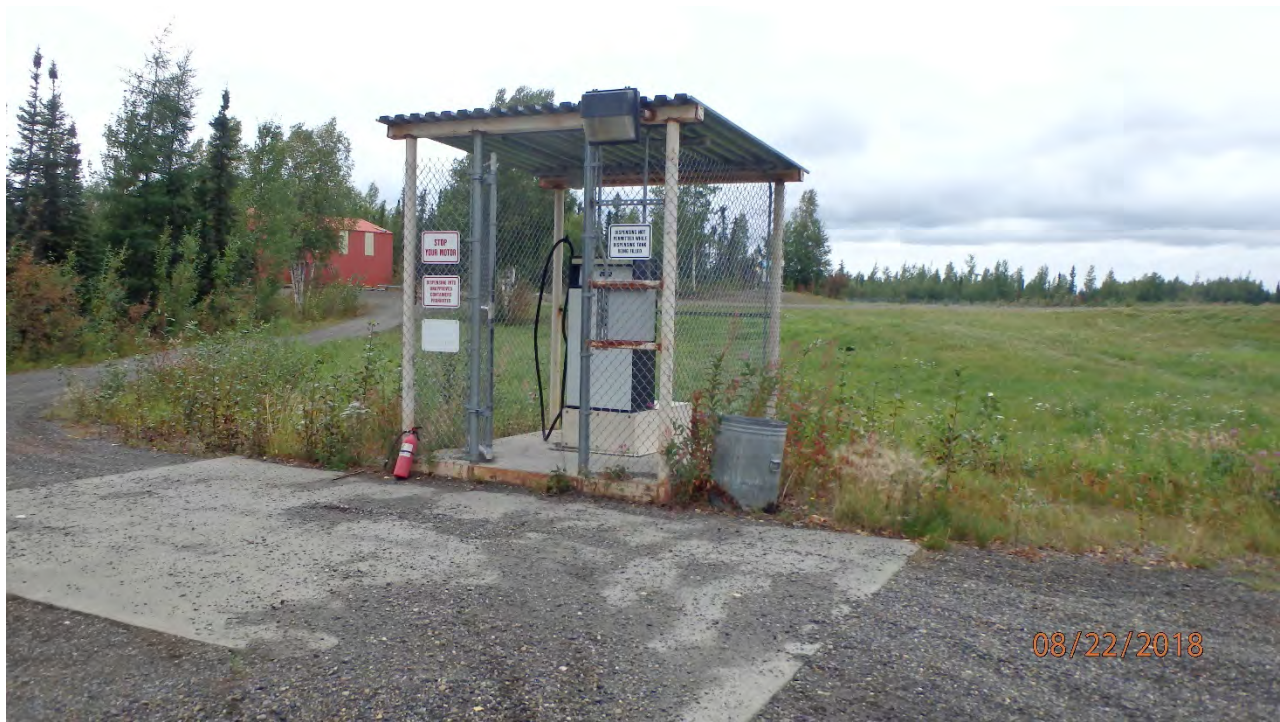
FIGURE 13: GASOLINE DISPENSER ADJACENT TO TANK FARM.

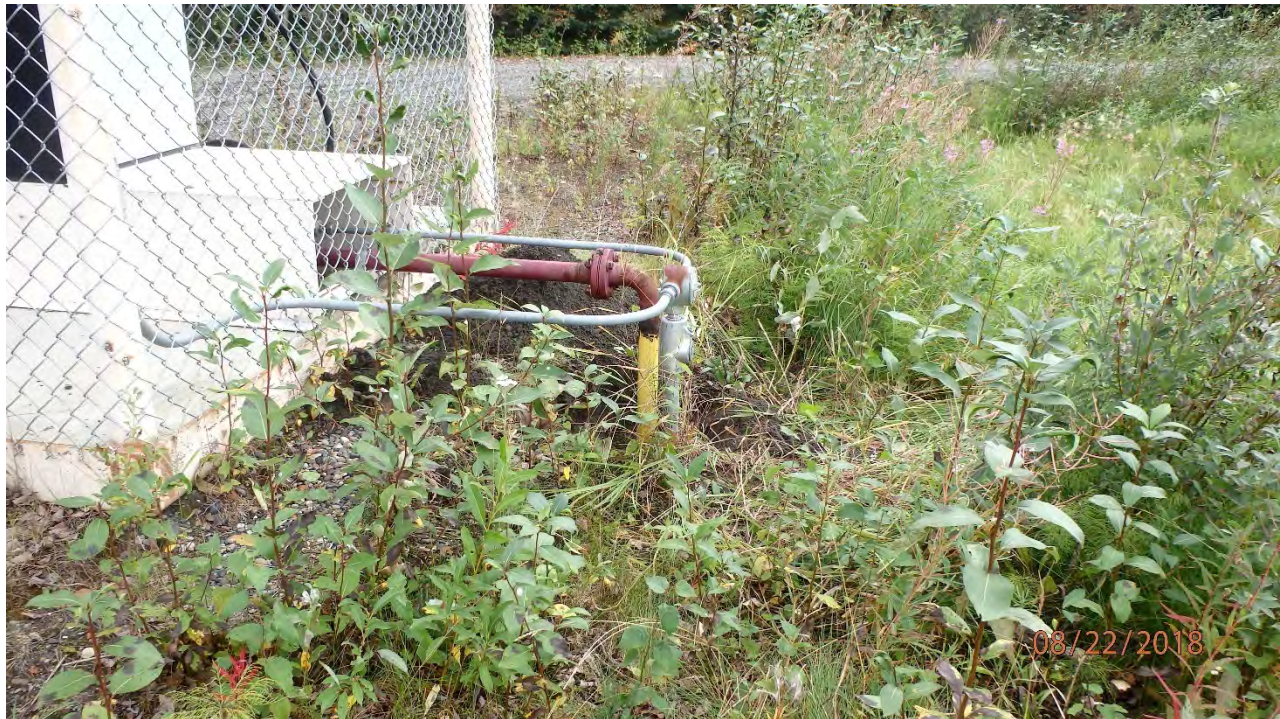
FIGURE 14: GASOLINE DISPENSER RISER.

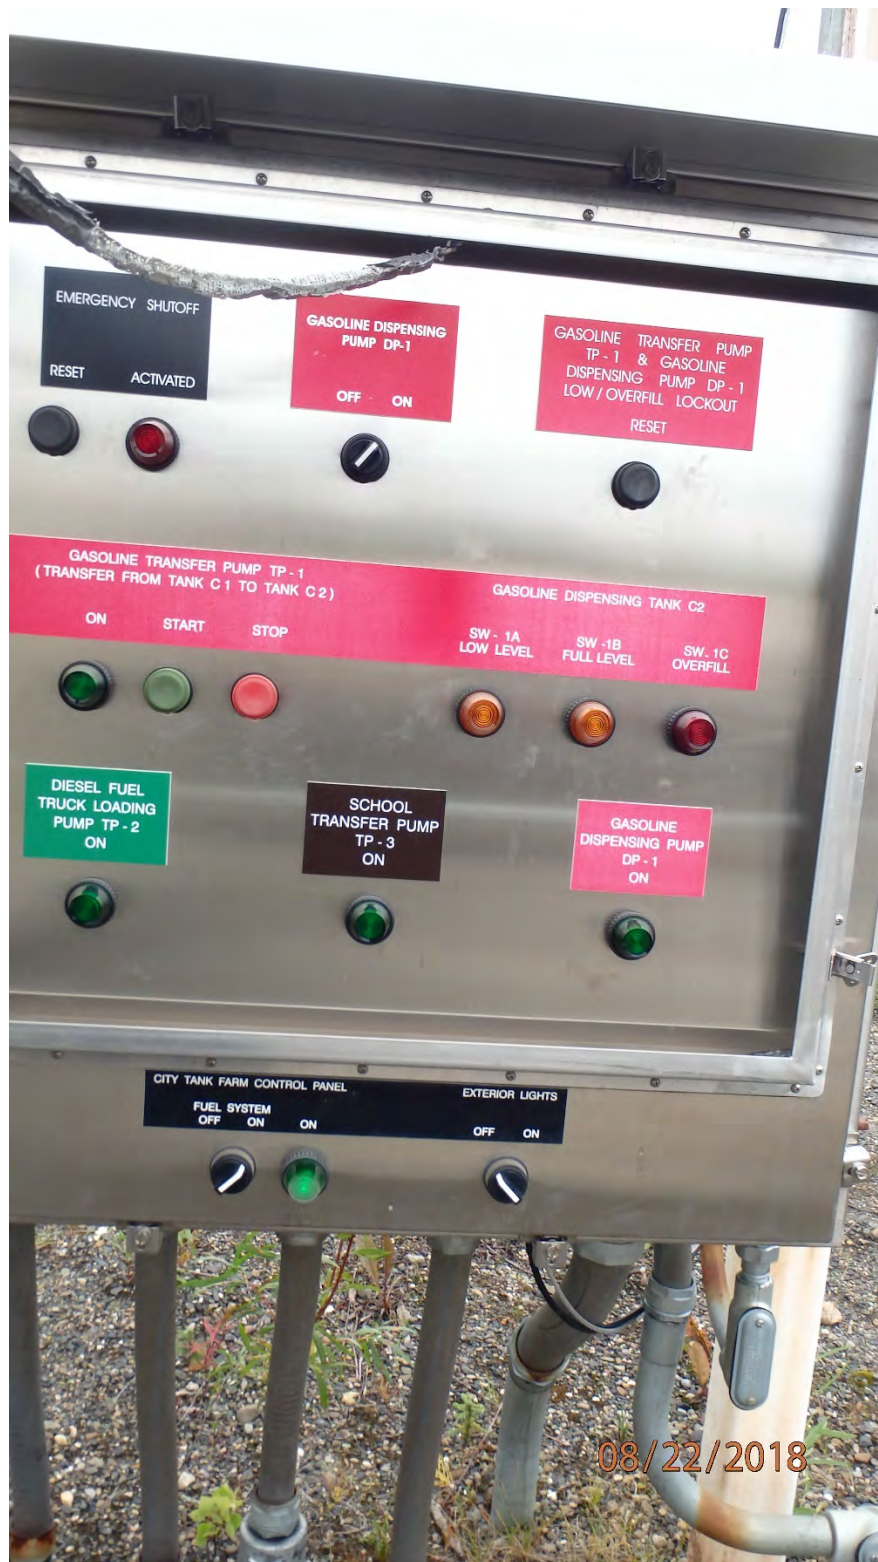
FIGURE 20: TANK FARM CONTROL PANEL.

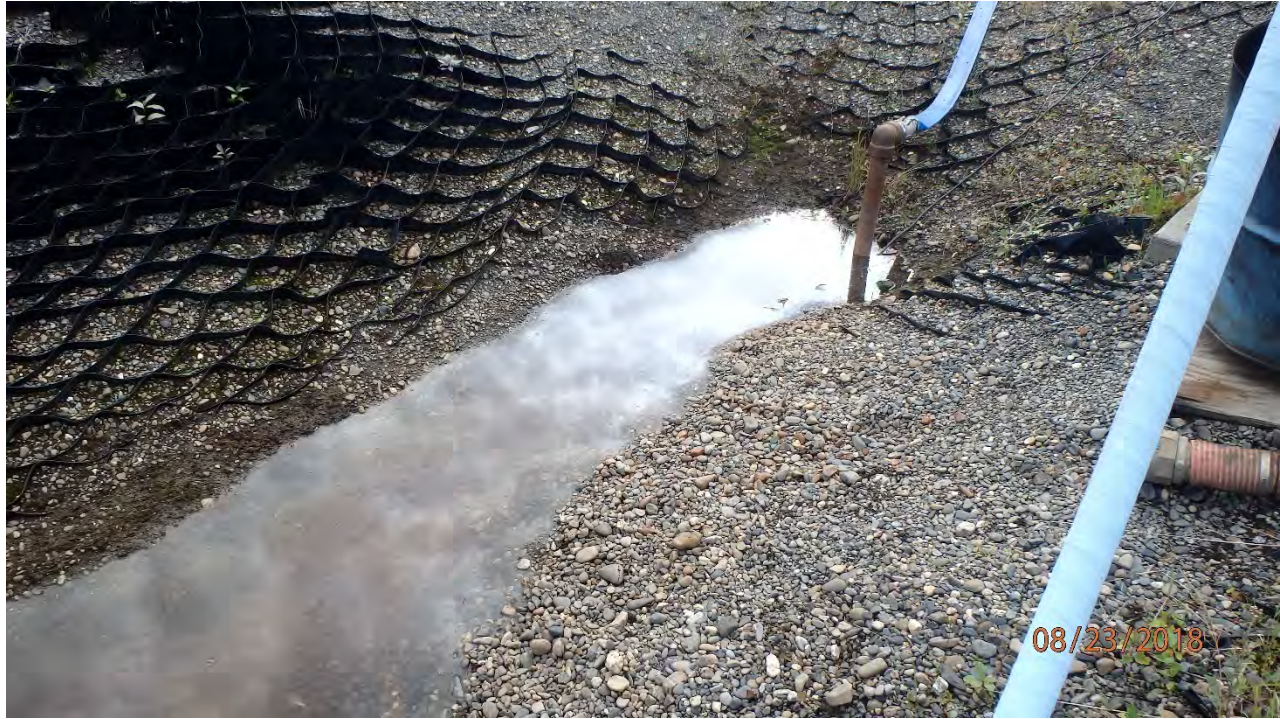
FIGURE 21: CATCHMENT ADJACENT TO AIRCRAFT HEADER AND DIESEL DISPENSER. FUEL SHEEN ON WATER.

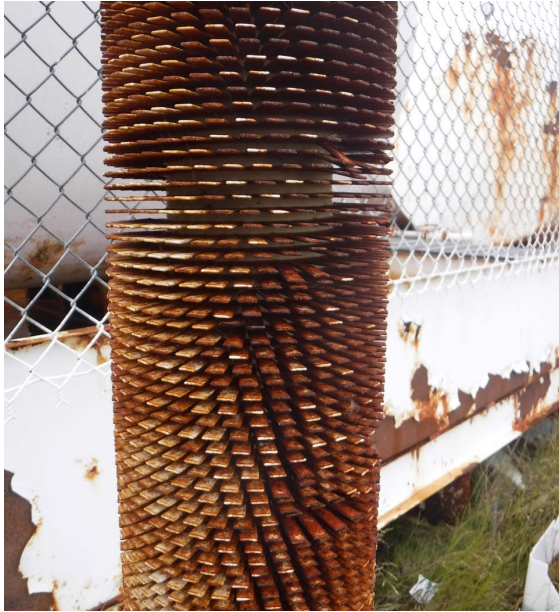
Figure 1: Finned Condenser Corrosion

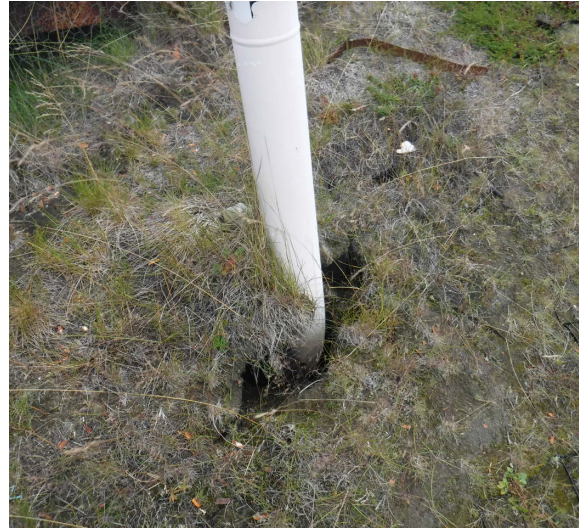
Jason observed cavities in the soil around the thermosyphon riser pipe (Figure 2). These cavities are assumed to be caused by slumping of the pad in these locations (Figures 3 and 4). No water was visible inside the cavities, however it is assumed that water does penetrate the cavities, ponds, and then seeps through the pad. It is recommended that a maintenance program be established to fill these cavities with fine-grained soil and keep them filled.

Figure 2: Ground Surface Cavities

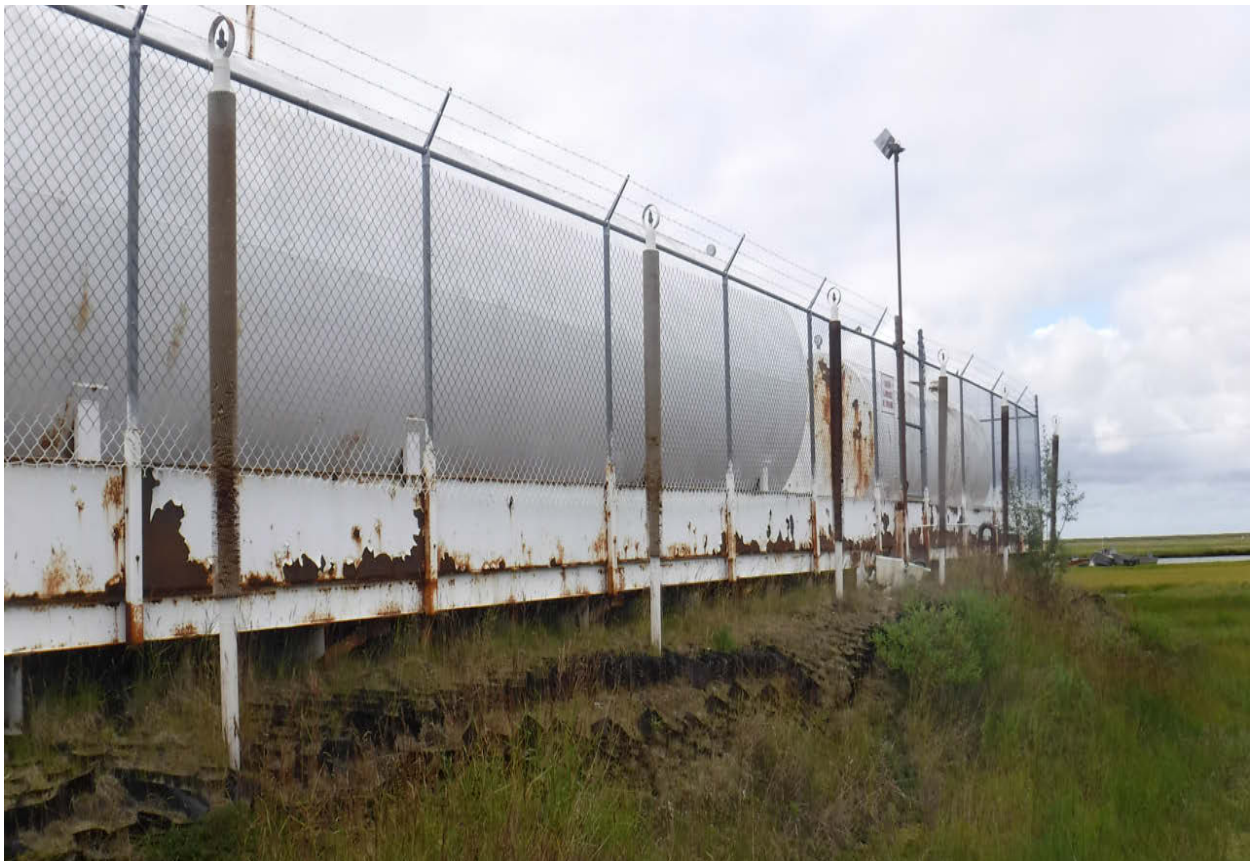
Figure 3: Pad slumping

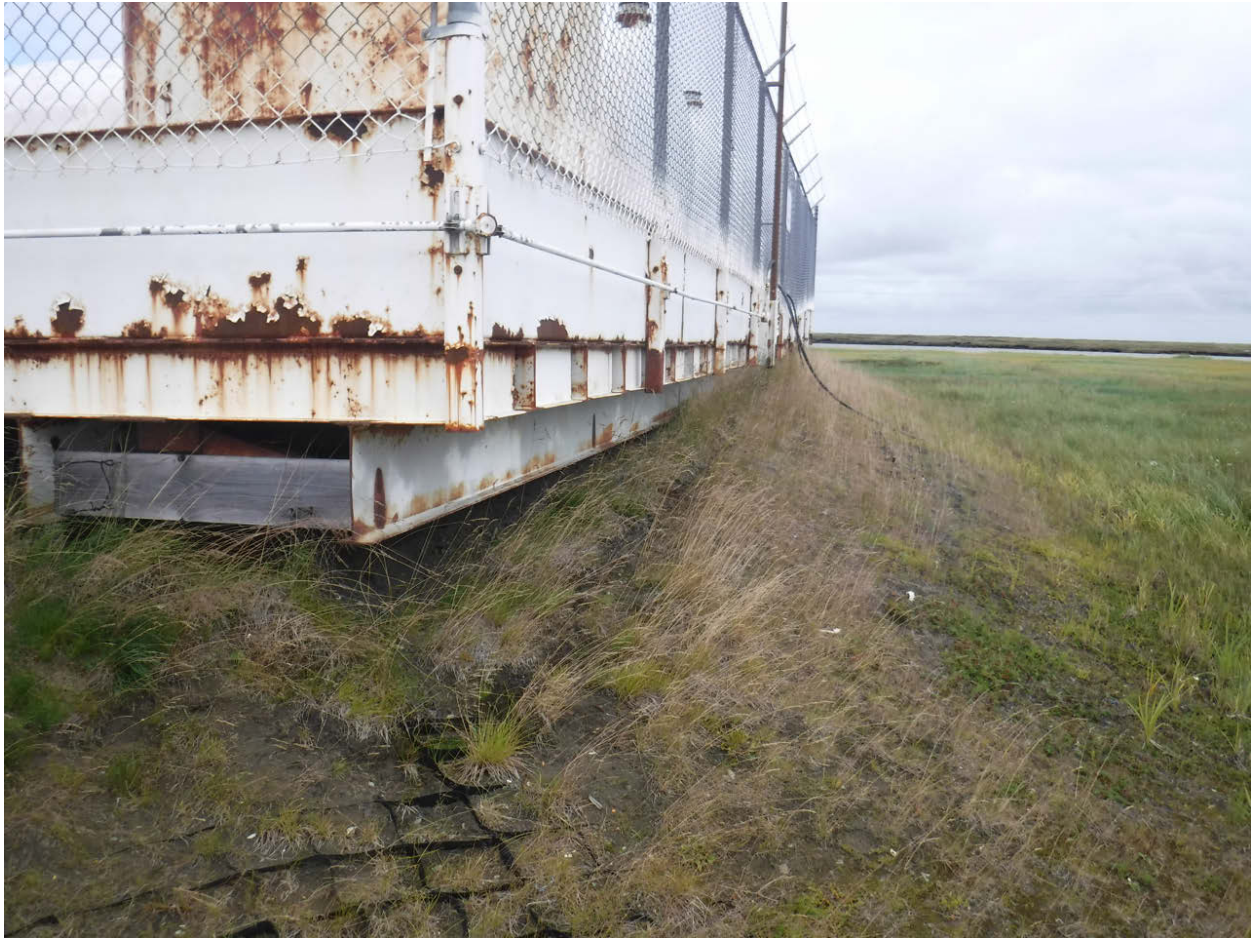
Figure 4: Southwest corner of bulk fuel tank farm (typical of all four corners)

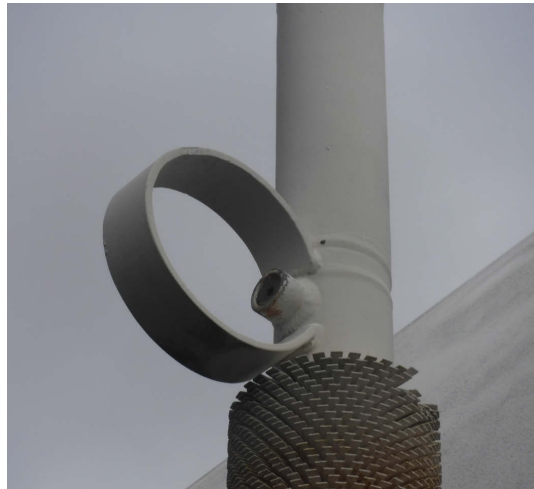
Unit #7 had a sheared valve (Figure 5). The primary part of the valve is sheared off and the threaded portion of the valve is still installed. Unit #8 had zero pressure. Unit #11 had low pressure. It's likely that impact during installation may have caused a slight leak on unit #11. All three of these units are not operational.

Figure 5: Missing valve on Unit #7

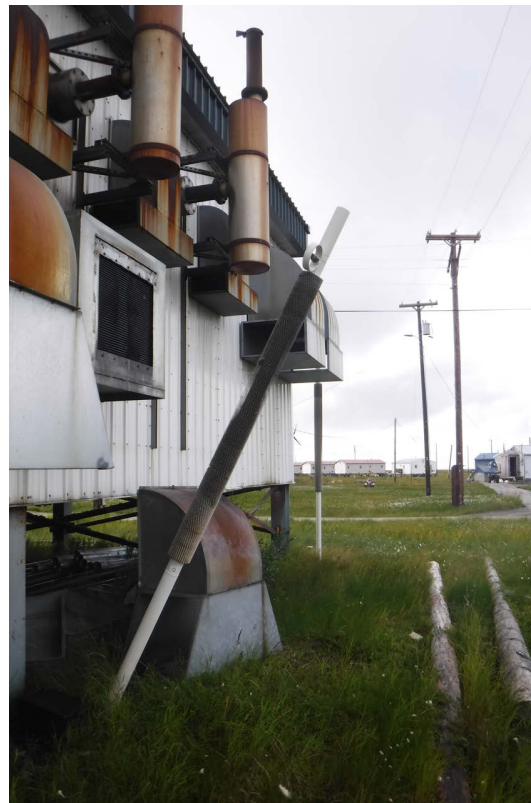
Unit #1, located at the SE corner of the powerhouse was not inspected. Power lines wrapped around the condenser made it unsafe to inspect (Figure 6). Also note, Unit #5, located on the west side of the powerhouse, is leaning (Figure 7). This unit was originally installed vertically (Figure 8). Sometime after the completion of the original construction someone added a hood on the outside of the module, which required bending of the thermosyphon. The thermosyphon has maintained its integrity as evidenced by the adequate internal pressure.

Figure 7: Unit #5 leaning

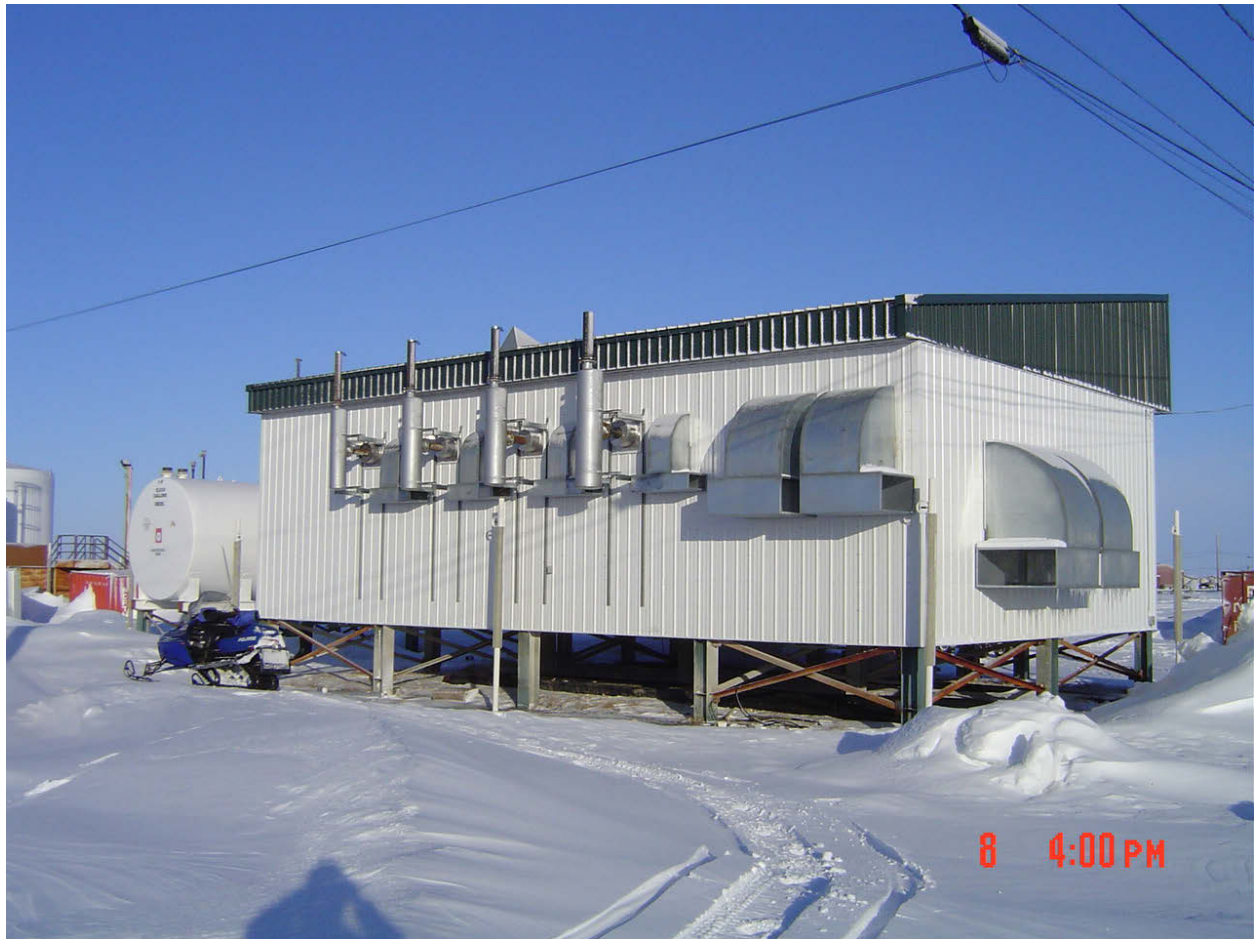
Figure 8: Thermosyphon #5 not leaning.

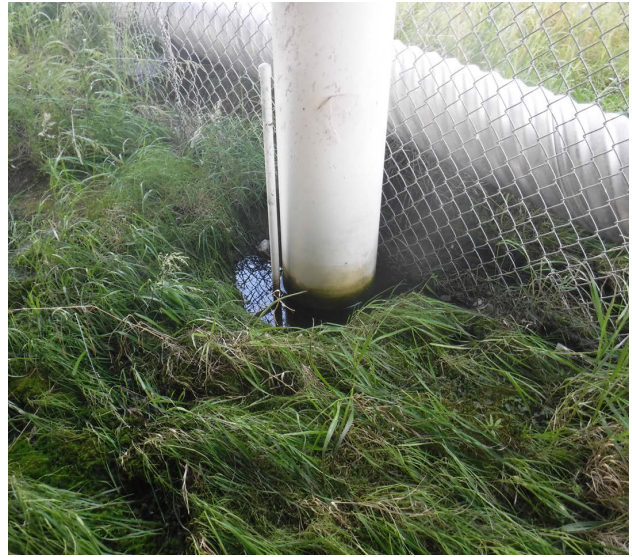
Water-filled depressions at the ground surface were observed around the circumference of nearly all the thermopiles (Figure 10). Thermopile unit #s 21 and 22 were located in an area of extensive ponded water, nearly a foot deep (Figure 11). It is recommended to establish positive drainage away from all the piles to prevent ponded water.

Figure 10: Water-filled depressions

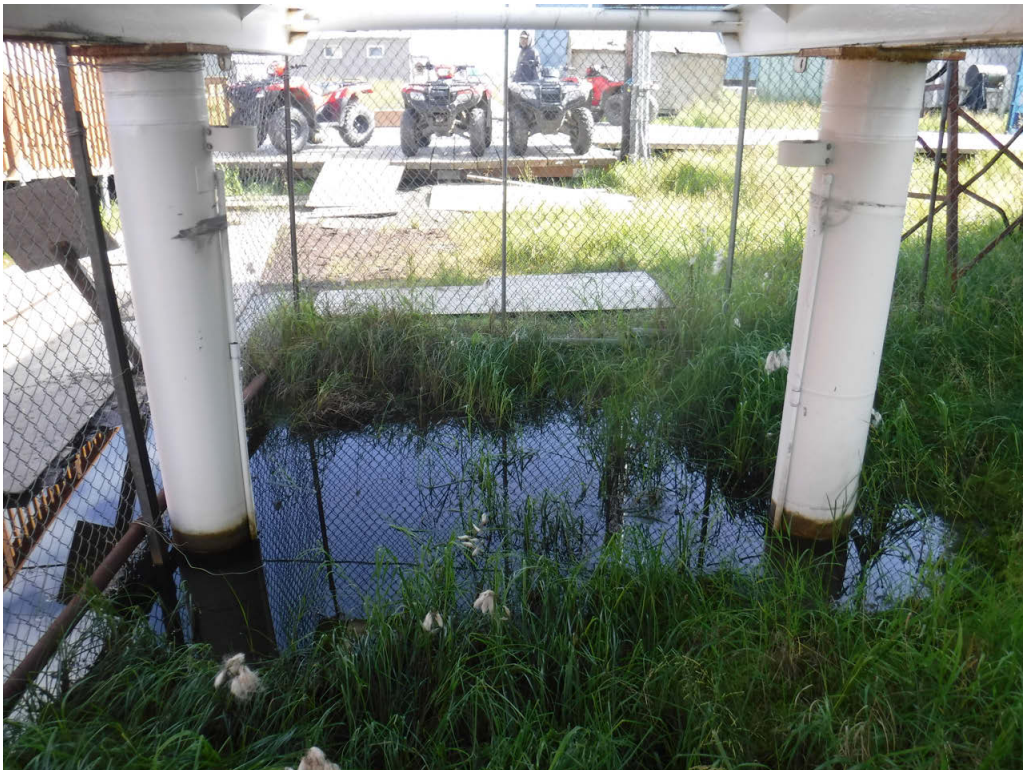
Figure 11: Extensive ponded water around piles under fuel tank at New Power House
